October 2023
FL966A-F
NHTSA #23V-073
Transport Canada #2023-051
REVISED BULLETIN

Subject: Brake Modulator Valves

Models Affected: Specific model years 2017-2022 Freightliner 114SD, and Cascadia; and Western Star 47X, and 49X vehicles manufactured June 28, 2016, through April 8, 2022.

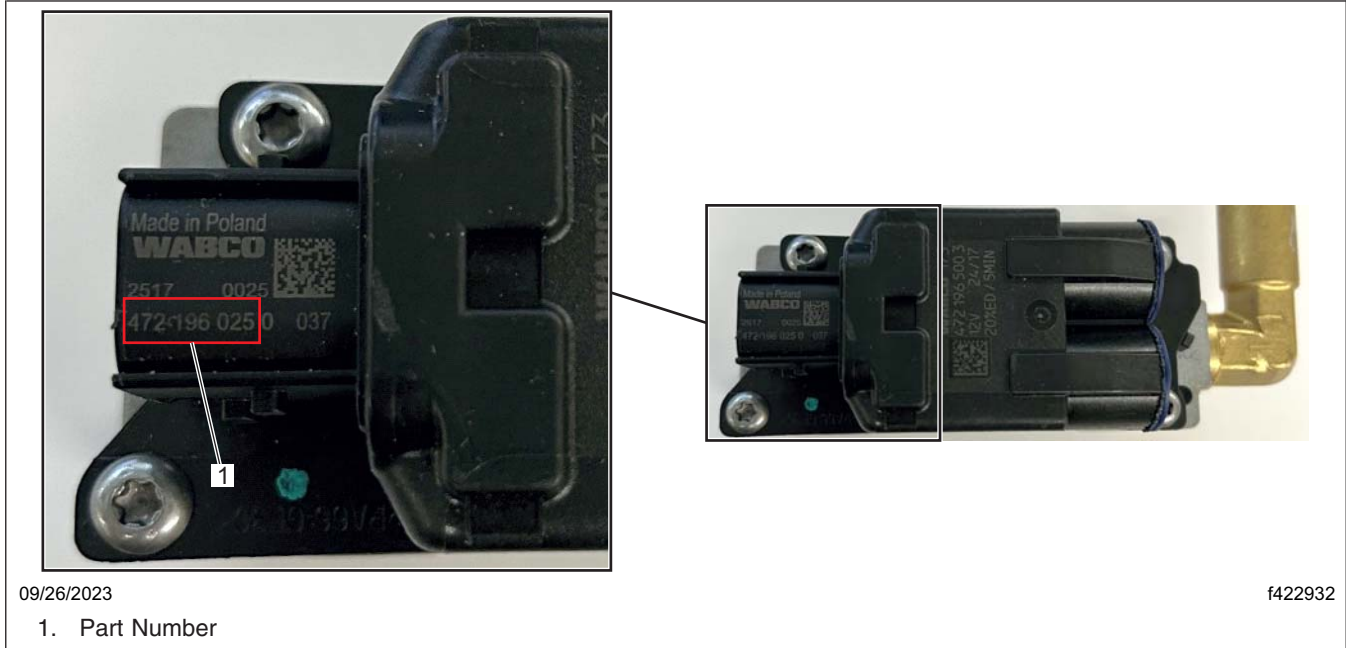
Fig. 1, Modulator Valve

4. Remove the connector from the valve, and inspect the part number underneath the connector. See [Fig. 1](#).

Good part numbers → **472 196 046 0** and **472 196 051 0**

Bad part numbers → **472 196 025 0** and **472 196 037 0**

- If the part numbers are good, install the connector. Clean a spot on the base label (Form WAR259), and attach a campaign completion sticker for FL966 (Form WAR260), indicating this work has been completed.
- If at least one of the part numbers is bad, go to the replacement procedure for the specified group, and replace both the modulator valves.
