PRODUCT CAMPAIGN BULLETIN

APPLICABILITY: 2004-2005 Impreza (including WRX)

NUMBER: WRF-23

SUBJECT: Improper Air Bag Inflator Installation

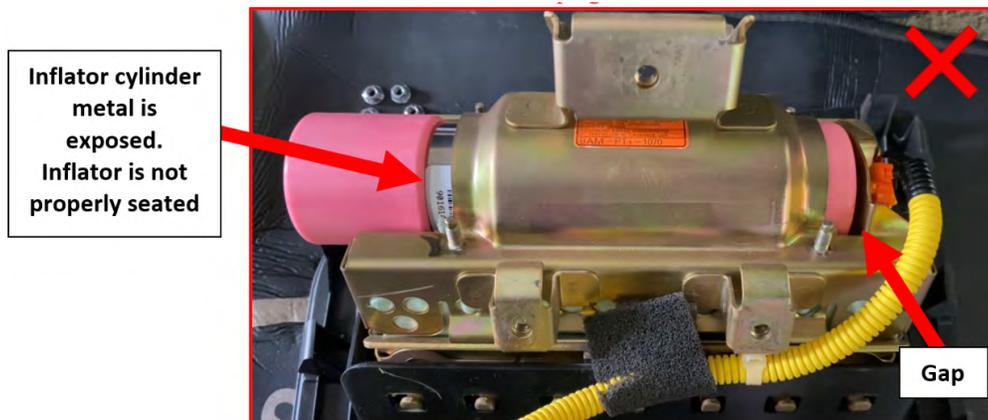
INCORRECT: When incorrectly installed (backwards) the inflator cylinder (silver colored) metal is exposed, and a gap can be seen between the inflator and the end bracket. Further action will be required. Follow this service procedure. If inspection confirms the inflator is installed incorrectly (backwards), photograph the incorrectly installed inflator in the bracket and attach photo to the claim, then proceed to the “INFLATOR REPLACEMENT” section of this campaign.

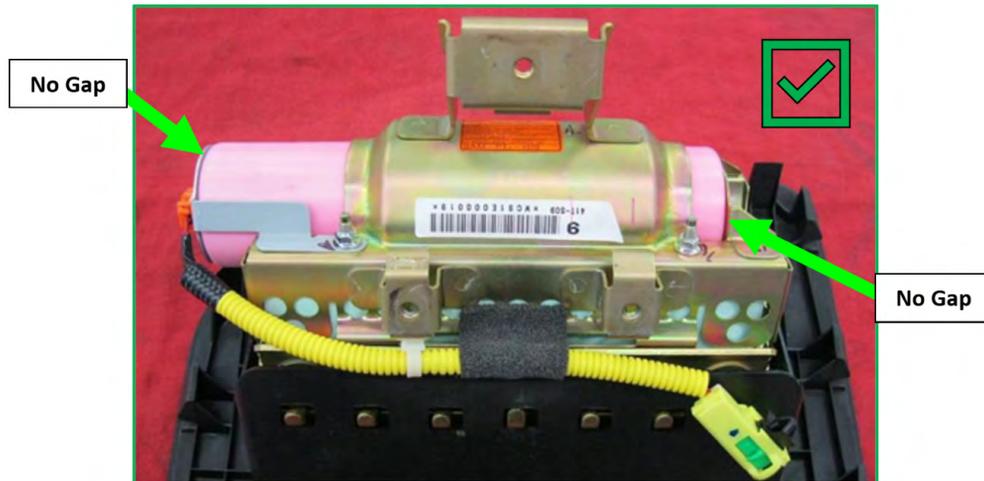
CORRECT: When correctly installed, no inflator cylinder metal is exposed and there are no gaps between the inflator and the end brackets on both sides. If inspection confirms the affected vehicle has the inflator installed correctly in the bracket, do not remove inflator from the bracket. Photograph the inflator in the bracket and attach photo to the claim. Reinstall the airbag assembly as per the applicable Service Manual.

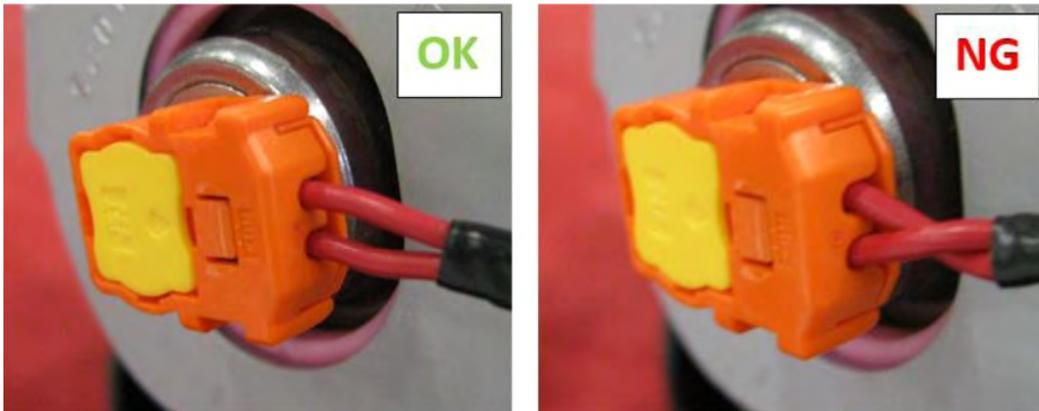
IMPORTANT: Confirm the harness is not twisted at the inflator connector as shown below.
