PRODUCT CAMPAIGN BULLETIN

APPLICABILITY: 2019-2022 Crosstrek Hybrid

NUMBER: WRD-23R

SUBJECT: 12V Inverter Connector Corrosion

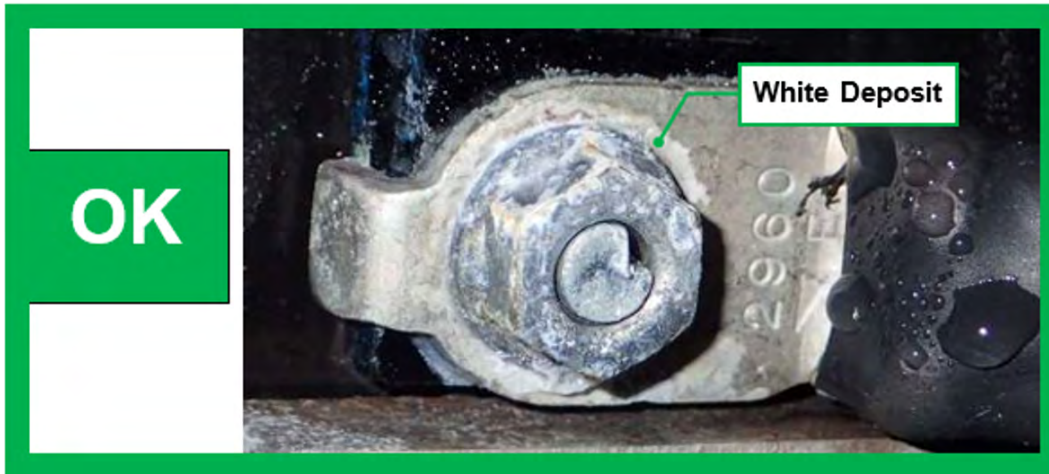
STEP 9: Perform a visual inspection of the High Voltage (HV) air conditioning wire terminal for corrosion and/or damage. See the example images below.

NOTE: White Deposits found on the terminal is considered acceptable.

Inspection Result		Next Step
OK	No Corrosion, Red Rust and/or Breakage found	Proceed to Service Procedure A
NG	Corrosion, Breakage, and/or Red Rust was found	Proceed to Service Procedure B
