**PRODUCT CAMPAIGN BULLETIN**

**APPLICABILITY:** 2019-2022 Crosstrek Hybrid

**NUMBER:** WRD-23R

**SUBJECT:** 12V Inverter Connector Corrosion

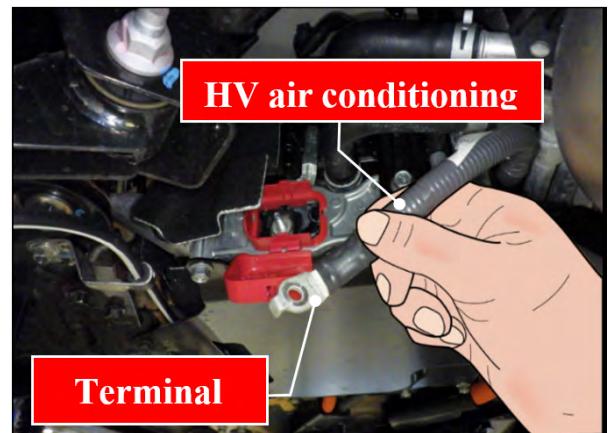
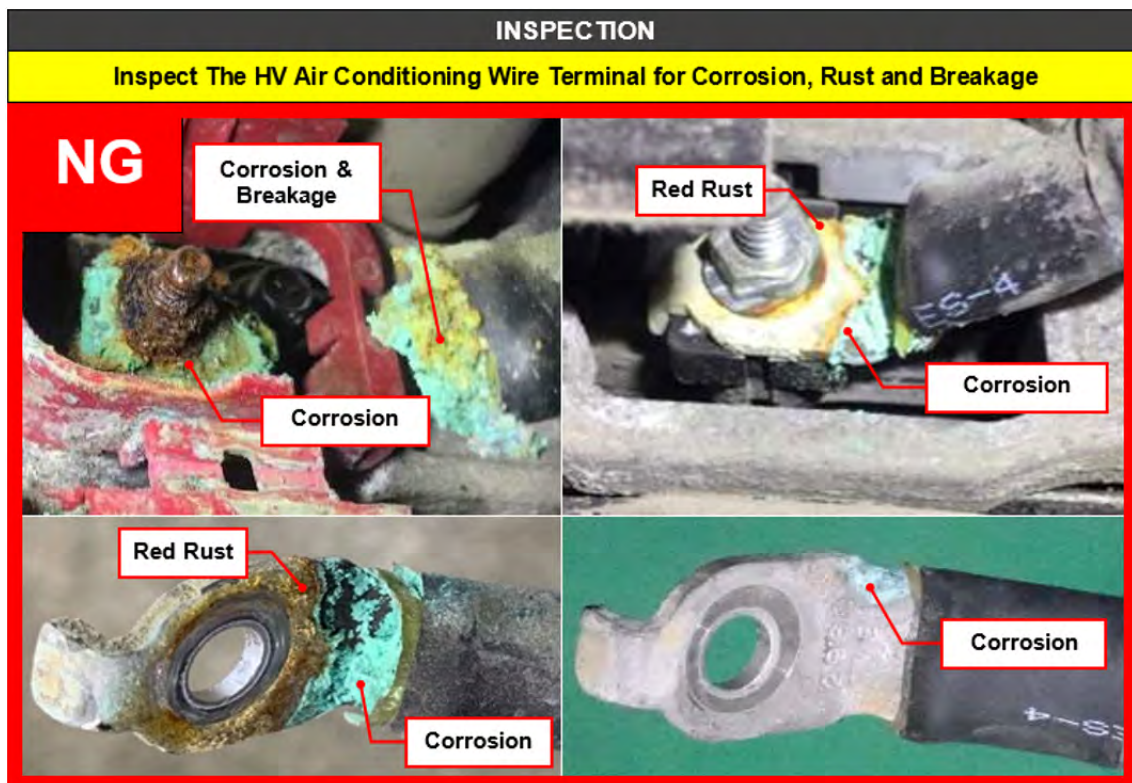
**STEP 9:** Perform a visual inspection of the High Voltage (HV) air conditioning wire terminal for corrosion and/or damage. See the example images below.

**NOTE:** White Deposits found on the terminal is considered acceptable.

Inspection Result		Next Step
<b>OK</b>	No Corrosion, Red Rust and/or Breakage found	Proceed to Service Procedure A
<b>NG</b>	Corrosion, Breakage, and/or Red Rust was found	Proceed to Service Procedure B

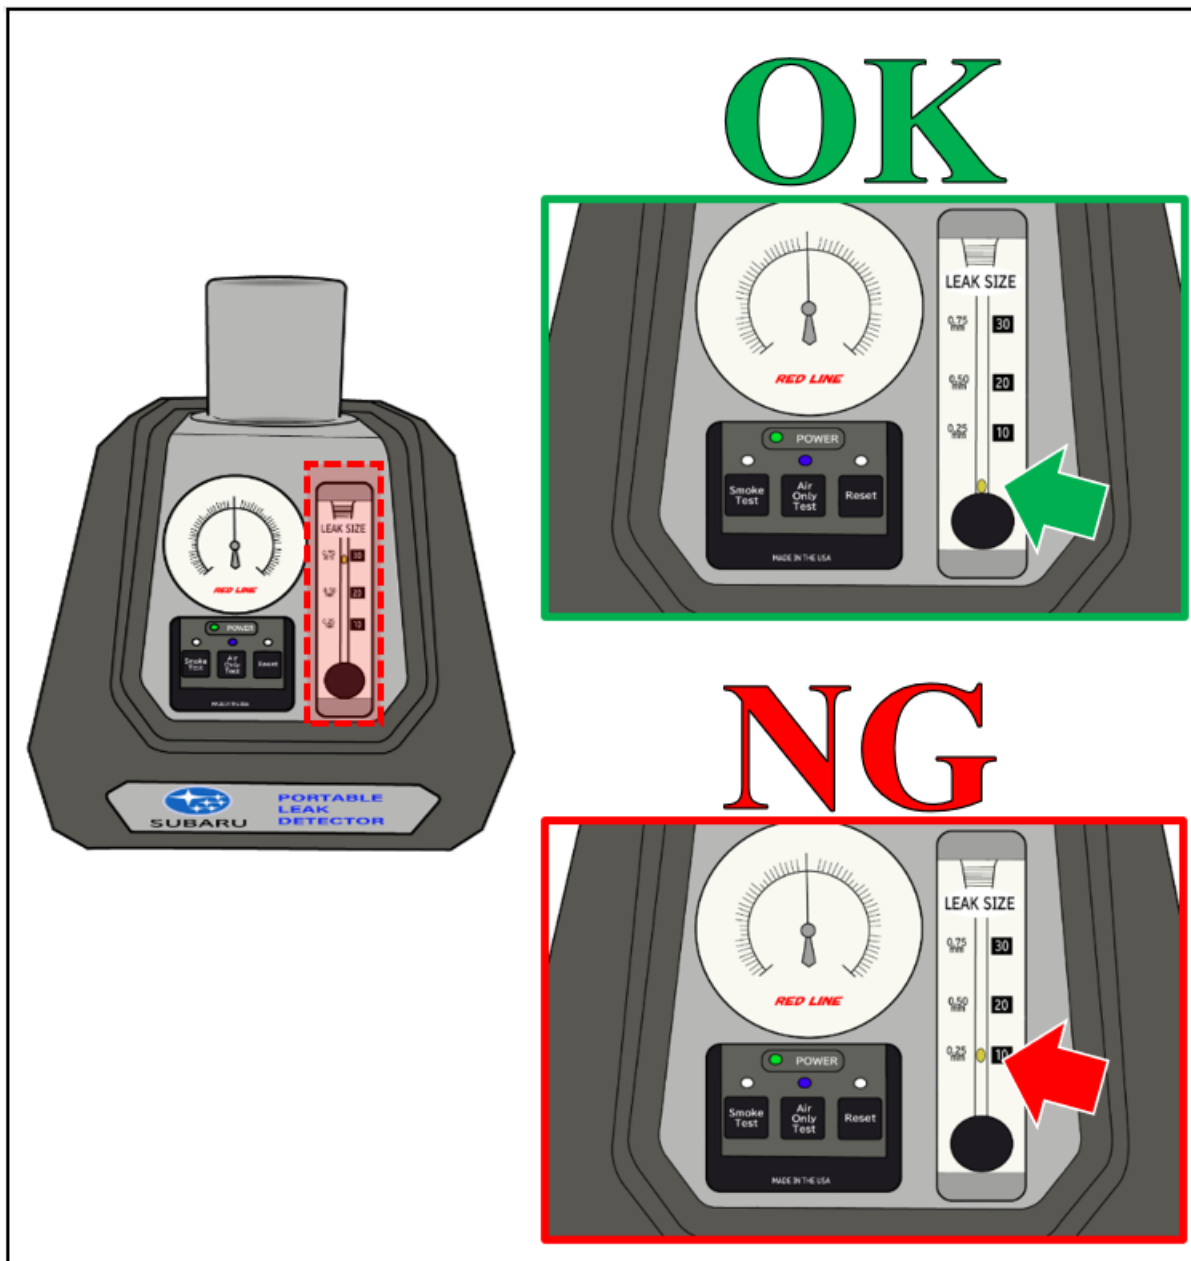
**STEP 45:** During the leakage test, confirm the float stays at the bottom.

**CAUTION:** If leakage is detected, check connection conditions, the testing equipment for damage and/or deformation of the inverter/converter lid then re-test. If no visible fault is found and leakage is still found, removed the inverter/converter lid, clean and reseal the lid then retest.
