**PRODUCT CAMPAIGN BULLETIN**

**APPLICABILITY:** 2019-2022 Crosstrek Hybrid

**NUMBER:** WRD-23R

**SUBJECT:** 12V Inverter Connector Corrosion

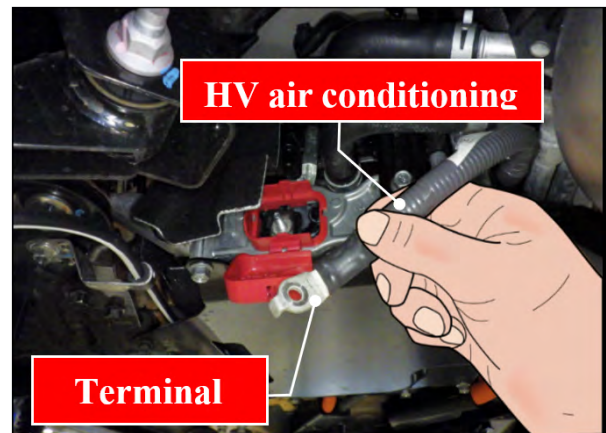
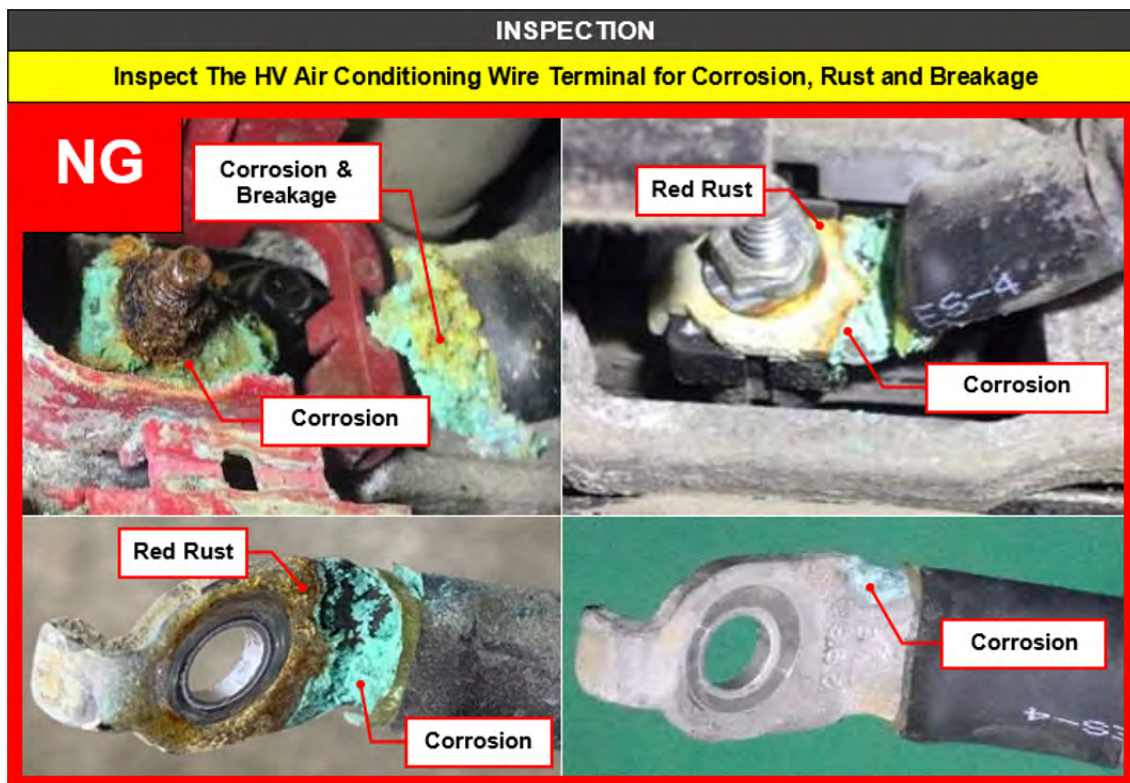
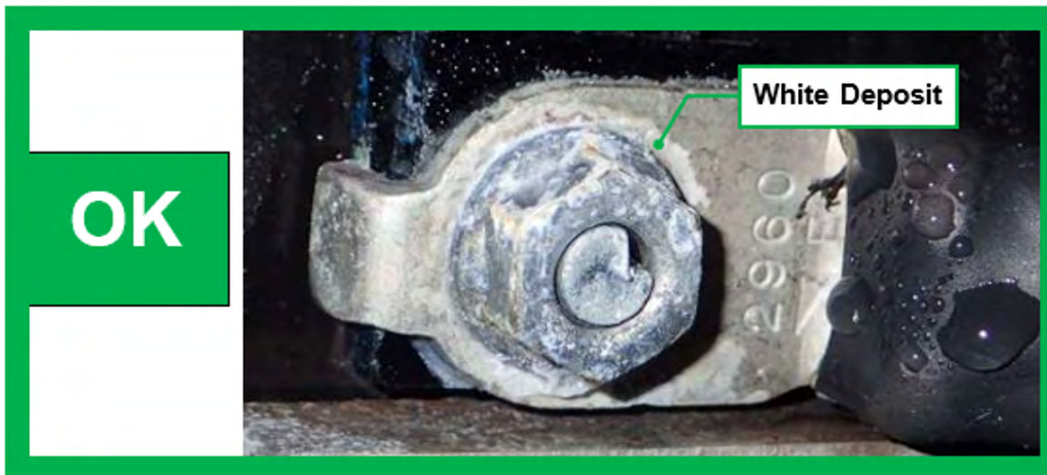
**STEP 9:** Perform a visual inspection of the High Voltage (HV) air conditioning wire terminal for corrosion and/or damage. See the example images below.

**NOTE:** White Deposits found on the terminal is considered acceptable.

Inspection Result		Next Step
<b>OK</b>	No Corrosion, Red Rust and/or Breakage found	Proceed to Service Procedure A
<b>NG</b>	Corrosion, Breakage, and/or Red Rust was found	Proceed to Service Procedure B

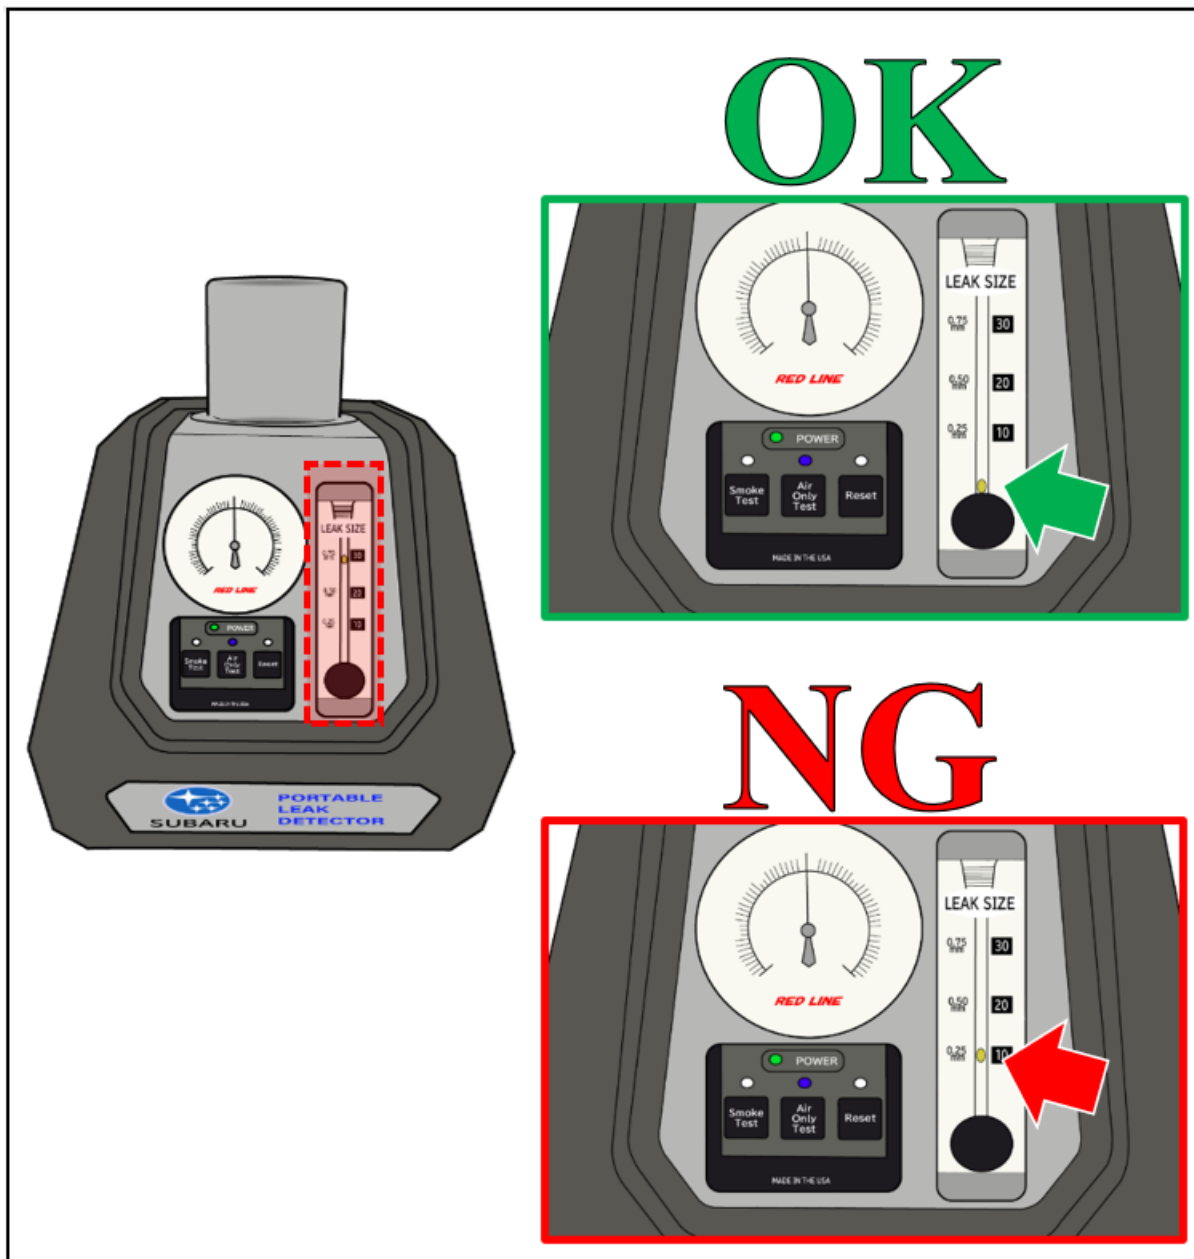
**STEP 45:** During the leakage test, confirm the float stays at the bottom.

**CAUTION:** If leakage is detected, check connection conditions, the testing equipment for damage and/or deformation of the inverter/converter lid then re-test. If no visible fault is found and leakage is still found, removed the inverter/converter lid, clean and reseal the lid then retest.
