**PRODUCT CAMPAIGN BULLETIN**

**APPLICABILITY:** 2019-2022 Crosstrek Hybrid

**NUMBER:** WRD-23R

**SUBJECT:** 12V Inverter Connector Corrosion

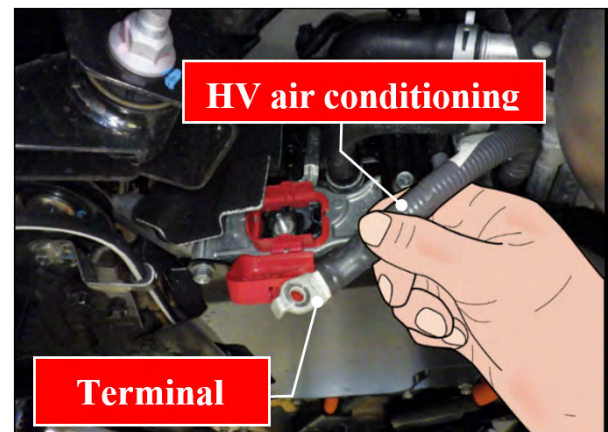
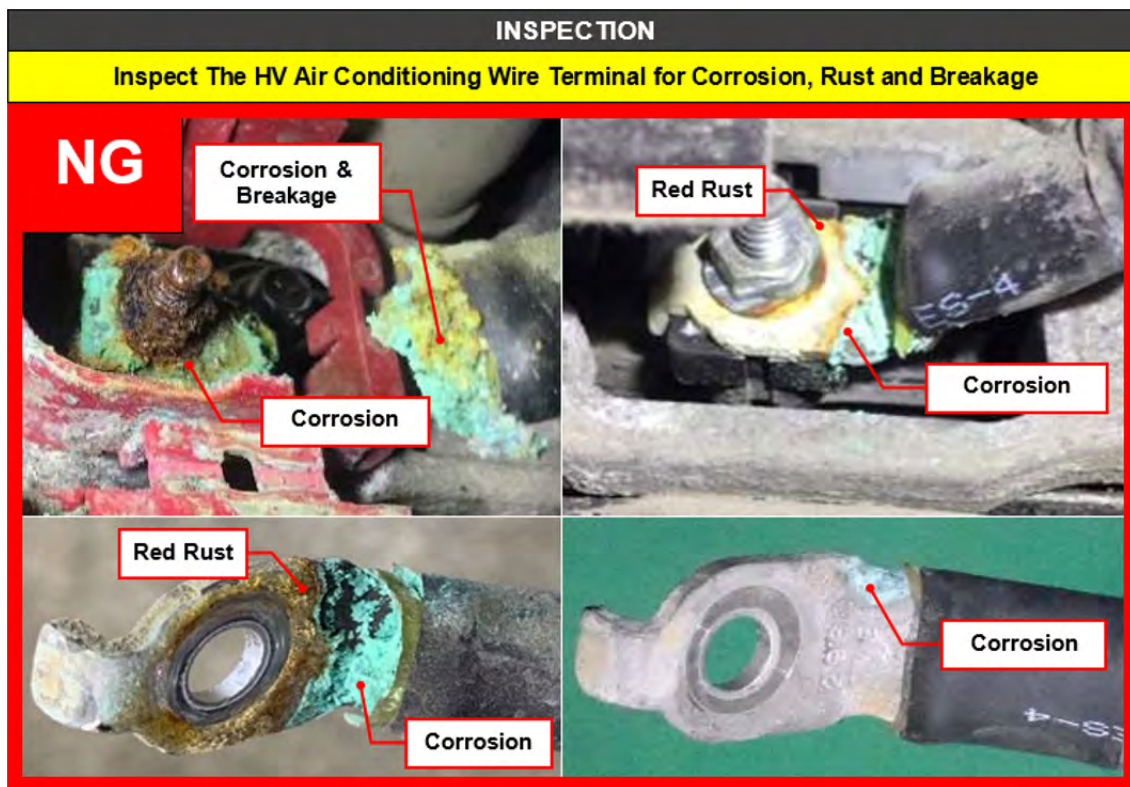
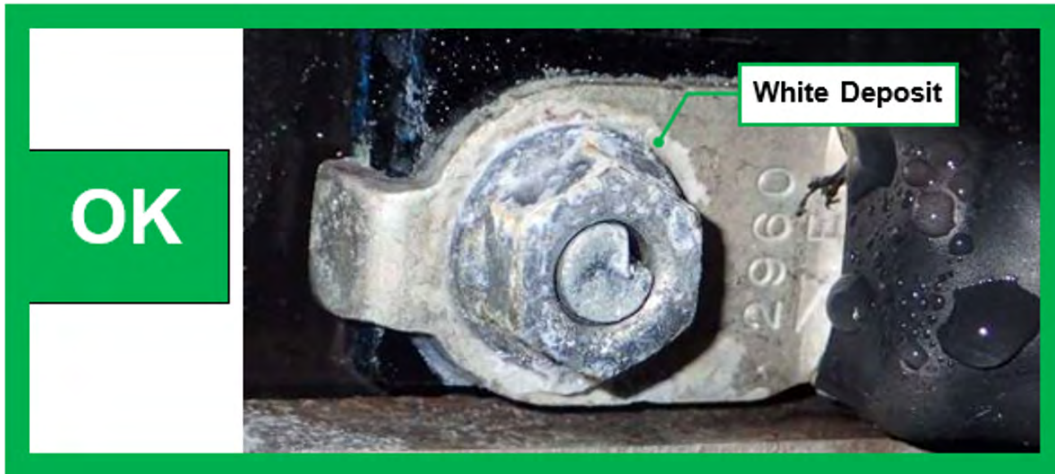
**STEP 9:** Perform a visual inspection of the High Voltage (HV) air conditioning wire terminal for corrosion and/or damage. See the example images below.

**NOTE:** White Deposits found on the terminal is considered acceptable.

Inspection Result		Next Step
<b>OK</b>	No Corrosion, Red Rust and/or Breakage found	Proceed to Service Procedure A
<b>NG</b>	Corrosion, Breakage, and/or Red Rust was found	Proceed to Service Procedure B
