IMPORTANT SAFETY RECALL

INTERIM NOTICE

Subject: Motor Vehicle Safety Recall 23V-083 ESS liquid accumulation

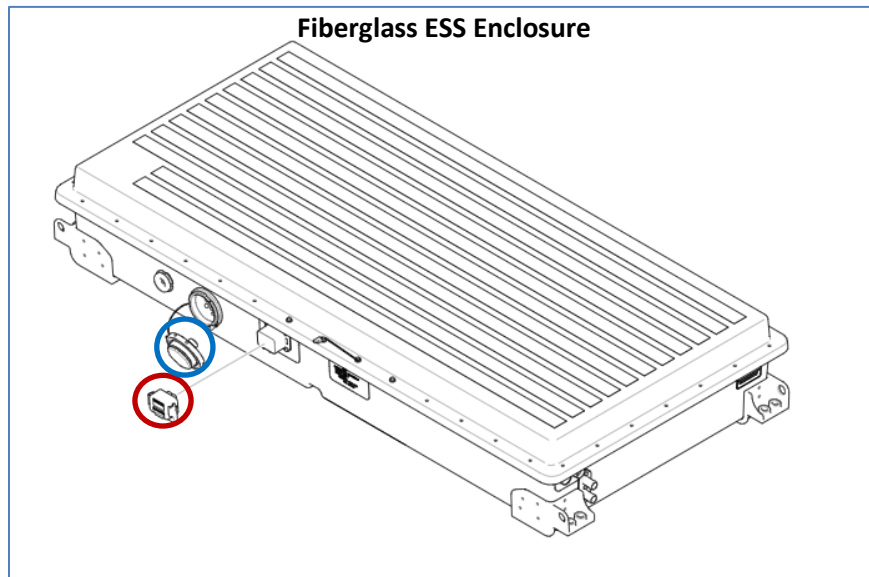
This notice is sent to you in accordance with the requirements of the *National Traffic and Motor Vehicle Safety Act*. New Flyer of America Inc. (New Flyer) has decided that a defect which relates to motor vehicle safety exists in certain 2021-2022 XE35, 2021-2023 XE40, and 2021-2022 XE60 battery electric vehicles. These vehicles are outfitted with an Energy Storage System (ESS) that is a fiberglass enclosure as depicted below. (Note that previous ESS versions that were metallic enclosures are not included in this recall.)

If a leak occurs inside of an ESS and is uncorrected, liquid can accumulate, leading to an electrical short, increasing the risk of a fire.

- New Flyer will work with customers to inspect each ESS on affected buses for liquid inside of each ESS. This visual inspection can be completed through the desiccant cap at the "front" of each ESS. (Each customer may choose to complete these inspections as well themselves to expedite the process.) See **NOTE** below if liquid is noticed in an ESS. Contact your RPSM to discuss next steps. If no liquid is present, the bus can be operated as normal.

- Leave the desiccant cap off (circled in **blue** in the picture above)
- Remove the MSD (Manual Service Disconnect) from the ESS (circled in **red** in picture above)
 - Install a Plug, Blank Manual Service Disconnect (PN 869751) where the MSD was removed
- Coolant should be drained from the ESS cooling system
- Park bus in a safe outdoor location, away from other vehicles, structures, etc.
- The bus should be held from revenue service
- Do not charge the bus
- Additionally, customers should contact your New Flyer RPSM to discuss next steps
