SIB 84 01 23

RECALL 23V-099: WIRELESS CHARGING TRAY WILL NOT RECOGNIZE DIGITAL KEY REMOVAL

This Service Information Bulletin (Revision 4) replaces SI B84 01 23 **dated March 2023**.

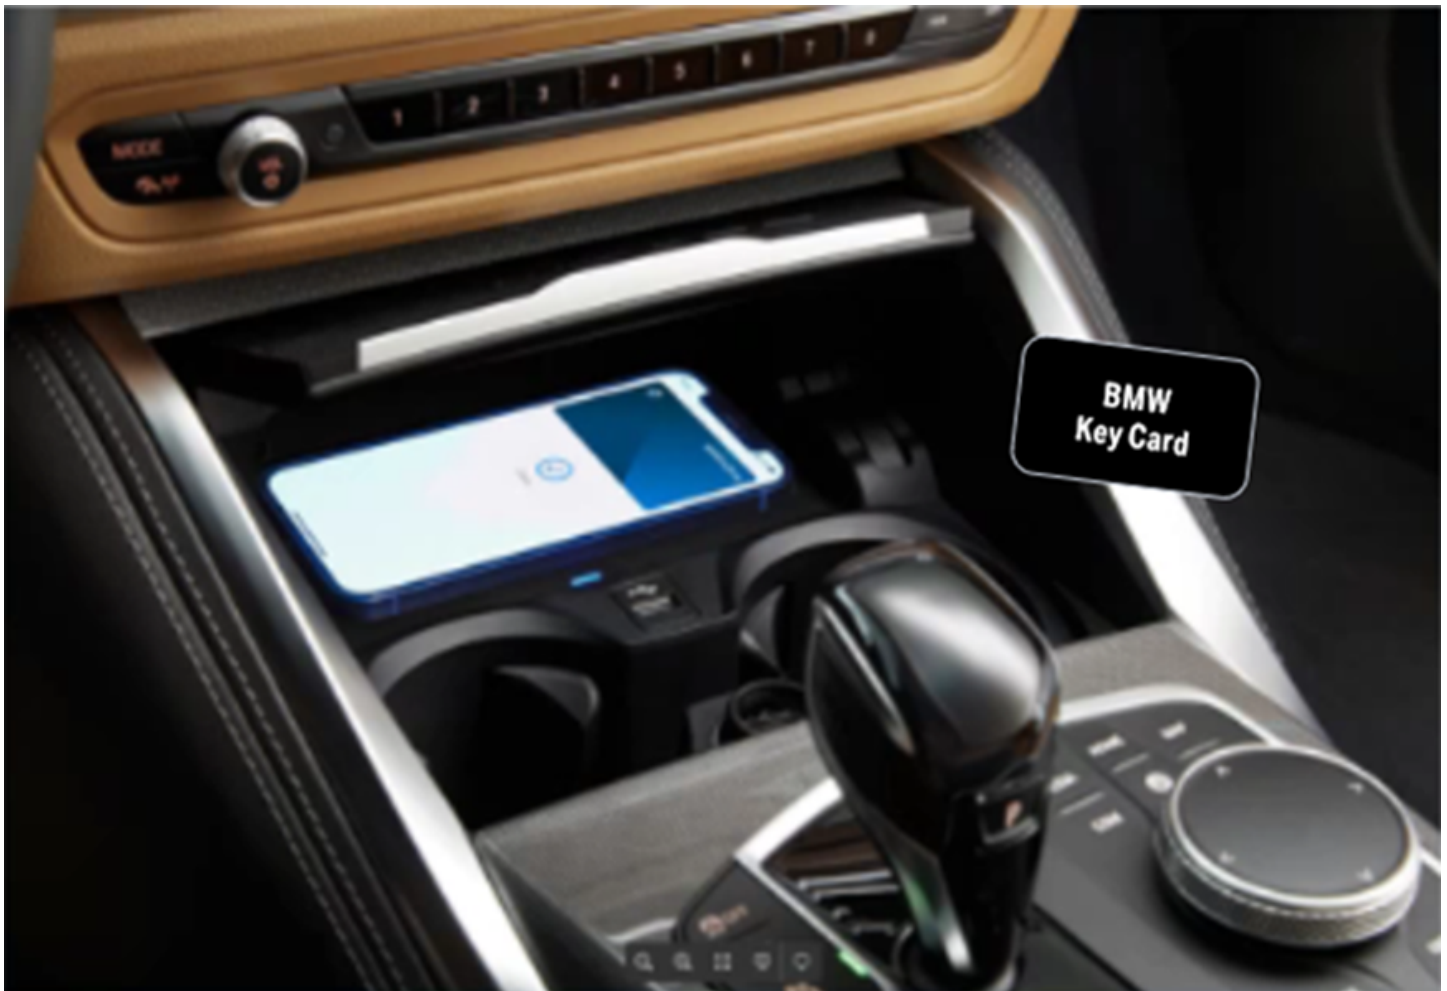
Unfavorable software causes the vehicle to not detect when the digital key (mobile phone/BMW Key Card) is removed from the wireless charging station (WCA). It is still possible to operate the window regulators, sunroof and convertible top for a certain period of time until the vehicle is locked, despite the digital key being removed from the WCA.

Example below: Wireless Charging Tray with either the BMW Key Card or a telephone with the Digital Key activated.

Program the vehicle to I-level S18A-23-03-550 or higher using ISTA 4.41.1x or later (release date is May 2, 2023).
