IMPORTANT RECALL CAMPAIGN INFORMATION

Campaign No. 2023030003, March, 2023

SUBJECT: **Model 907 Sprinter, Model Year 2022
Swivel Seat Wire Harness Routing**

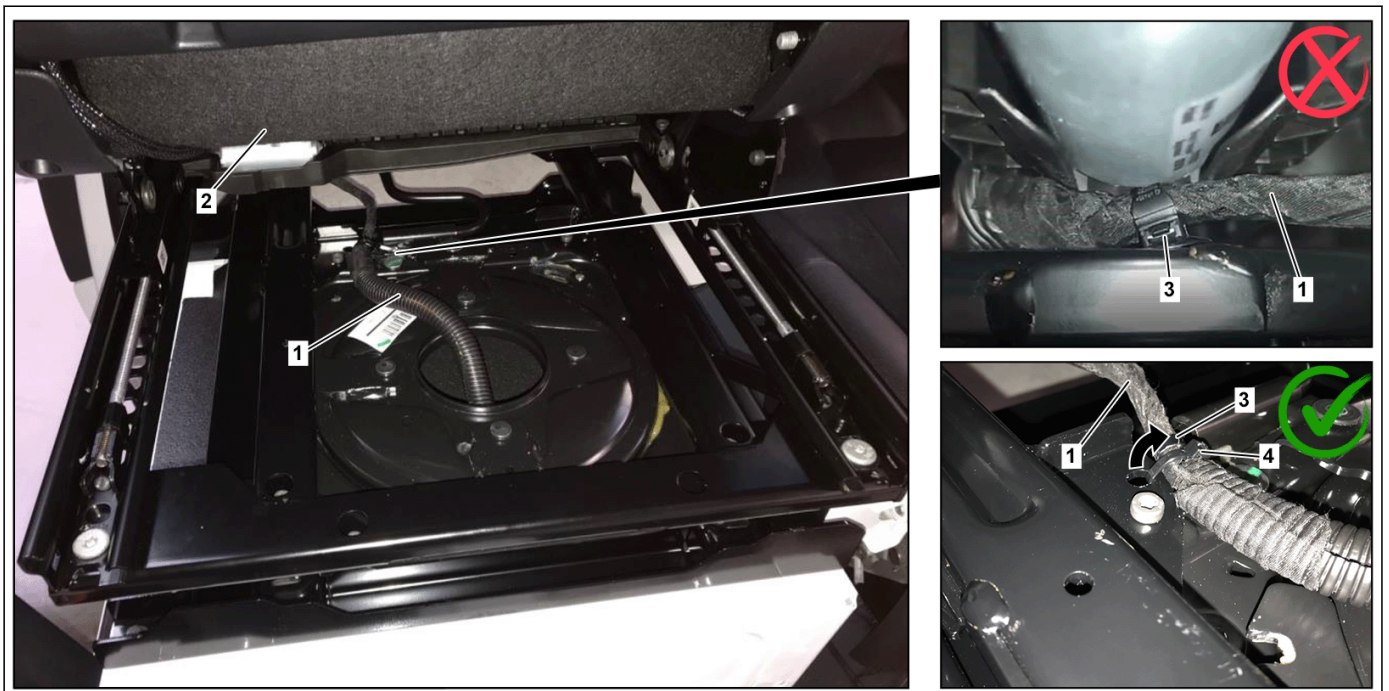
D91.29-A012-79

Mercedes-Benz AG (“MBAG”), the manufacturer of Mercedes-Benz Sprinter vehicles, has determined that on certain Sprinter (907 platform) vehicles equipped with electrically adjustable front swivel-seats, the electrical wiring harness might become damaged over time when a front swivel seat is adjusted. In the event of a damaged wiring harness, it cannot be ruled out that the function of the side airbag installed in the seat back might be impaired. This could increase the risk of injury.

Shown on driver's seat with code SF1 (Electrically adjustable driver's seat) and code SR8 (Driver's seat rotating frame)

2	Check wiring harness (1) on rotating seat (2).	<p>i</p> <p>To do so, move rotating seat (2) down completely using electrical seat adjustment, and check whether there is sufficient space between wiring harness (1) and rotating seat console, or whether actuator motor of electrical seat adjustment CANNOT touch wiring harness (1).</p> <p>Check wiring harness (1) for damage.</p> <p>i</p> <p>If rotating seats (2) are installed on the driver's side and front passenger side, then the wiring harnesses (1) of both rotating seats (2) must be checked and adapted if necessary.</p> <p>If actuator motor of electrical seat adjustment touches wiring harness (1) (see picture) or wiring harness (1) is damaged:</p> <p style="text-align: center;">↓</p> <p>Repair wiring harness and continue with next operation step.</p> <p>If wiring harness (1) does not touch actuator motor of electrical seat adjustment and wiring harness (1) is not damaged:</p> <p style="text-align: center;">↓</p> <p>end the measure.</p>

Adapt line installation			
3	Adjust rotating seat (2) until wiring harness (1) is accessible.		
4	Subsequently modify mount of wiring harness (1) at rotating seat (2).	<p>i</p> <p>To do so, remove cable tie with fir tree clip (2) from rotating seat console and fasten wiring harness (1) next to original position on rotating seat console with a new cable tie (4). See figure.</p> <p>The old cable tie with the fir tree clip (2) can remain on the wiring harness (1).</p>
