Subject: Safety Recall T-23-01 Released

Safety Recall T-23-01

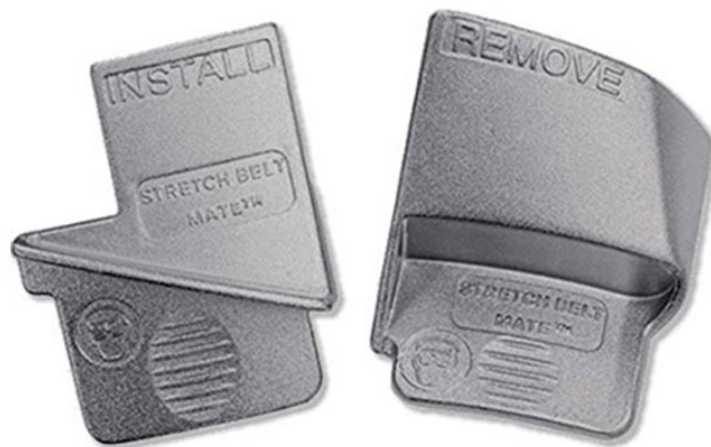
Polaris has determined that on some Model Year 2022-23 Slingshot vehicles, the alternator may have been improperly manufactured by the supplier and an internal rotor segment may crack and separate during operation, posing a fire hazard and risk of serious injury. The affected population is less than 100 vehicles.

To resolve this concern, Polaris has developed a procedure to replace the alternator on affected units. Please refer to the links below for complete information.

Special Service Tool required: Stretch Belt Installation Tool (commercially available, such as OEM Tools 24388, OTC 7425).
