SAFETY RECALL

Communication #: T-23-01

Model Year(s): 2022–2023

SUBJECT: ALTERNATOR REPLACEMENT

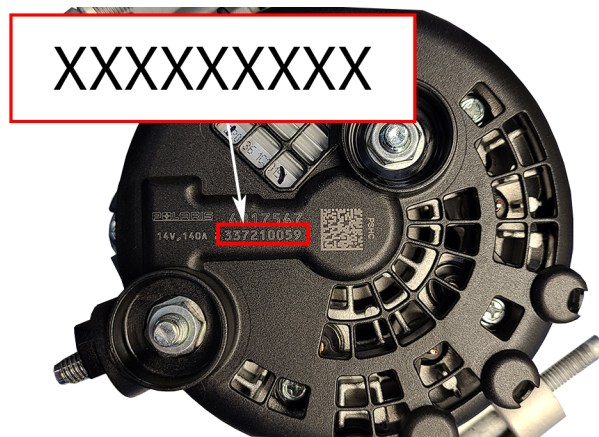
ALTERNATOR SERIAL NUMBER LOCATION

Reference the **NINE DIGIT** serial number on alternator according to image below:

If an alternator is found with an affected serial number and is installed on a vehicle:
Submit an Ask Polaris case under Service & Warranty Questions >> All Vehicle

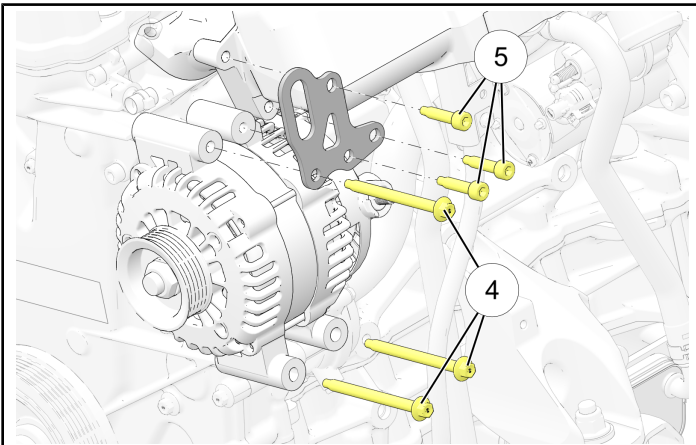
6. Remove three bolts ④ securing the alternator to the engine block and three bolts ⑤ securing the alternator to the intake manifold. Remove the alternator.

Retain the alternator, as it will need to be returned through the parts recall process.

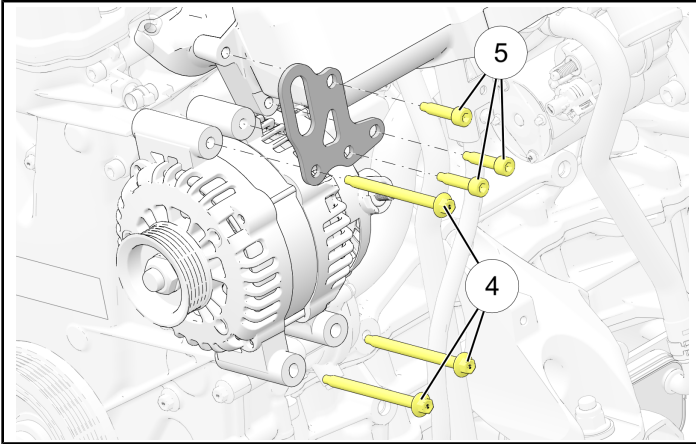
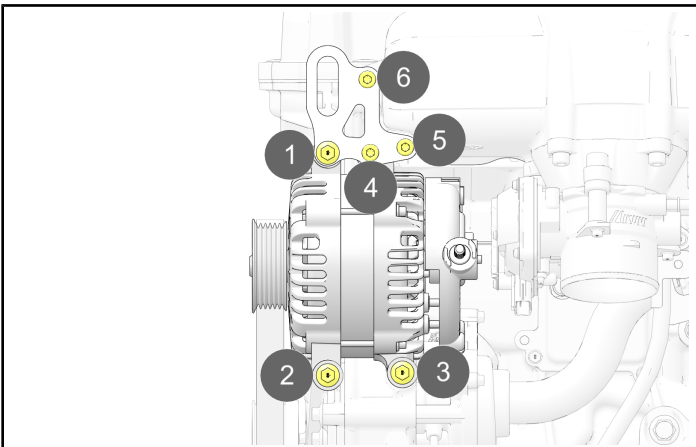
1. Install new alternator. Loosely install fasteners ④ and ⑤. Torque fasteners to specification in sequence shown.

Alternator Mounting Fasteners:
16 ft-lbs (22 N·m)

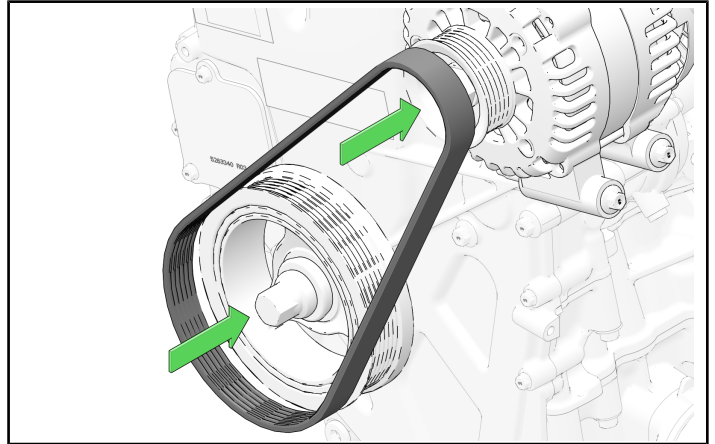
Harmonic damper pulley can be rotated using a 19 mm socket and a long ratchet on the harmonic damper bolt. The engine must only be rotated in the **CLOCKWISE** direction.

2. Using a commercially-available stretch belt installation tool, install a NEW stretch belt over the alternator pulley and then onto the crankshaft pulley with the installation tool.

Verify the belt is completely seated in the alternator and crankshaft pulleys.

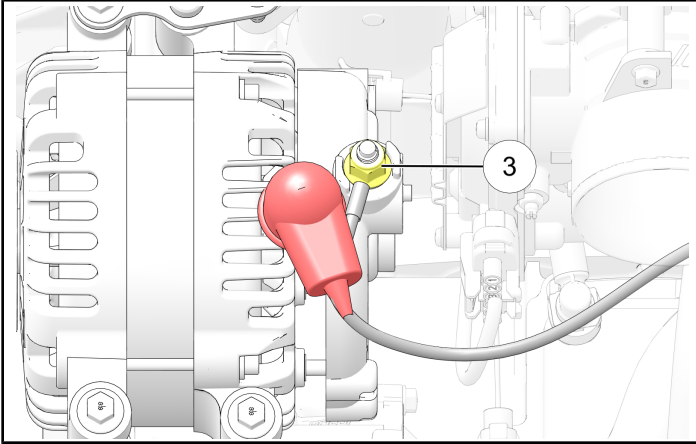
4. Install the main charging lead to the alternator. Install positive terminal nut ③ and torque to specification. Cover the terminal nut with the red protective cap.

Alternator Terminal Nut:
84 in-lbs (9 N·m)
