SAFETY RECALL

Communication #: T-23-01

Model Year(s): 2022–2023

SUBJECT: ALTERNATOR REPLACEMENT

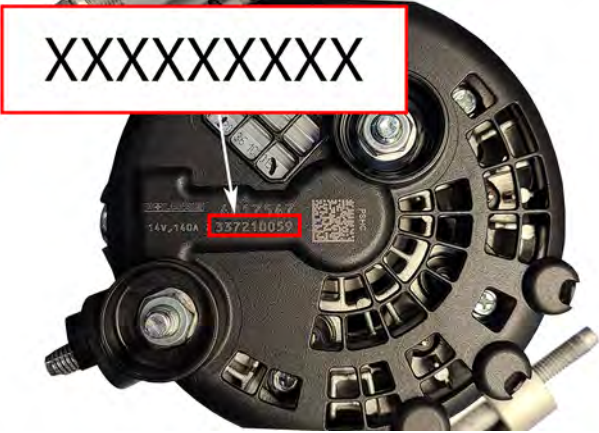
ALTERNATOR SERIAL NUMBER LOCATION

Reference the **NINE DIGIT** serial number on the alternator.

REQUIRED ALTERNATOR SERIAL NUMBER	
<p>Record the NINE DIGIT serial numbers on the <i>NEW</i> alternator for warranty claims processing. Claims filing will not be permitted without the <i>NEW</i> alternator serial number.</p>
