Dealer Service Instructions for:

Safety Recall 20A / NHTSA 23V-115

Rear Spoiler

2021-2023 (WD) Dodge Durango

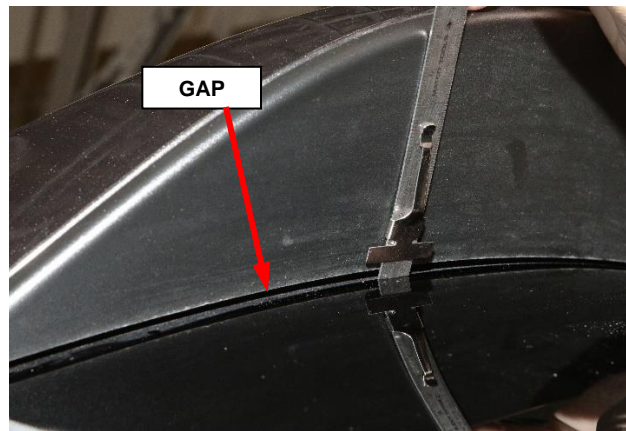
**Figure 1 – Gap to Glass Inspection**

1. Grasp the rear spoiler with one hand and gently push to feel for loose fasteners. After feeling for looseness, release the spoiler, and check the gap between the spoiler and the hatch glass on each side of the spoiler in line with the roof rack. If the gap is greater than 5mm, the upper spoiler must be replaced (Figure 1).

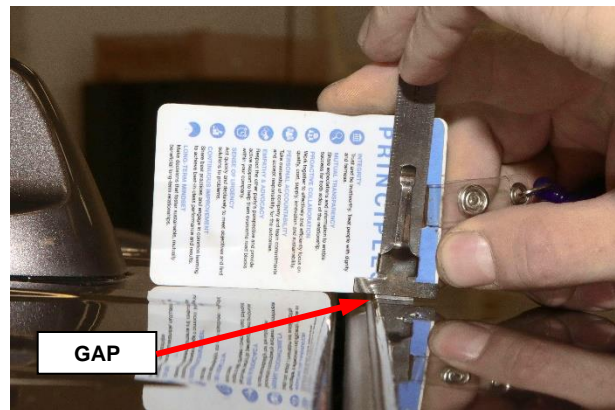
**Figure 2 – Flushness of Spoiler to Roof**

2. Rest a small straight edge (like to driver license or credit card) on the roof and check for flushness of the liftgate. Check at the center (behind the antennae), and at each end. The spoiler must not be more than 1mm over flush to the body. If it is, the upper spoiler must be replaced (Figure 2).

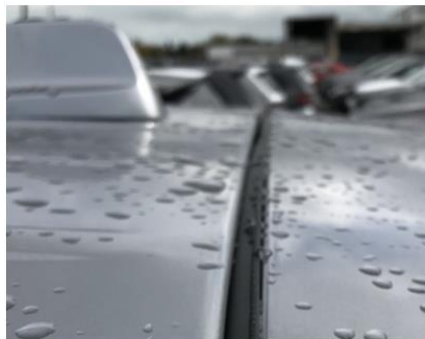
**Bad****Figure 5 – Lip Seal Inspection**

4. Visually inspect the lip seal. The seal must be sitting tight to the spoiler and not catching on the roof. The seal must not be distorted. If the seal does not pass inspection, the upper spoiler must be replaced (Figure 5).

**Good**
