March 30, 2023

**SUBJECT: NEW VEHICLE DEMONSTRATION / DELIVERY HOLD
Compliance Recall 23C02
Certain 2023 Model Year Transit
Wiring Harness Missing Jumper Loop**

For certain 2023 Model year Transit vehicles, Ford shipped a Special Service Kit that contains an auxiliary wiring harness for upfit or alterations. If the auxiliary wire harness is installed into the vehicle, including chassis cab units and vans, the HVAC system will not function as required by Federal Motor Vehicle Safety Standard (FMVSS) No.103 Windshield Defrosting and Defogging Systems, due to incorrect wiring in the auxiliary wiring harness connector. Loss of the ability to control the defrost or defog function may decrease the driver's visibility under certain driving conditions, increasing the risk of a crash.

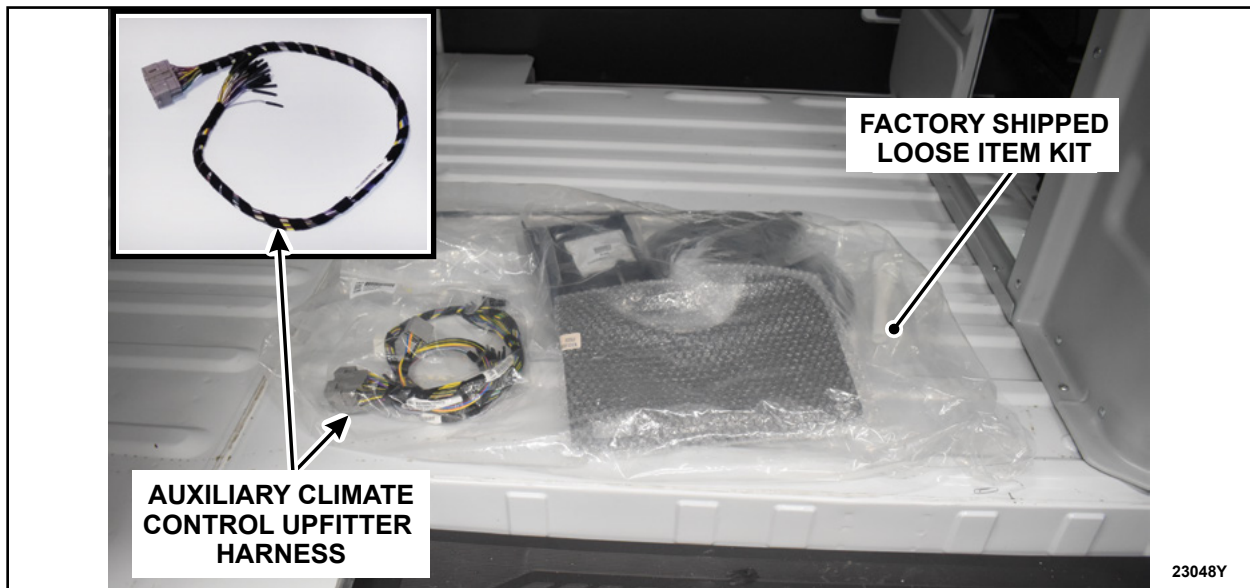
FIGURE 1

2. Locate the loose item kit (shipped from factory) and remove the auxiliary climate control upfitter harness. See Figure 1. Was the auxiliary climate control upfitter harness found within the vehicle?

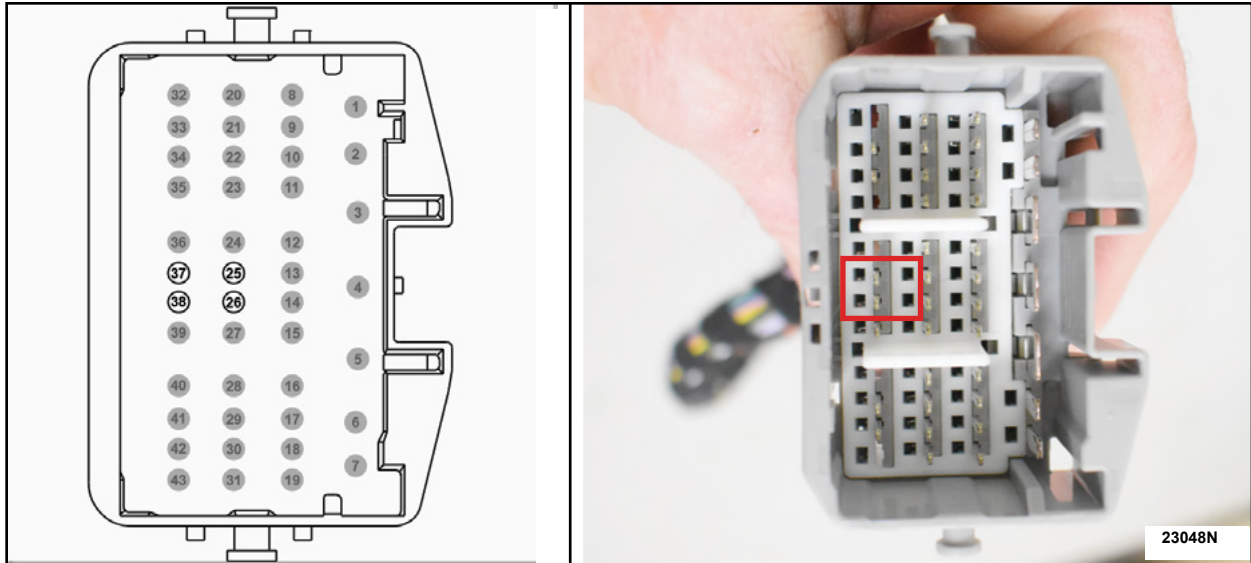
FIGURE 2

3. Locate pin terminal numbers 25, 26, 37 and 38 from within the auxiliary climate control upfitter harness connector as shown in Figures 2 and 3.
