N232403240 Child Seat Anchor Interference

Revision: 02

Model Year			
Make	Model	From	То	RPO	Description
Chevrolet	Equinox	2020	2023		
GMC	Terrain	2020	2023

F/CMVSS Noncompliance Recall N232403240 Child Seat Anchor Interference

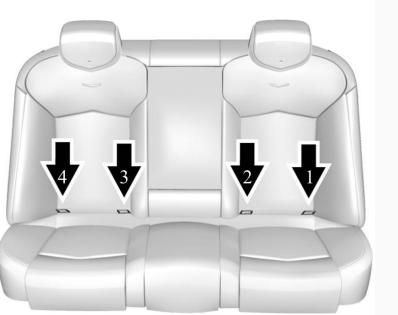
6353620

1. Locate the rear seat child seat anchors as shown above.

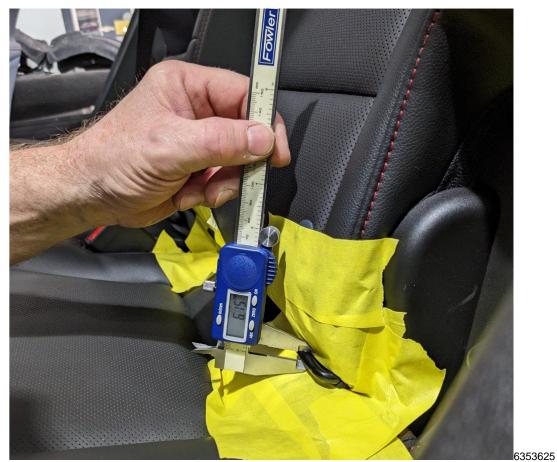
2. Using calipers, measure the diameter of the straight part of the anchors parallel to the seats.

- If the diameter is less than 6.1mm, no further action is required for that specific anchor.
- If the diameter is GREATER than 6.1mm, proceed to step 3 and perform the repair steps for any anchor whose diameter exceeds 6.1mm.
