Remedy available for
 2021 - 2023 (WL) Jeep Grand Cherokee L
 2022 - 2023 (WL) Jeep Grand Cherokee

SAFETY RECALL

Intermediate Shaft

Reference: 58A / NHTSA 23V-352

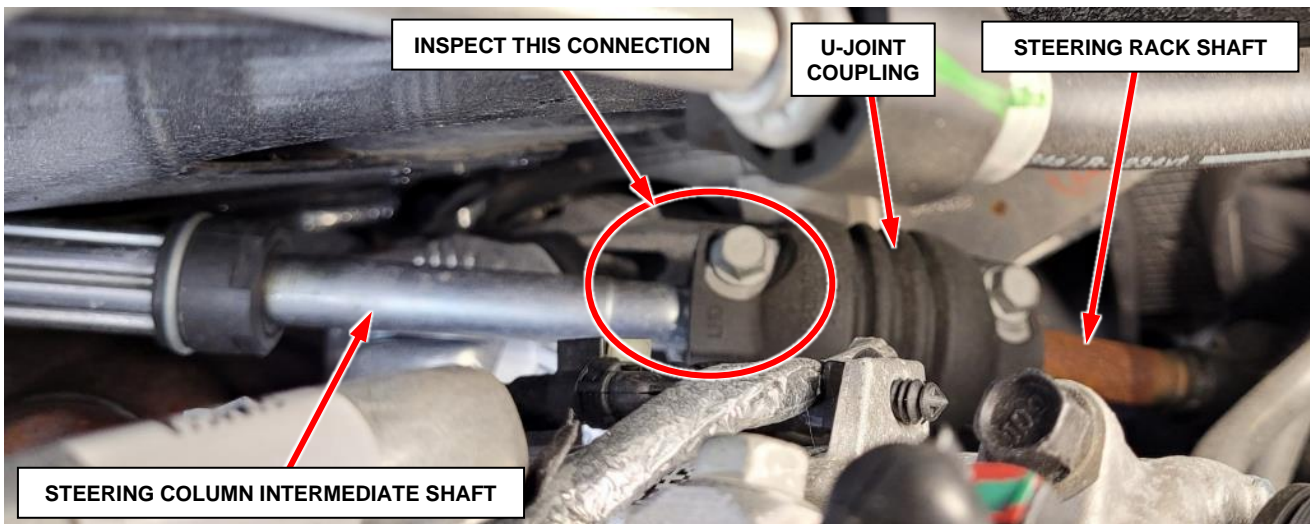
Figure 3 – Locate Suspect Steering Connection

4. Visually locate the steering column intermediate shaft to U-joint interface connection for inspection (Figure 3).

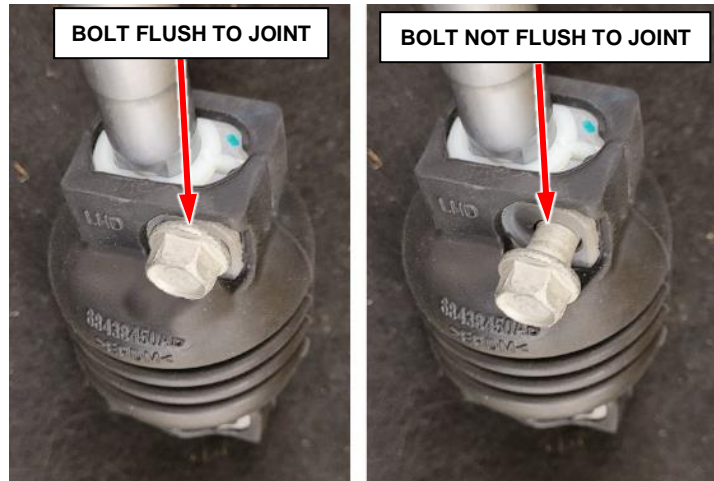
Figure 4 – Inspect Bolt Flushness with U-Joint Connection

- a) Does the U-joint coupling upper bolt appear to be fully tightened flush against the U-joint coupling or not fully tightened? (Figure 4).

Bolt Fully Flush **Bolt NOT Fully Flush**

6. Do **ANY** of the identified conditions (a-c) exist:
- a) Bolt is NOT fully tightened flush to U-joint coupling.
 - b) White plastic clip is MISSING.
 - c) Intermediate shaft is NOT fully inserted into the U-joint coupling.

YES >>> One or more of the above conditions (a-c) exist, proceed to the **Repair Procedure**.

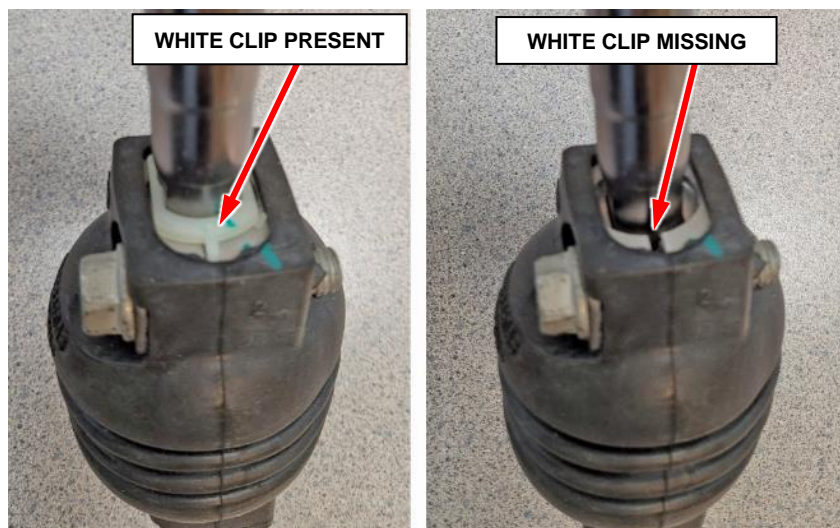
Figure 5 – Inspect for White Clip at U-Joint Connection

- b) Is the white spacer clip present or missing? (Figure 5).

White Clip Present **White Clip MISSING**

- **White Plastic Clip Present:** Continue to next step of repair procedure.
- **White Plastic Clip Missing:** Obtain a **NEW** white plastic clip and follow these instructions.

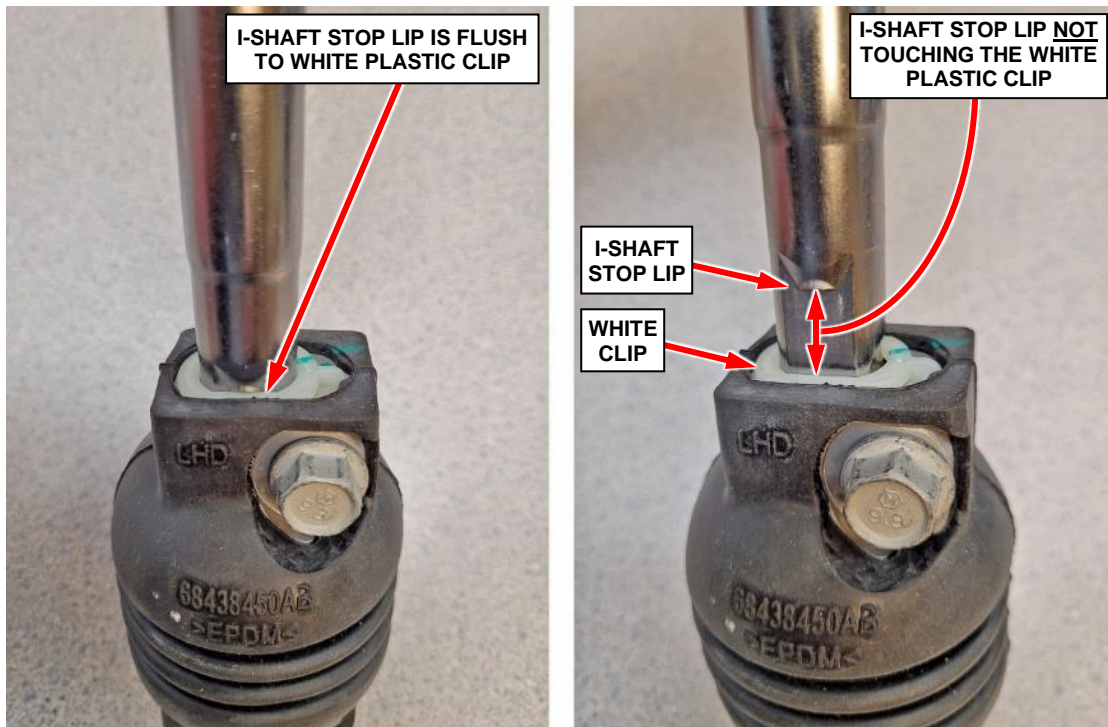
- c) Is the intermediate shaft fully inserted into the U-joint coupler with I-shaft stop lip touching the white plastic clip or not fully inserted? (Figure 6).

Shaft Inserted to Clip

Shaft NOT Fully Inserted to Clip

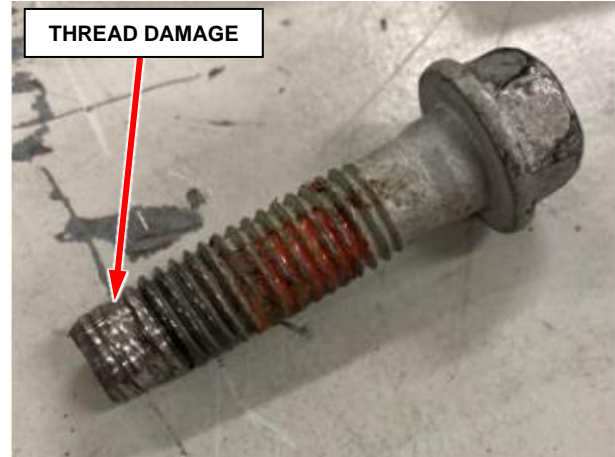
Figure 21 – Inspect Bolt Threads

5. Remove the upper steering column shaft U-joint coupling pinch bolt and examine the bolt threads for any damage then **DISCARD** the bolt (Figure 21).

- **Bolt Threads Damaged:** The U-Joint coupling will require replacement. Contact campaign team as directed in the parts section to order the appropriate parts then continue to **Step 6** of repair procedure.
- **Bolt Threads NOT Damaged:** U-Joint coupling may be reused. U-joint coupling replacement step may be skipped. Contact campaign team as directed in the parts section to order the appropriate parts then continue to **Step 7** of the repair procedure.

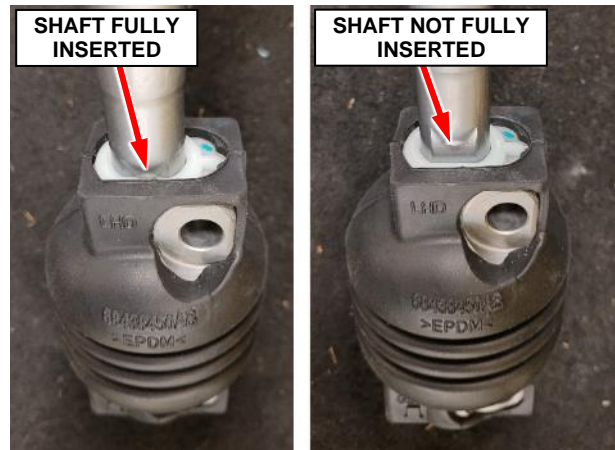
Figure 25 – Intermediate Shaft Insertion Into U-Joint Coupling

- **I-Shaft Stop Lip Contacts White Plastic Clip:**
Continue to **Step 10** of repair procedure.
- **I-Shaft Stop Lip NOT Contacting White Plastic Clip and CANNOT Be Inserted Further:**
Intermediate shaft is oversize. Obtain a **NEW** intermediate shaft then follow these instructions.

Fully Inserted

Not Fully Inserted
