VOLUNTARY RECALL CAMPAIGN

Classification: RS23-004	Reference: NTB23-046	Date: May 25, 2023
-----------------------------	-------------------------	-----------------------

VOLUNTARY SAFETY RECALL CAMPAIGN REAR SEAT BELT ANCHOR

CAMPAIGN ID #: PC978
APPLIED VEHICLES: 2023 Rogue (T33)

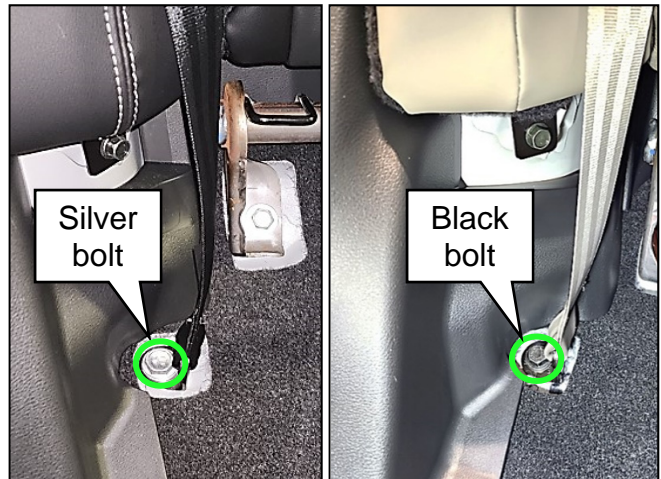
Figure 1

2. Locate and inspect BOTH outboard lower rear seat belt anchor bolts (Figure 1 and Figure 2).
 - For ALL bolts that are **SILVER** with an 18mm head, complete steps 3-16 for installing the rear seat belt warning label and replacing the lower rear seat belt anchor bolt washer.
 - For ALL bolts that are **BLACK** with a 14mm head, **DO NOT** install a rear seat belt warning label or replace the washer for that seat belt.
