## Safety Recall – 2024 CX-90 Suspension and Steering Insufficient Bolt Torque

### CONDITION OF CONCERN

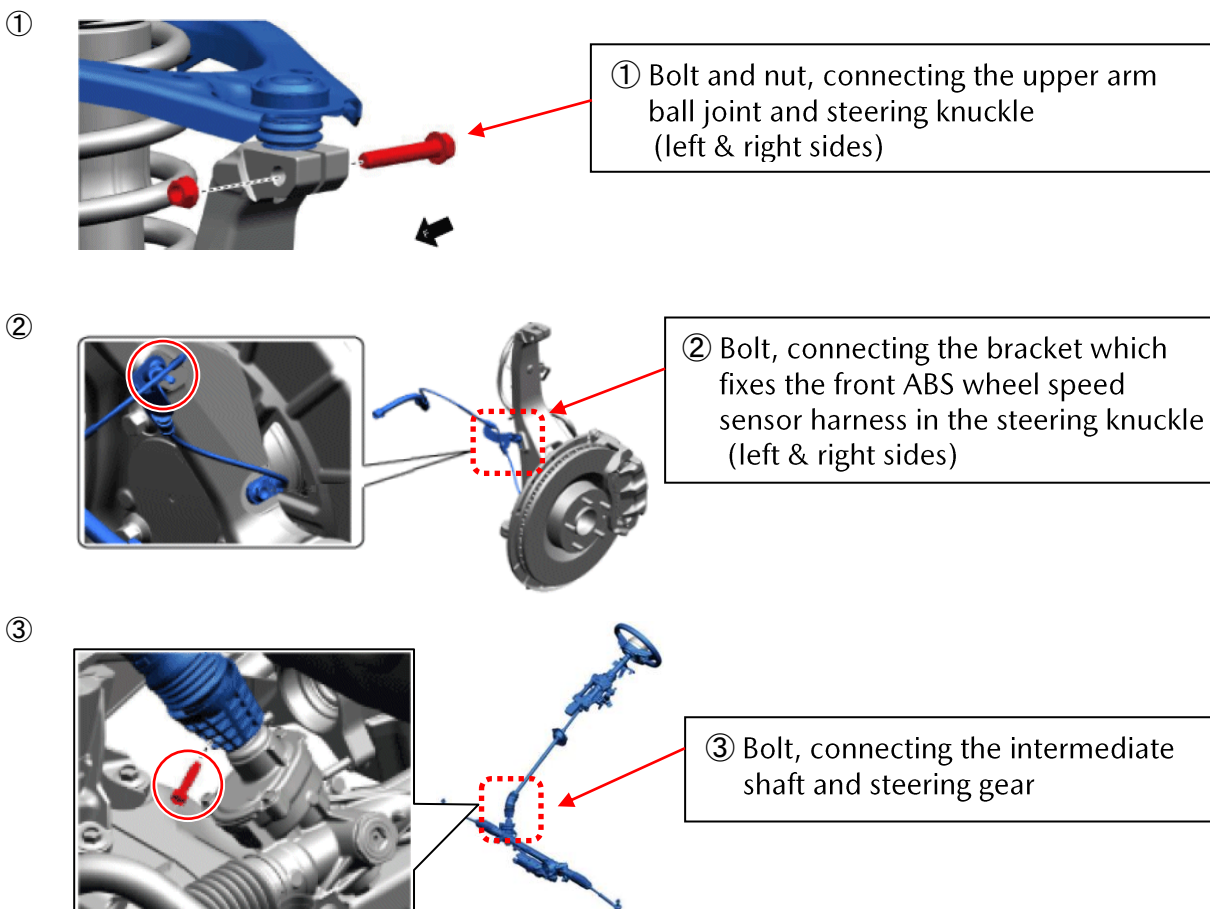
On the subject CX-90 vehicles, certain bolts for the steering intermediate shaft, front ABS wheel speed sensor harnesses or front upper control arms may not have been torqued to proper specification during quality checking activity of assembled vehicles. If that is the case, one or more of these components may loosen or separate while driving and cause a loss of ability to control the vehicle, increasing the risk of a crash.

#### Potentially affected bolts:
