# SAFETY RECALL

Volvo Trucks North America

Date	Number	Release	Page
07. 2023	RVXX2307	01	1 (4)

## Steering Gearbox Fastener Re-Torque

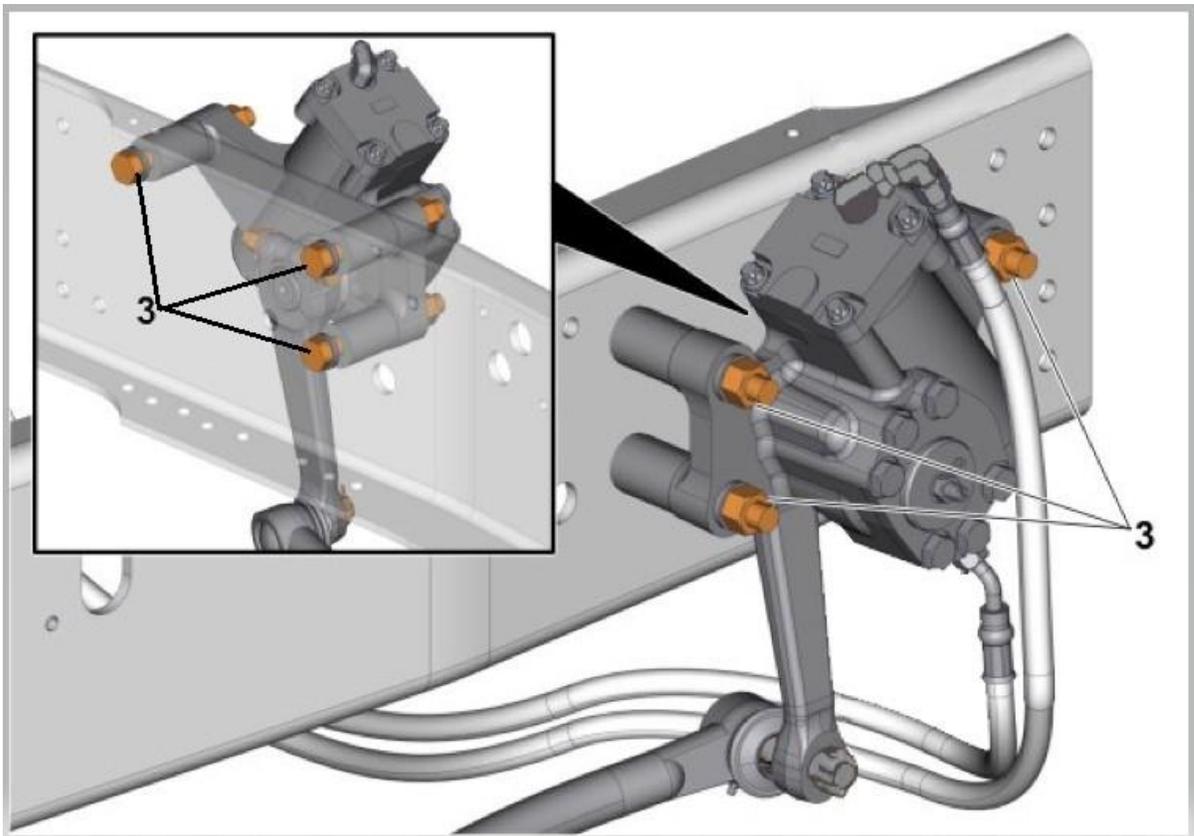
The steering gear mounting fasteners to the frame rail may not be torqued to specification. The under-torqued fasteners could result in a loss of clamp load on the steering gearbox. Indication of this occurrence may include steering wander or a feeling of looseness in the steering.

5. Unlatch and raise the hood.
6. Locate the steering gearbox mounting fasteners – driver's side frame rail.

7. Set torque wrench to  $275 \pm 15$  Nm. Check relaxed torque in tightening direction.

- a. If found loose, check both bolt and nut for damage.
  - i. If damage is found on hardware, replace both bolt and nut.
  - ii. If no damage is found on hardware, replace nut only.
- b. Tighten to install torque and angle of  $200 \pm 10$  Nm + angle  $145^\circ \pm 10^\circ$ .

$200 \pm 10$  Nm + angle  $145^\circ \pm 10^\circ$
