TO: Mercedes-Benz Dealer Principals, General Managers, Sales Managers, Service Managers, Parts Managers	FROM: Anthony Washington, Senior Manager, Regulations and Certifications
Re: Launch Recall Campaign Notification Model Sprinter 447 Model Years 2021-2022 Replace Fuel Delivery Module	DATE: December, 2023

Campaign No. 2023100006 December, 2023

SUBJECT: **Model 447 Metris, Model Year 2021-2022**
Replace Fuel Delivery Module

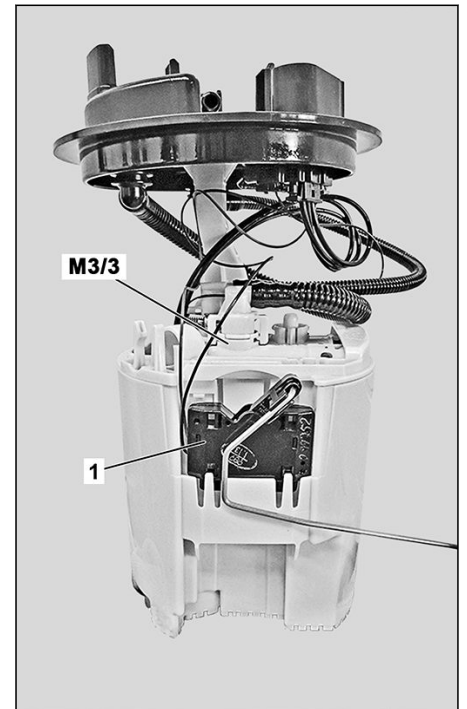
S47.20-A027-03

- 1 Fuel tank fill level sensor
- M3/3 Fuel pump with fuel delivery module

Transfer fuel tank fill level sensor (1) of removed fuel pump with fuel delivery module (M3/3) to new fuel pump with fuel delivery module (M3/3).	Only if new fuel pump with fuel delivery module (M3/3) was delivered without fuel tank fill level sensor (1).	AR47.50-S-0111E

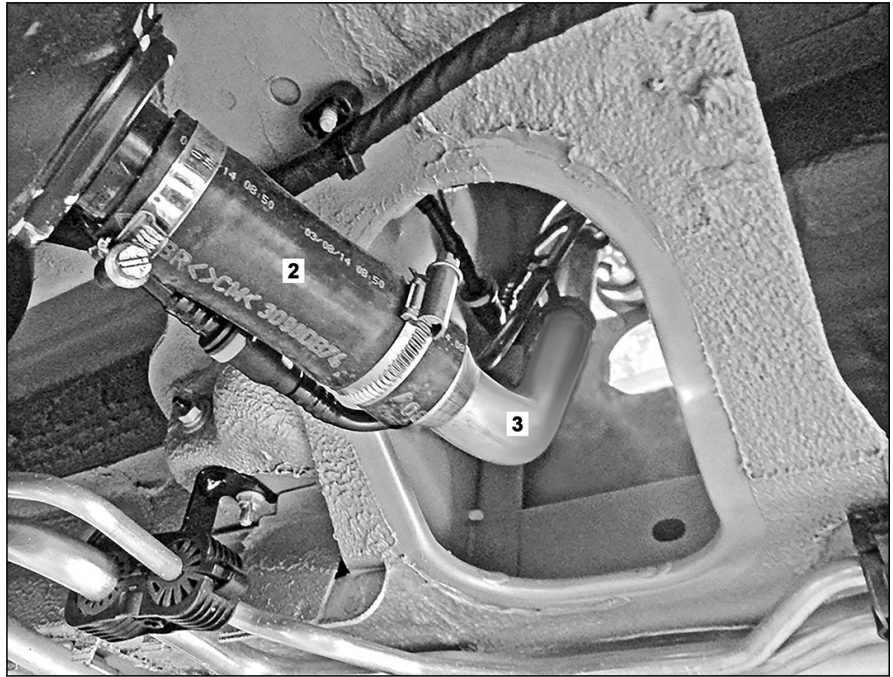
S47.20-A028-06

- 2 Fuel hose
- 3 Filler neck

Model 447 except code ZL3 (National version for Latin America)</p> <p>Contrary to the statement in the reference document on removal of the fuel tank, the fuel hose (2) does not need to be removed.</p> <p>The filler neck (3) is only detached from the body and remains on the fuel tank.</p> <p>
