<p>TO: Freightliner Dealer Principals, General Managers, Sales Managers, Service Managers, Parts Managers</p>	<p>FROM: Anthony Washington, Senior Manager, Regulations and Certifications</p>
<p><b>Re: Launch Recall Campaign Notification</b> <b>Model Sprinter 907</b> <b>Model Years 2021</b> <b>Replace Fuel Delivery Module</b></p>	<p>DATE: October, 2023</p>

Campaign No. 2023090004 October, 2023

SUBJECT: **Model 907 Sprinter, Model Year 2021**  
**Replace Fuel Delivery Module**

Order No. V-RC-2023090004

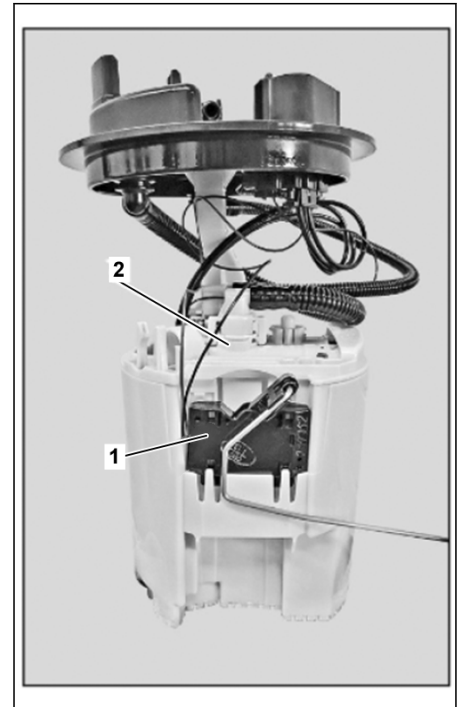
D47.20-A027-03

- 1 Fuel tank fill level sensor
- 2 Fuel feed module

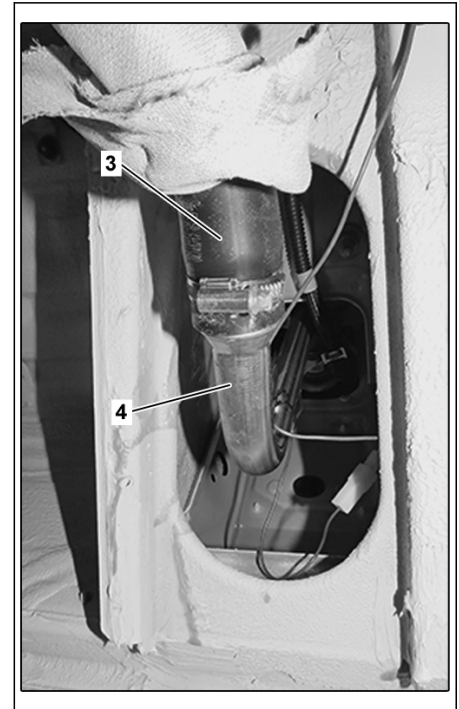
D47.20-A028-03

- 3 Fuel hose
- 4 Filler neck

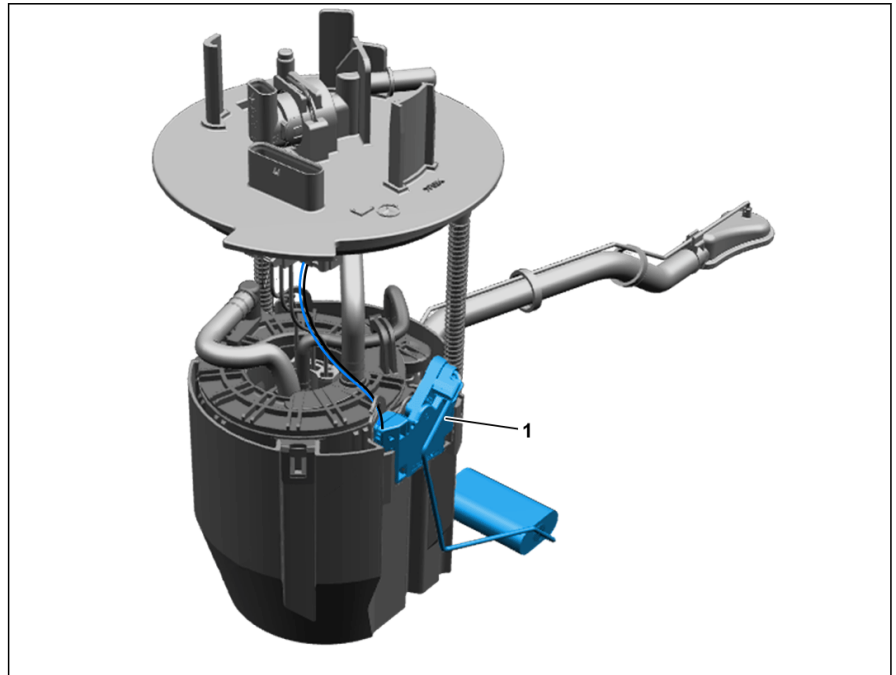
D47.20-A029-76

1 Fill level sensor
