| RE: Recall Campaign Launch Notification Replace Fuel Pump Delivery Module – Wave 3 MY21-23 C-Class, E-Class, CLS, S-Class, SL, GT, GLC, GLE, GLS and G-Class (205/206, 213/238, 257, 223, 232, 290, 253, 167 and 463 platforms) | DATE: November 17, 2023 |

| Recall Campaign Launch Notification | | | November 17, 2023 |
|---|--|---|---|
| Campaign No. : | NHTSA ID : | Campaign Desc. : | Replace Fuel Pump Delivery Module – Wave 3 |
| 2023070012 | 23V445 | 23P4790205 | |

Replace Fuel Pump Delivery Module

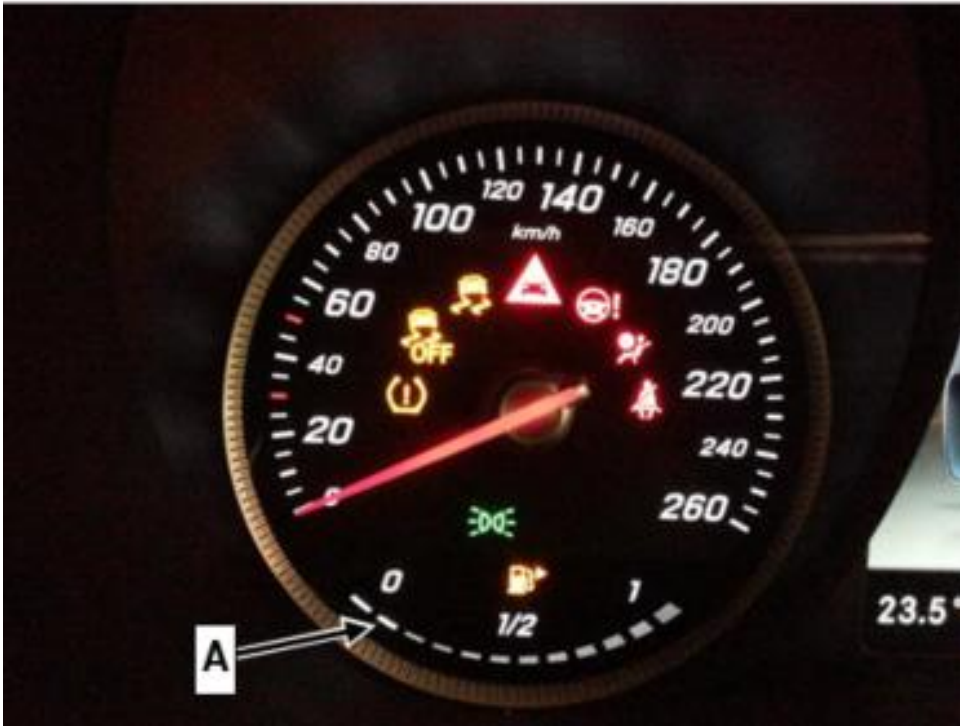
Figure 1 (shown on model 205)

- i** The fuel tank may only be filled up to a **maximum of 20%**.
- i** This corresponds to two lines (A) on the fuel display (**Figure 1**).

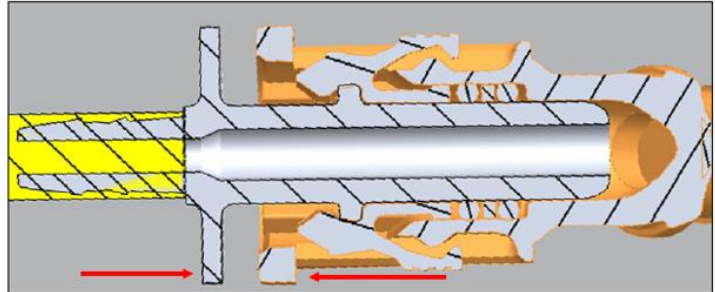
MRA2 Quick Connector suction jet pump drive line

Min. - 1 mm

Separate at this point

Squeeze the QC connection by at least 1mm, then unlock the latching lugs. If this is not possible. Step 1 -3

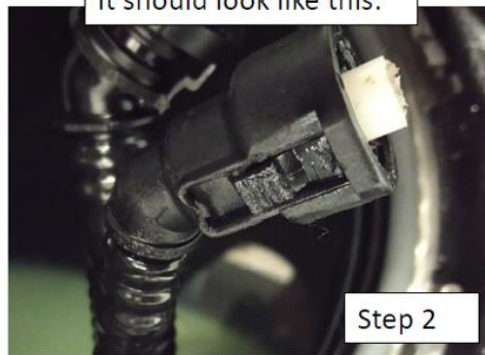
Step 2

It should look like this:

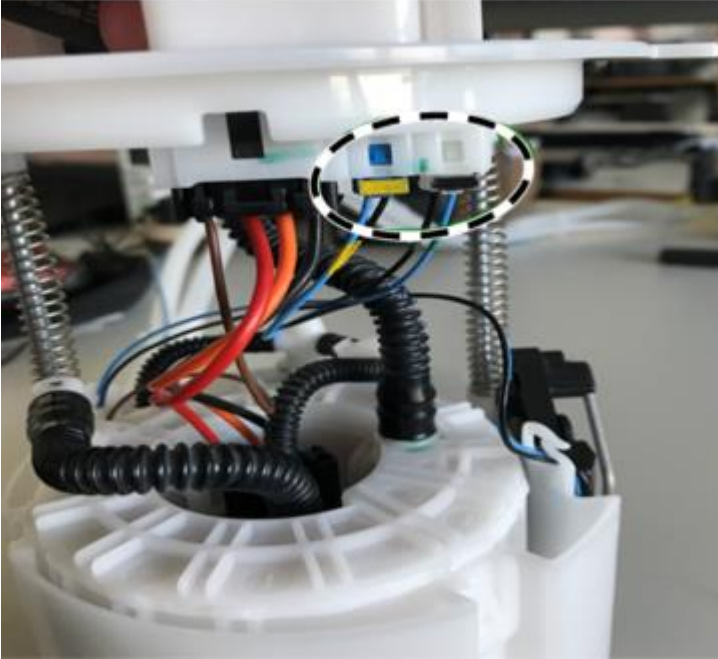
i Delivery modules that are delivered **without float-and-lever sensor** must be modified. (Figure 3-5)

Figure 3 (release corresponding connector and disconnect the contacts)
