TO: Mercedes-Benz Dealer Principals, General Managers, Sales Managers, Service Managers, Parts Managers	FROM: Gregory Gunther, Senior Manager, Vehicle Compliance and Analysis, Engineering Services
RE: Recall Campaign Launch Notification Replace Fuel Pump Delivery Module – Wave 2 MY21-23 C-Class, E-Class, CLS, S-Class, SL, GT, GLC, GLE, GLS and G-Class (205/206, 213/238, 257, 223, 232, 290, 253, 167 and 463 platforms)	DATE: October 27, 2023

Recall Campaign Bulletin

Campaign No. 2023070012, September 2023

Replace Fuel Pump Delivery Module

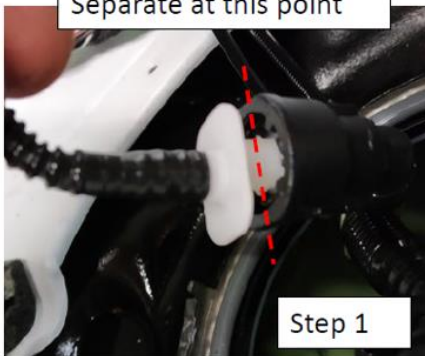
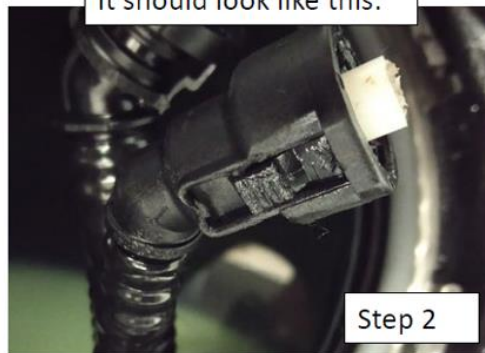
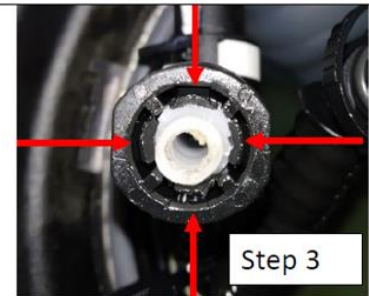
Figure 2

i **Only model 206, 232:** Note on disassembly of suction jet pump drive line quick connector.

The procedure step 1-3 should only be performed when the quick disconnect is not working (**Figure 2**).

Squeeze the QC connection by at least 1mm, then unlock the latching lugs. If this is not possible. Step 1 -3

Min. - 1 mm

Separate at this point

Locking lugs are now accessible and carefully unlock

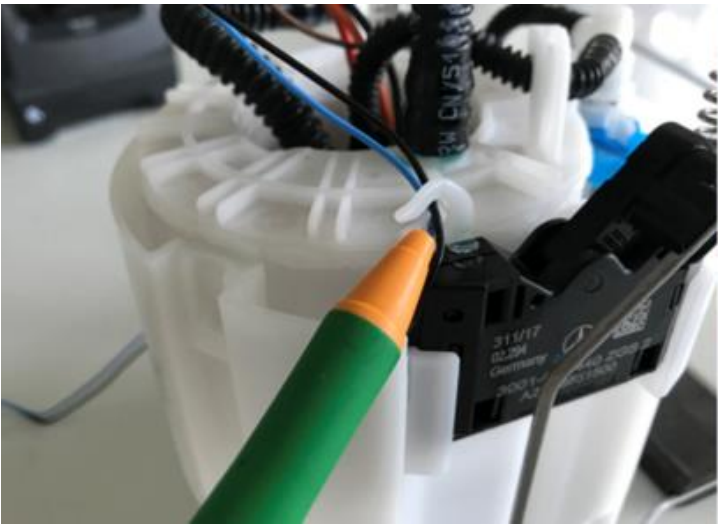
Figure 4 (remove lines from routing clip)

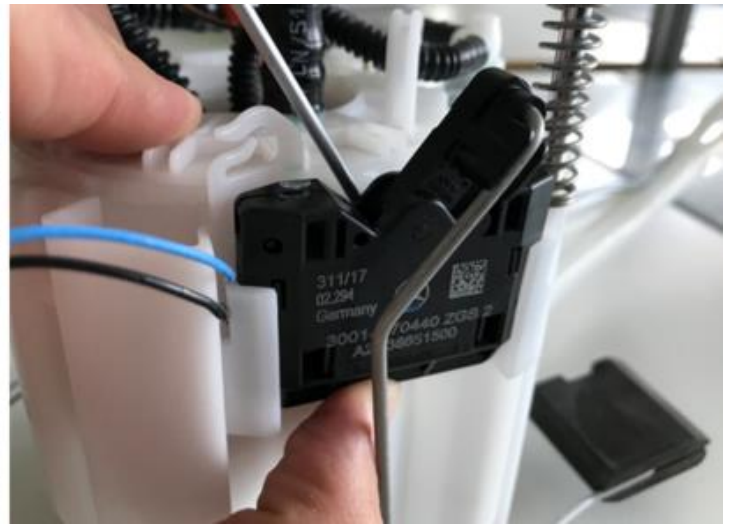
Figure 5 (using a screwdriver, carefully push float-and-lever sensor housing away from module housing and at the same time push float-and-lever sensor housing upwards.)
