Campaign No. 2023070015, August 2023

SUBJECT: **Model C-Class (206 platform)**  
**Model Year 2022-2023**

## **Inspect Transmission Wiring Harness Routing**

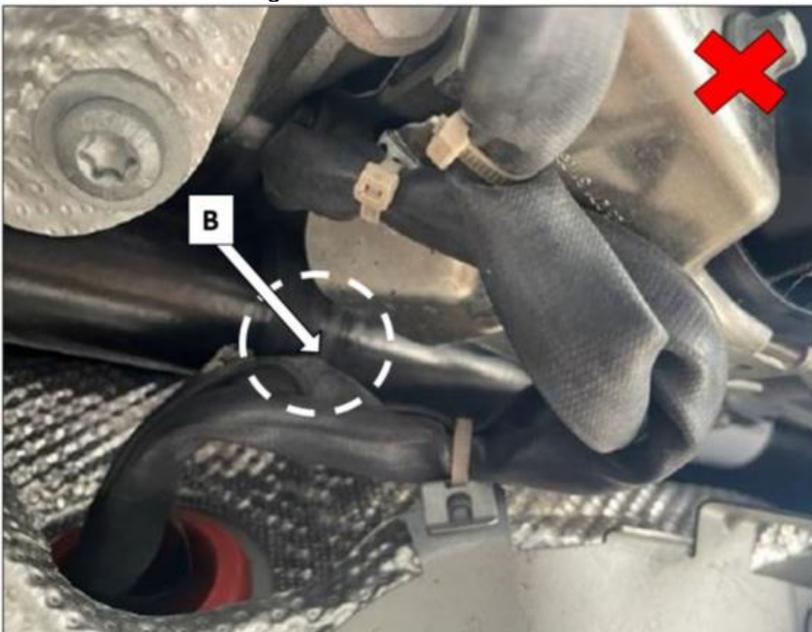
Figure 2, condition not OK

2. Check routing and clearance (B, Figure 2) between the electrical wiring harnesses and the transmission tunnel/drive shaft, and the transfer case for the front axle differential.

**i** The electrical wiring harnesses **must not** contact the drive shaft or the transfer case for the front axle differential!

- a. If the electrical wiring harness is in contact but **not damaged**:  
Carry out **Work Procedure 1**.
- b. If the electrical wiring harness is in contact and **is damaged**:  
Carry out **Work Procedure 2**.
- c. If the electrical **power supply line (3, Figure 3)**  
**(Cable cross section 10 mm<sup>2</sup>) is damaged**:  
Carry out **Work Procedure 3**.
- d. If the electrical wiring harness is **routed correctly**:  
**End measure**.

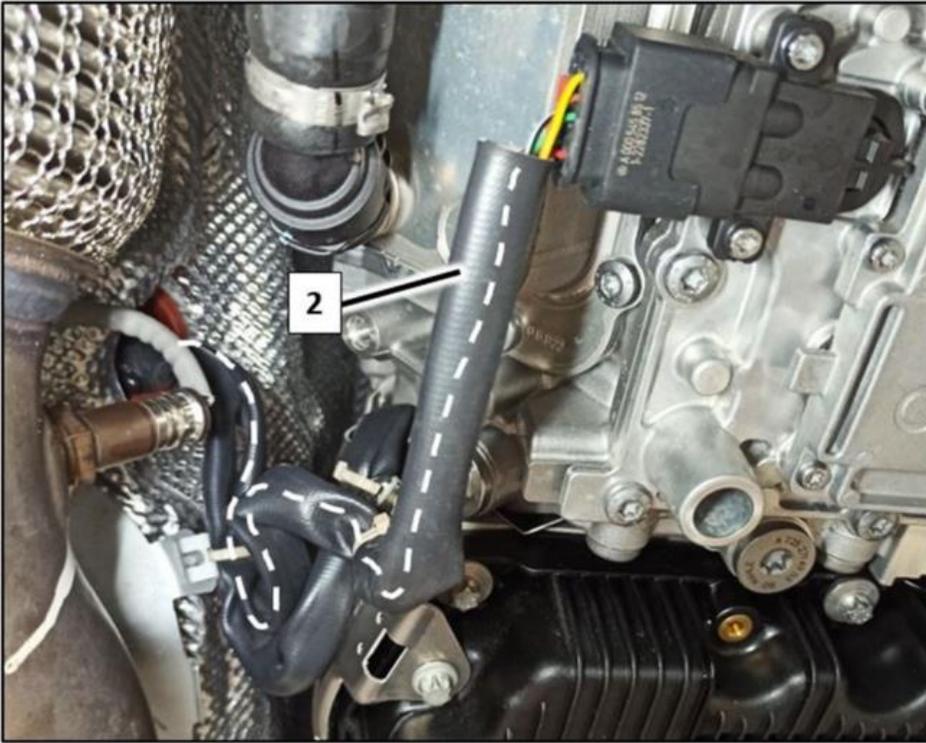
**Figure 5**

**i** If the electrical wiring harness is in contact and **is damaged**.

**i** If one or more of the electrical signal lines (**cable cross section 0.35 mm<sup>2</sup> or 0.75 mm<sup>2</sup>**) in the electrical wiring harness (**2, Figure 5**) are damaged:

1. Wrap fabric tape around affected area.
2. Route the electrical wiring harness (2, Figure 5) correctly as shown.
  - i** The electrical wiring harness (2, Figure 5) may not be in contact at **any point!**

1. Repair the affected electrical signal line (**cable cross section 0.35 mm<sup>2</sup> or 0.75 mm<sup>2</sup>**) in the electrical wiring harness (**2, Figure 5**) using a line connector.

2. Route electrical wiring harness (**2, Figure 5**) correctly as shown.

**i** The electrical wiring harness (**2, Figure 5**) may not be in contact at **any point!**

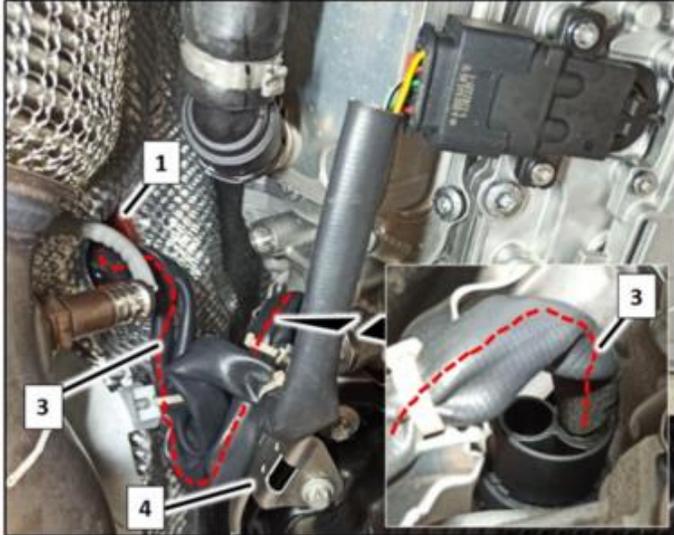
Figure 6

**i** If the electrical power supply line (3, Figures 6 and 7) (cable cross section 10 mm<sup>2</sup>) is damaged, replace electrical supply line

1. Disconnect ground line of battery of 12 V on-board electrical system.  
**i** For basic information, see AR54.10-P-0051WT.
2. Remove protective metal sheet (4, Figure 6).
3. Disconnect electrical power supply line (3, figure 6) from electrical connector.
4. Remove front floor covering on the passenger side.  
**i** For basic information, see AR68.80-P-0008WT.
5. Remove electrical power supply line (3, Figures 6 and 7) with grommet (1, Figures 6 and 7).
6. Replace electrical power supply line (3, Figures 6 and 7).  
**i** The electrical wiring harness may not be in contact at *any point!*
7. Assemble in reverse order.
