# Recall Campaign Bulletin

Campaign No. 2023070015, August 2023

SUBJECT: **Model C-Class (206 platform)**  
**Model Year 2022-2023**

## **Inspect Transmission Wiring Harness Routing**

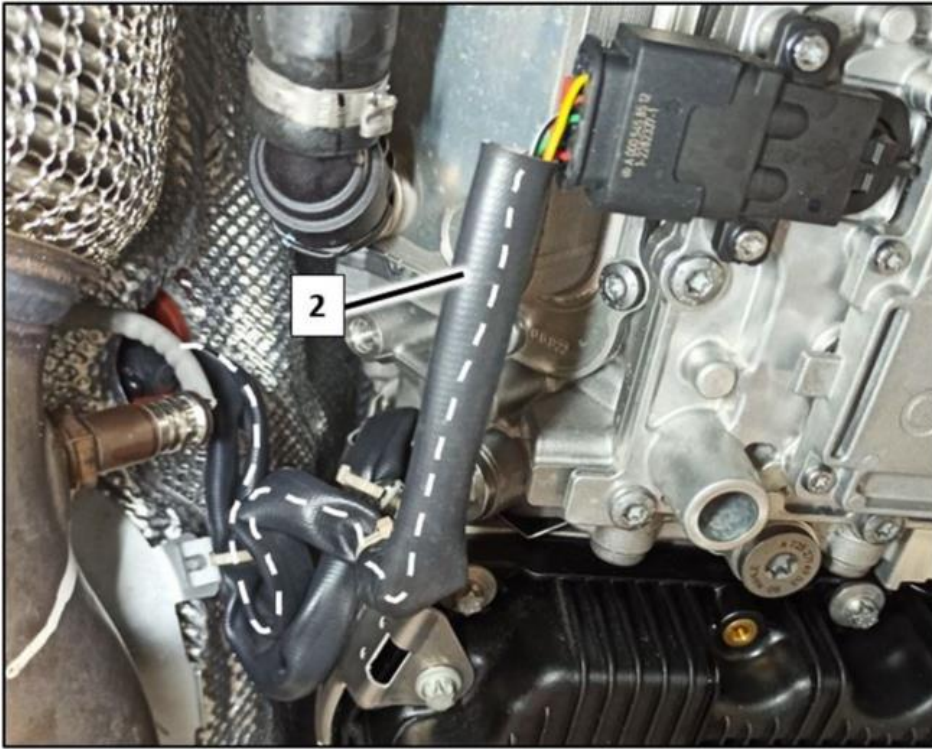
**Figure 5**

**i** If one or more of the electrical signal lines (**cable cross section 0.35 mm<sup>2</sup> or 0.75 mm<sup>2</sup>**) in the electrical wiring harness (**2, Figure 5**) are damaged:

1. Wrap fabric tape around affected area.
2. Route the electrical wiring harness (2, Figure 5) correctly as shown.
  - i** The electrical wiring harness (2, Figure 5) may not be in contact at **any point!**

1. Repair the affected electrical signal line (**cable cross section 0.35 mm<sup>2</sup> or 0.75 mm<sup>2</sup>**) in the electrical wiring harness (**2, Figure 5**) using a line connector.

2. Route electrical wiring harness (**2, Figure 5**) correctly as shown.

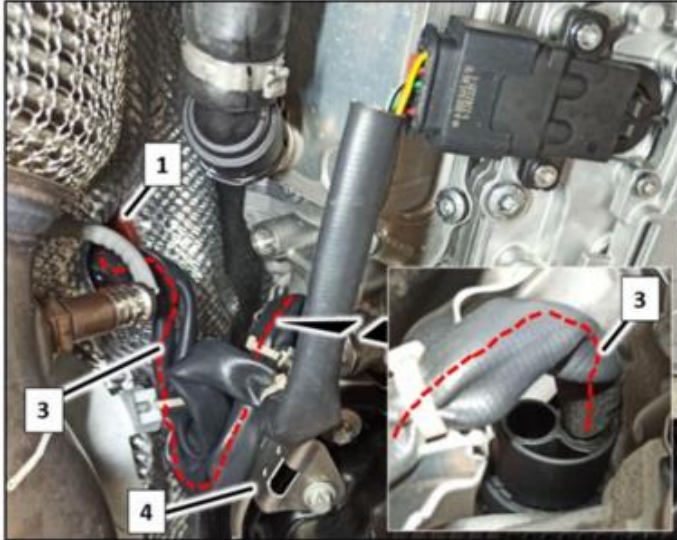
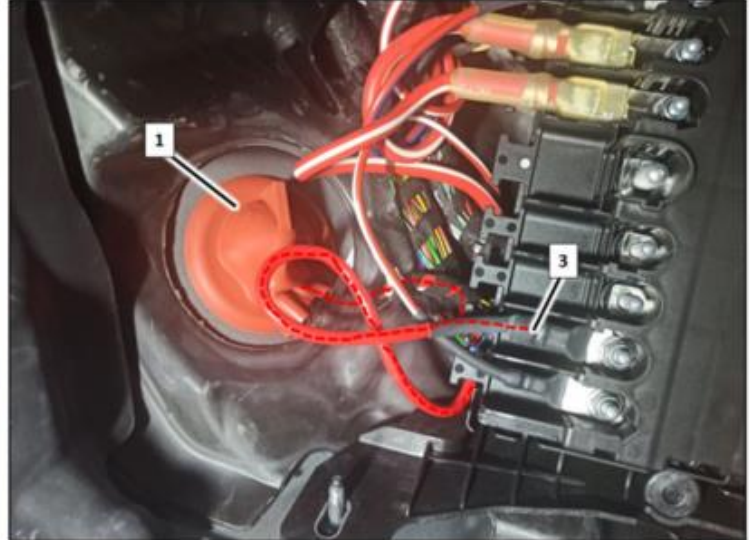
**i** If the electrical power supply line (3, Figures 6 and 7) (cable cross section 10 mm<sup>2</sup>) is damaged, replace electrical supply line

1. Disconnect ground line of battery of 12 V on-board electrical system.  
**i** For basic information, see AR54.10-P-0051WT.
2. Remove protective metal sheet (4, Figure 6).
3. Disconnect electrical power supply line (3, figure 6) from electrical connector.
4. Remove front floor covering on the passenger side.  
**i** For basic information, see AR68.80-P-0008WT.
5. Remove electrical power supply line (3, Figures 6 and 7) with grommet (1, Figures 6 and 7).
6. Replace electrical power supply line (3, Figures 6 and 7).  
**i** The electrical wiring harness may not be in contact at *any point!*
7. Assemble in reverse order.
