Recall Campaign Bulletin

Campaign No. 2023070015, August 2023
Revision A 8/18/2023

SUBJECT: **Model C-Class (206 platform)**
Model Year 2022-2023

Inspect Transmission Wiring Harness Routing

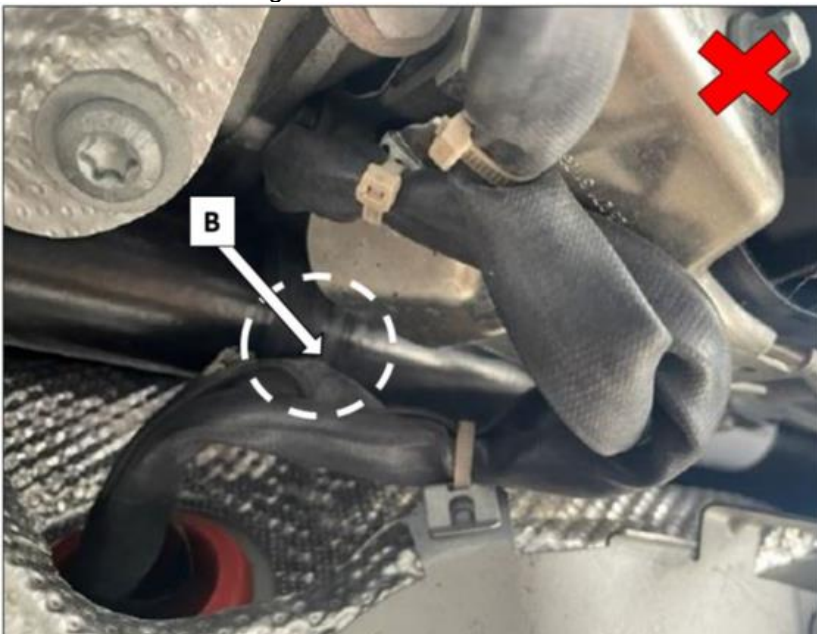
2. Check routing and clearance (B, Figure 2) between the electrical wiring harnesses and the transmission tunnel/drive shaft, and the transfer case for the front axle differential.

i The electrical wiring harnesses **must not** contact the drive shaft or the transfer case for the front axle differential!

Figure 2, condition not OK

- a. If the electrical wiring harness is in contact but **not damaged**:
Carry out **Work Procedure 1**.
- b. If the electrical wiring harness is in contact and **is damaged**:
Carry out **Work Procedure 2**.
- c. If the electrical **power supply line (3, Figure 3)**
(Cable cross section 10 mm²) is damaged:
Carry out **Work Procedure 3**.
- d. If the electrical wiring harness is **routed correctly**.
End measure.

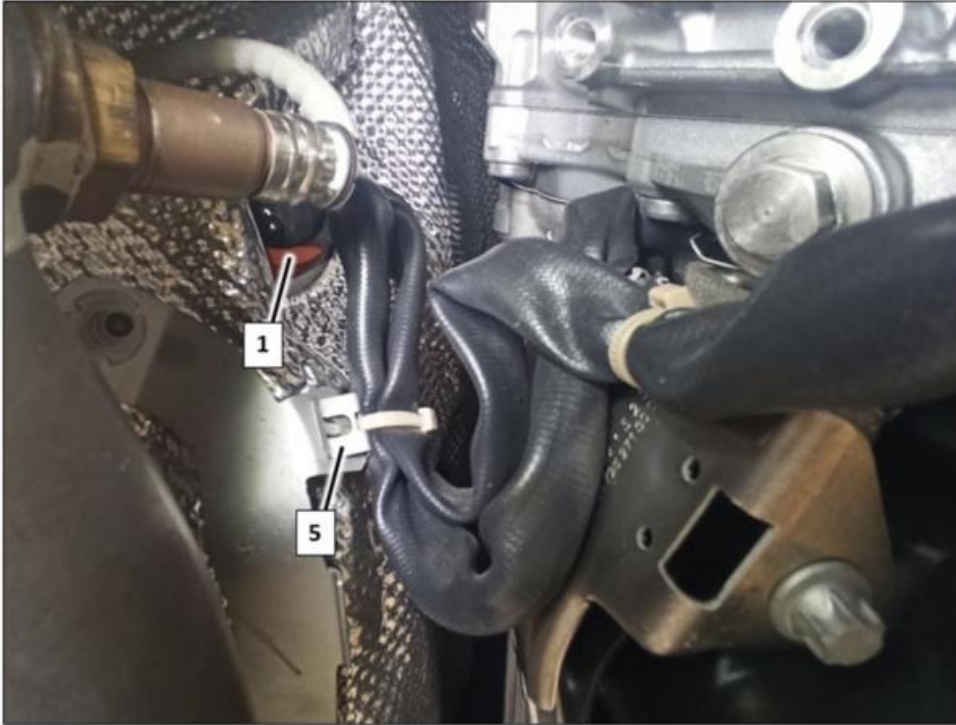
Figure 4

i The electrical wiring harness is in contact but **not damaged!**

1. Cut cable tie at first clip (5, Figure 4).

1. Adjust length of electrical wiring harnesses between red grommet (1, Figure 4) to first clip (5, Figure 4) as shown.
 - i** The length must be between **90 mm and max. 100 mm**. The electrical wiring harnesses **may not be** in contact!
2. Fasten both electrical wiring harnesses to the first clip with a new cable tie (5, Figure 4).
 - i** Check whether both electrical wiring harnesses are in contact at a different location. If so, carry out further corrective measures.
 - i** The electrical wiring harness may not be in contact at **any point!**
3. Assemble in reverse order.

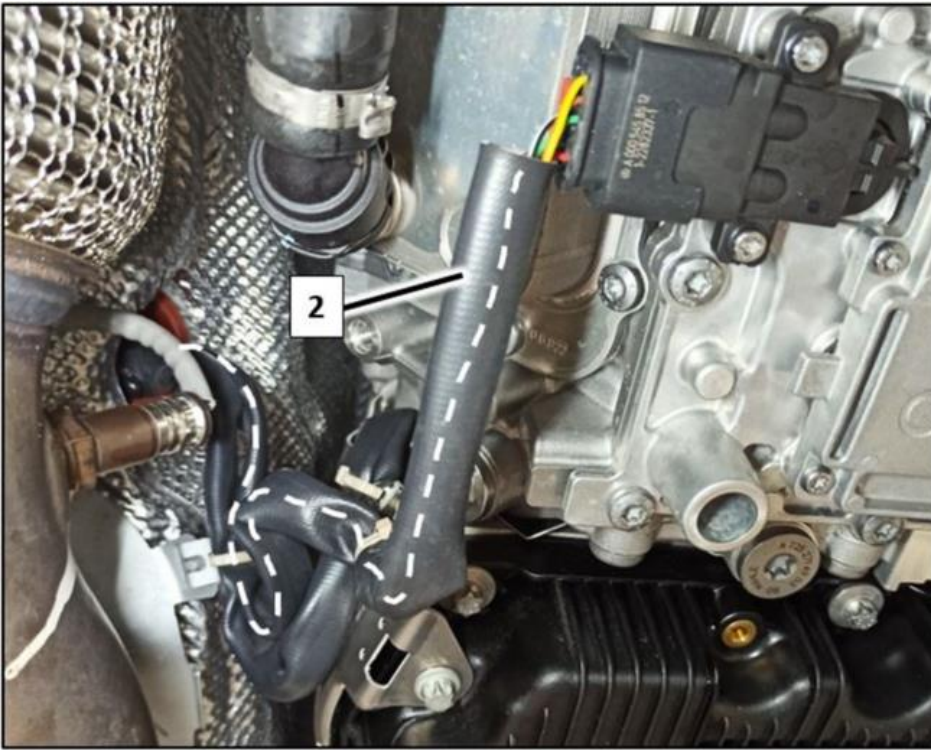
Figure 5

i If the electrical wiring harness is in contact and **is damaged**.

i If one or more of the electrical signal lines (**cable cross section 0.35 mm² or 0.75 mm²**) in the electrical wiring harness (**2, Figure 5**) are damaged:

1. Wrap fabric tape around affected area.
2. Route the electrical wiring harness (2, Figure 5) correctly as shown.
 - i** The electrical wiring harness (2, Figure 5) may not be in contact at **any point!**

1. Repair the affected electrical signal line (**cable cross section 0.35 mm² or 0.75 mm²**) in the electrical wiring harness (**2, Figure 5**) using a line connector.

2. Route electrical wiring harness (**2, Figure 5**) correctly as shown.

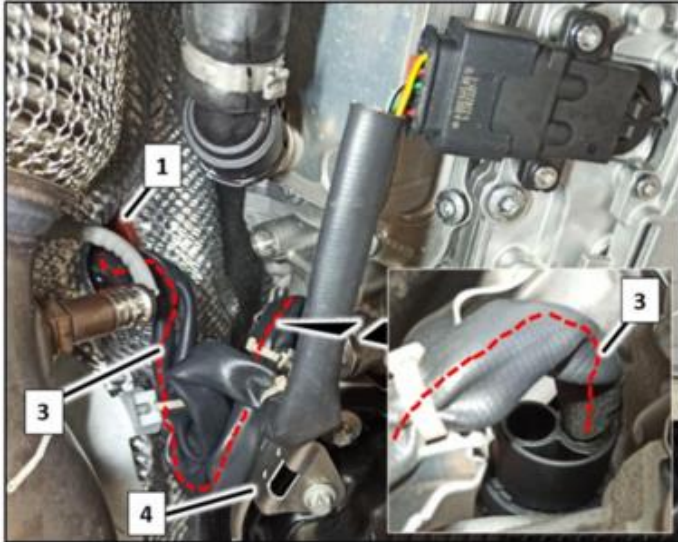
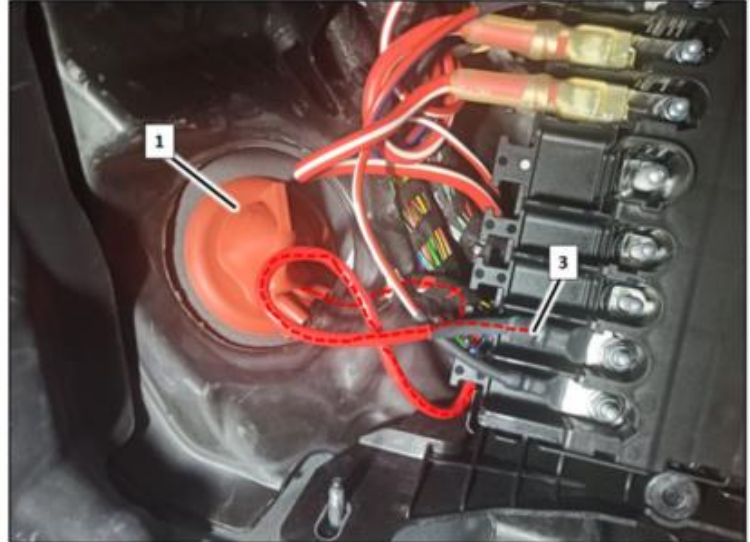
i If the electrical power supply line (3, Figures 6 and 7) (cable cross section 10 mm²) is damaged, replace electrical supply line (3, Figures 6 and 7):

1. Disconnect ground line of battery of 12 V on-board electrical system.
i For basic information, see AR54.10-P-0051WT.
2. Remove protective metal sheet (4, Figure 6).
3. Disconnect electrical power supply line (3, figure 6) from electrical connector.
4. Remove front floor covering on the passenger side.
i For basic information, see AR68.80-P-0008WT.
5. Remove electrical power supply line (3, Figures 6 and 7) with grommet (1, Figures 6 and 7).
6. Replace electrical power supply line (3, Figures 6 and 7).
i The electrical wiring harness may not be in contact at *any point!*
7. Assemble in reverse order.
