$\widehat{\gamma}$	Tesla, Inc.
TESLA	Service Bulletin

Inspect Front Seat Belt Pre-Tensioners and Seat Belts for Correct Installation

SB-23-20-004 July 21, 2023

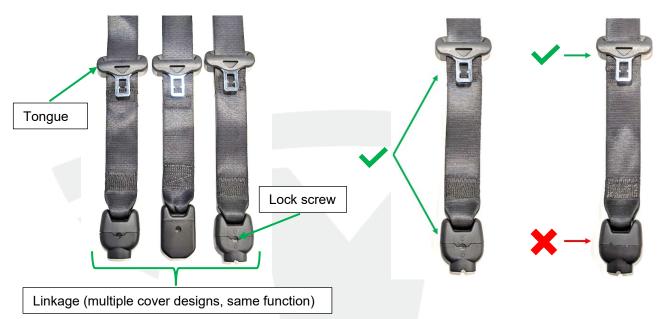
- 3. Verify the LH and RH 1st row seat belts are orientated correctly:
 - The seat belt tongue must be on the same side as the seat belt linkage lock screw (Figure 1).
 - The lock screw must face inboards (towards the occupant) (Figure 2).
 - Make sure that there are no noticeable twists in the seat belt webbing from the upper B-pillar trim to the pre-tensioner connection (Figure 3).

Figure 1

Figure 2 (Occupant view of the seat belt)

Figure 3

- If both seat belts are orientated correctly, continue to the next step.
- If one or both seat belts are orientated incorrectly:
 - Take clear pictures of the defective seat belt(s).
 - Note the seat belt serial number(s) (Figure 4).
 - Add detailed notes and the images to the repair order.
 - NOTE: Corrective action(s) will be determined later in this procedure, continue to the next step after the repair order is updated.

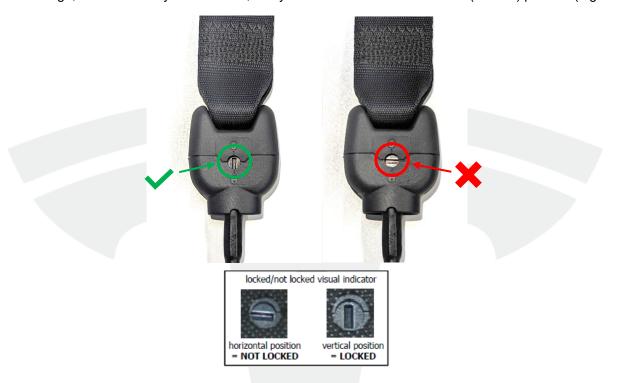
Figure 7 (Pre-tensioner lock screw positions)

- If the lock screw is in the locked (vertical) position, the seat belt pre-tensioner is installed correctly. Continue to step 5.
- If the lock screw is in the unlocked (horizontal) position, the seat belt pre-tensioner is installed incorrectly. Continue to step 5.
- 5. Determine corrective action(s) based on the condition(s) observed in this procedure.
 - Replace any incorrectly oriented 1st row seat belt retractors (refer to Service Manual procedure 20054102; <u>Model S</u>, <u>Model X</u>).
 - Resecure any incorrectly connected 1st row seat belt pre-tensioners.
 - a. If necessary, turn the lock screw counterclockwise to unlock the seat belt linkage. **DO NOT** rotate the lock screw clockwise.
 - NOTE: An audible click will be heard, and the lock screw will remain horizontal.
 - b. If not already disconnected, disconnect the pre-tensioner from the seat belt linkage.

c. Verify that the error proofing notch on the pre-tensioner cable is on the RH side of the linkage (Figure 8). The pre-tensioner latch will not engage if the notch is positioned incorrectly.

- d. Press the seat belt linkage down onto the pre-tensioner cable.
 - NOTE: An audible click will be heard, and the lock screw will remain vertical.
- e. Repeat the seat belt pull test performed in step 4a.
- 6. Move the front seats back to original position.
- 7. Raise the front windows and close the LH and RH front doors.
- 8. Close out this document using the appropriate correction code based on the repair(s) performed.
