VOLUNTARY RECALL CAMPAIGN

Classification:	Reference:	Date:
EL23-017	NTB23-057	July 17, 2023

VOLUNTARY SAFETY RECALL CAMPAIGN 2018-2023 LEAF; VCM REPROGRAM

CAMPAIGN ID #: R23A6
APPLIED VEHICLES: 2018-2023 LEAF (ZE1)

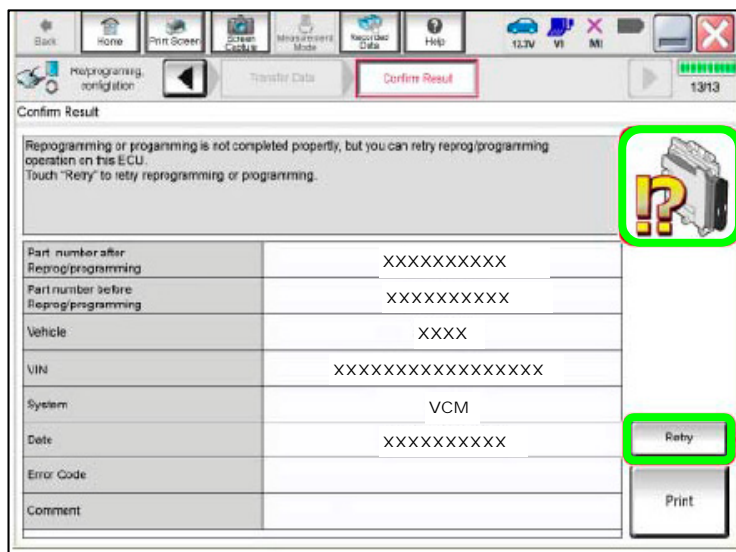
Figure 23

If reprogramming does not complete and the “!?” icon displays, as shown in Figure 23:

- Check battery voltage (12.0 V – 15.5 V).
- EV system is ON (Not Ready).
- External Bluetooth® devices are OFF.
- All electrical loads are OFF.
- Select **Retry** and follow the on screen instructions.
- Retry may not go through on first attempt and can be selected more than once.

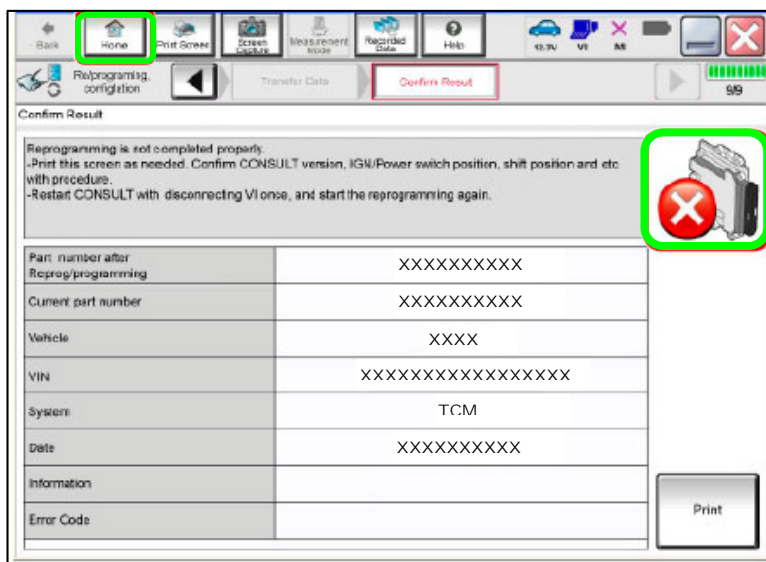
Figure 24

If reprogramming does not complete and the “X” icon displays, as shown in Figure 24:

- Check battery voltage (12.0 V – 15.5 V).
- CONSULT A/C adapter is plugged in.
- EV system is ON (Not Ready).
- Transmission is in Park.
- All C-III plus / VI2 cables are securely connected.
- All C-III plus updates are installed.
- Select **Home**, and restart the reprogram procedure from the beginning.
