Campaign Service

BULLETIN NUMBER:
CB23-N-001

IGNITION COIL PACK FUSE (New Dealer Inventory Only) – 23V-564 (Transport Canada 2023-444)

- 2023 – 2024MY Isuzu N-Series Vehicles Equipped with 6.6L (L8T) Gasoline Engines

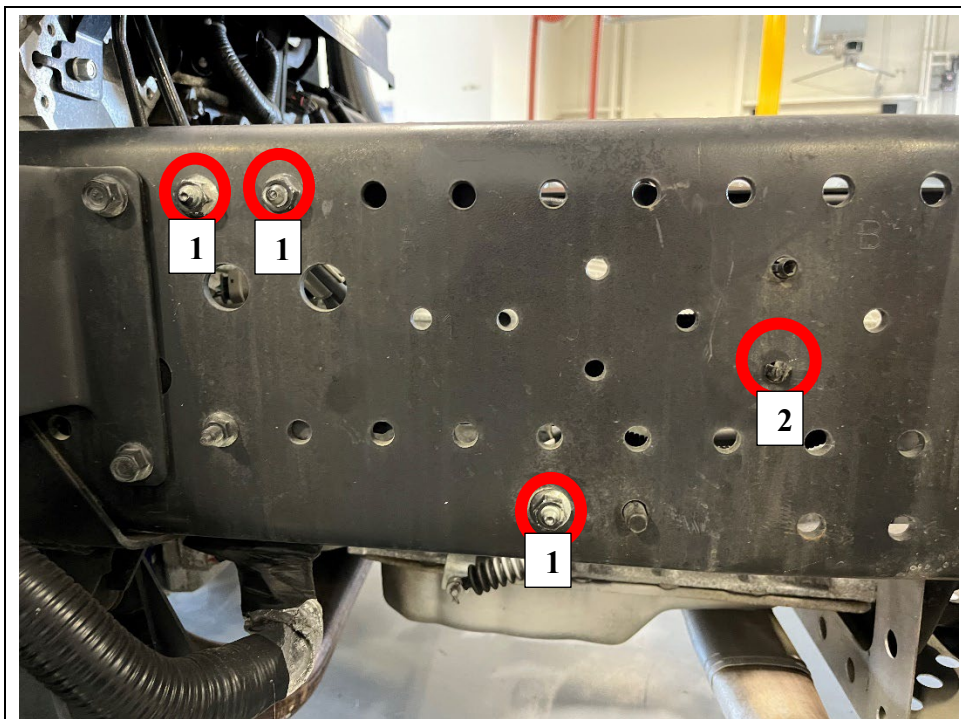
Figure 1 (NPR/NPRHD)

1. Transmission Cooler Line Bracket Nut & Bolt
2. Harness Clip

1. Disconnect the negative battery cable.
2. **(For NPR/NPRHD ONLY)** - Remove three (3) nuts and bolts (14mm) securing the transmission cooler lines and release one (1) chassis harness clip. (See Figure 1.)

13. **(NPR NPRHD ONLY)** - Secure the chassis harness to the frame by pushing the one (1) clip removed in Step 2 back into the frame. (See Figure 1.)
14. **(NPR NPRHD ONLY)** - Install the transmission cooler line mounting bracket bolts and nuts and torque to specification. (See Figure 1.) **Torque specification 40 Nm (30 ft lb)**
15. **(NPR NPRHD ONLY)** – Check the transmission cooler line position. Be sure the white tape mark on the cooler line lines up with the clip on the mounting bracket. (See Figure 12.)

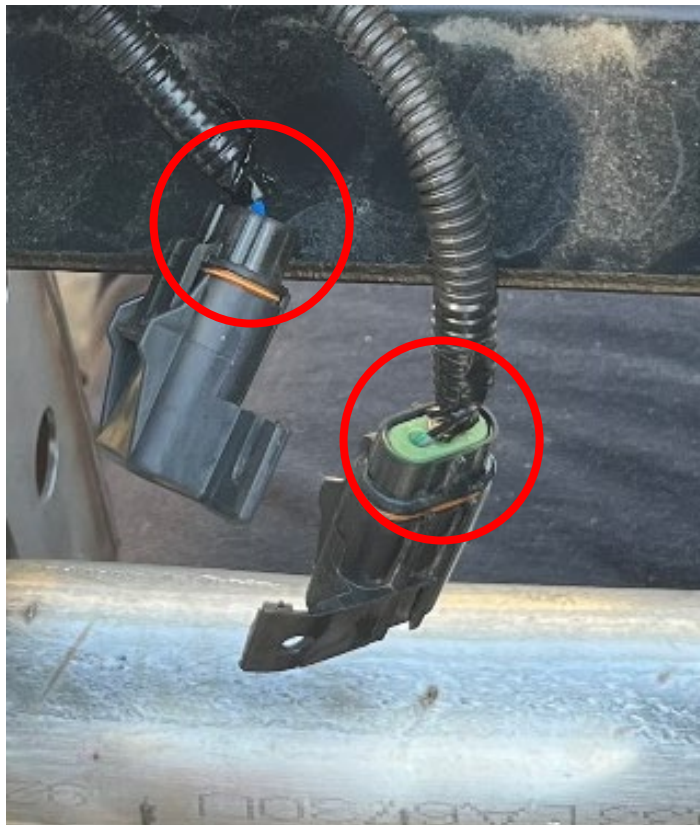
Figure 5

Locations to prepare for sealant

7. Clean the harness side of the fuse holder with electrical contact cleaner. (See Figure 5.)
 - a. Use plastic bristle brush. Spray cleaner onto the brush and remove debris.
 - b. Wipe dry with clean paper towel or cloth.

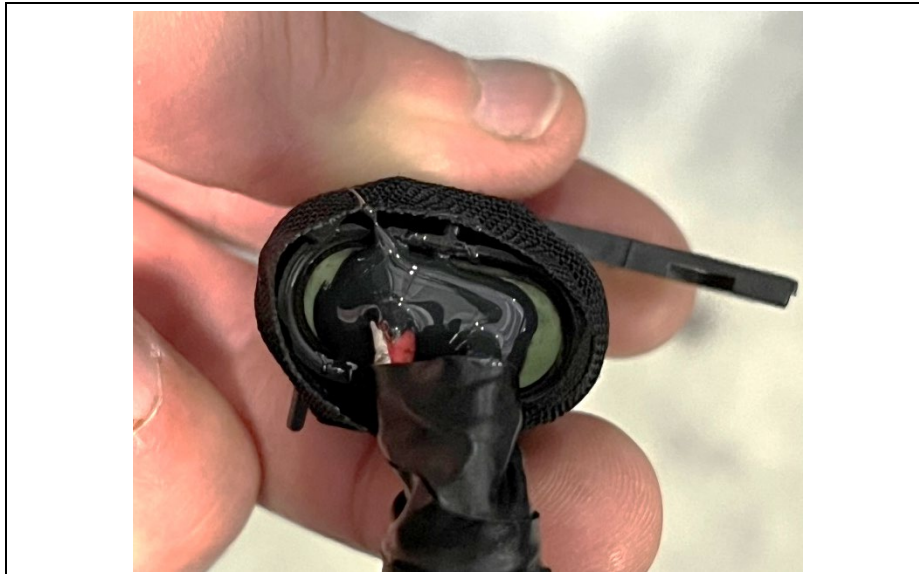
Figure 8

Isuzu Motors Limited has decided that a defect, which relates to motor vehicle safety, exists in certain 2023-2024MY N-Series vehicles equipped with 6.6L (L8T) gasoline engines. In the affected vehicles, an incorrectly sized wire seal was selected for the 2 externally mounted engine ignition coil pack fuse holders. This results in the potential for water intrusion into the fuse holders and eventual corrosion or failure of the fuses.

10. Apply the Super X silicone onto the fuse holder where the wires pass through the connector insulation. (See Figure 8.)
