Customer Legal Recall

(CLR 23-02)

Customer Legal Recall # 662 – U.S. MY23 MC20 Cielo – Windshield frame stud retainment sealant

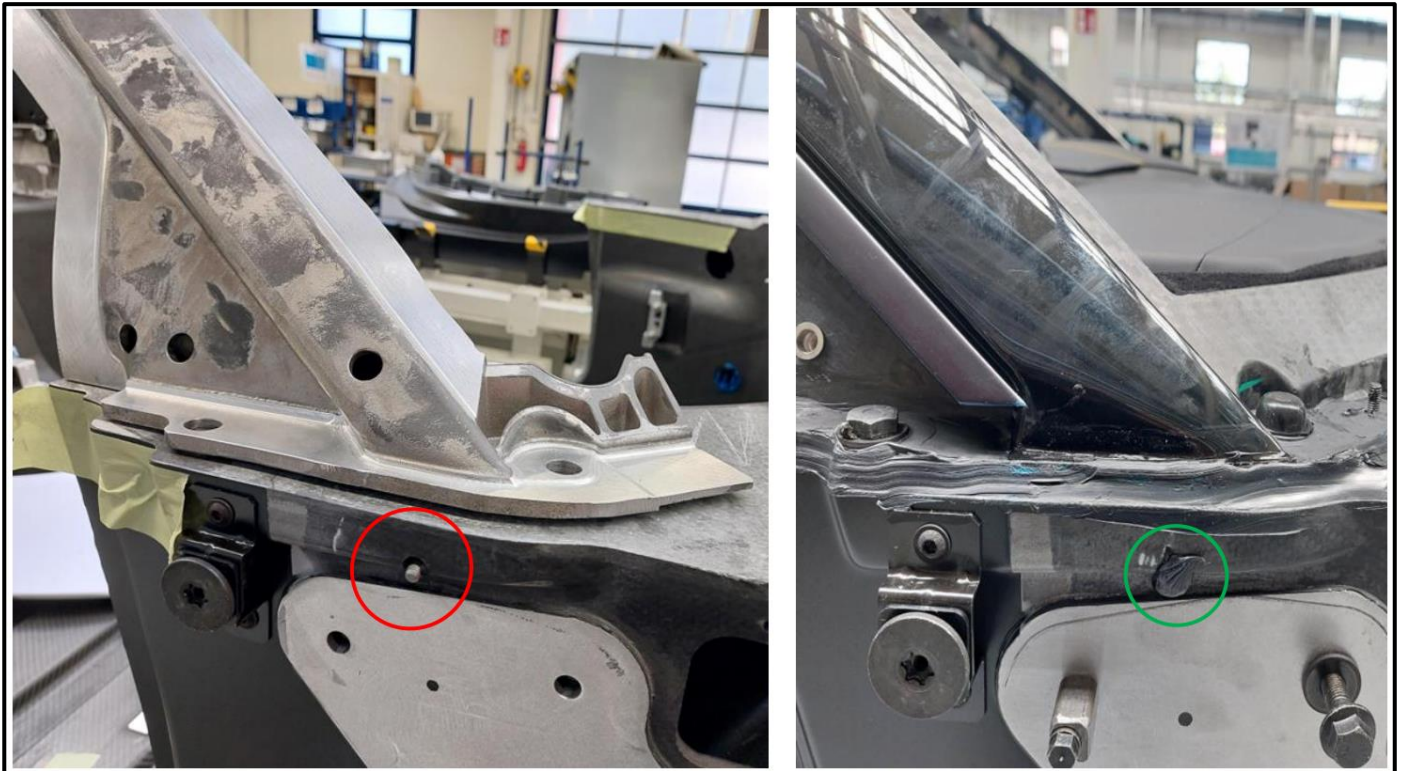
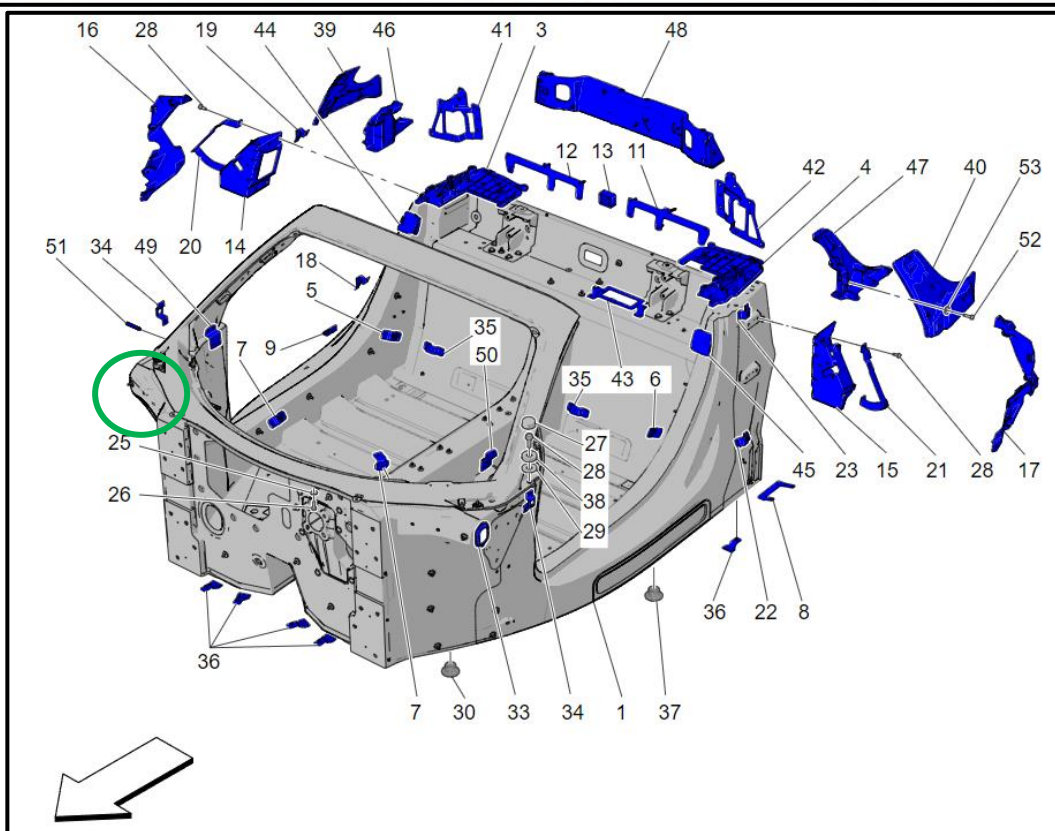
Figure 1: Image of bare body inserted for illustrative purposes only.

The procedure outlined in this bulletin is essential for verifying the presence of the retaining pin in the windscreen area. The procedure begins with a visual inspection that can either confirm or negate the existence of both the sealant and the corresponding pin.

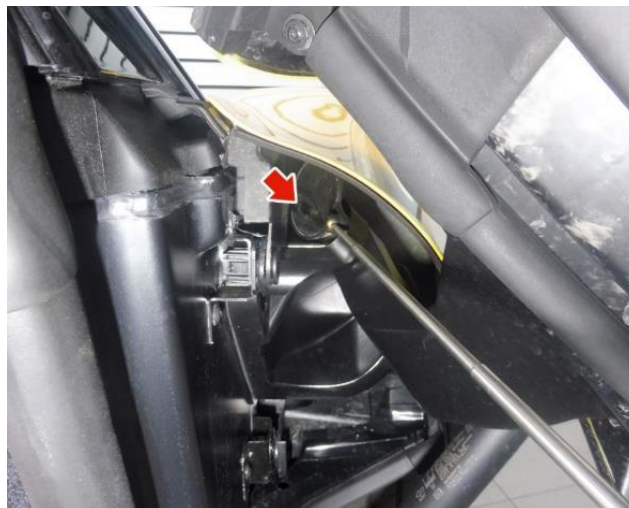
1. Prepare the vehicle for the work by arranging all the protections to avoid any damage to the bodywork and internal parts of the vehicle.
2. Open the door and, working in the door hinge area, use a mirror or endoscope to visually check for the presence of the sealant in the indicated location.

Note: After checking with the mirror, as a double check, also check the presence of the sealant by inserting your hand directly and checking the area of the A-pillar with a finger. **Attention:** This type of check is not a substitute for the mirror check.

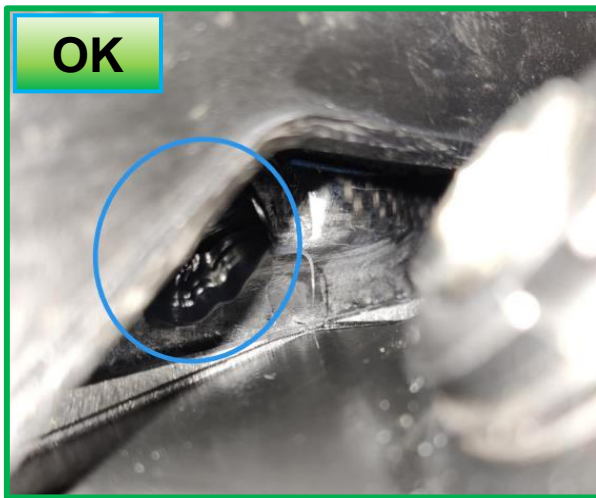
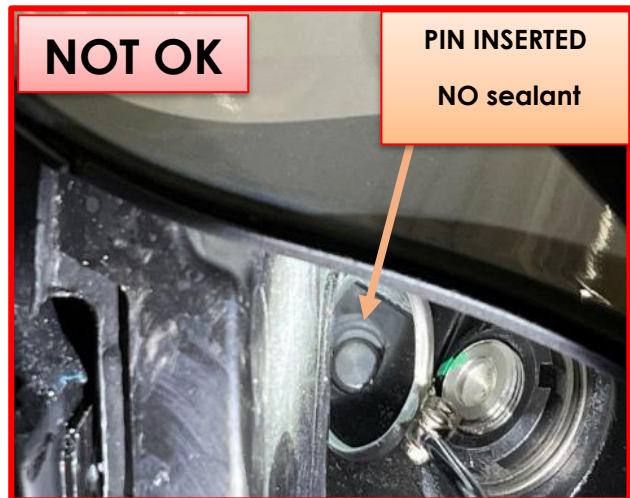
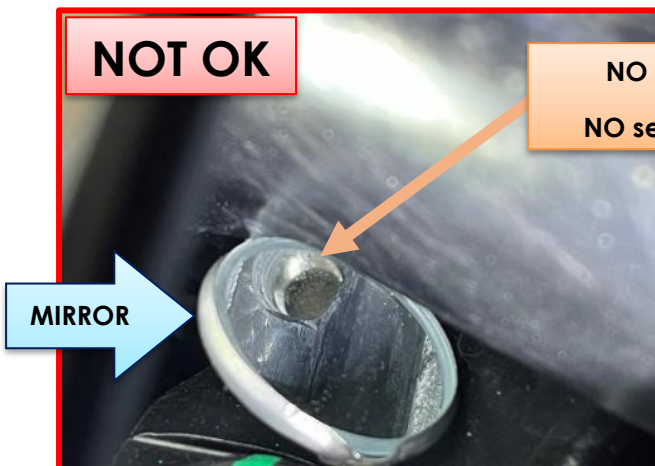
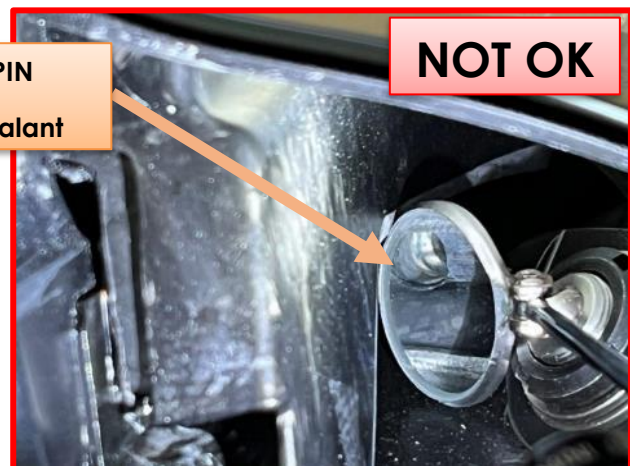
3. **Check the presence of the sealant and the backup pin.** Refer to the images below if in doubt.

- **OK** ► SEALANT IS PRESENT; the procedure is finished. No further action needed.
- **NOT OK** ► SEALANT AND OR THE PIN IS MISSING; the car is non-compliant and must be reworked. Continue with the rework procedure on the next page.
