HYUNDAI Technical Service Bulletin	GROUP RECALL	NUMBER 23-01-074H
	DATE AUGUST 2023	MODEL(S) PALISADE (LX2)
SUBJECT: OCCUPANT DETECTION SYSTEM(ODS) CALIBRATION (RECALL 249)

Description: Certain 2024 Palisade (LX2) equipped with the Calligraphy Night Edition AWD trim package and dark premium seats have an Occupant Detection System (“ODS”) that may have been improperly calibrated by the supplier. An improperly calibrated ODS may not detect the front passenger-side occupant, resulting in suppression of the passenger-side frontal airbags during a crash.

This bulletin provides the procedure to calibrate the Occupant Detection System (“ODS”) using the GDS tool.

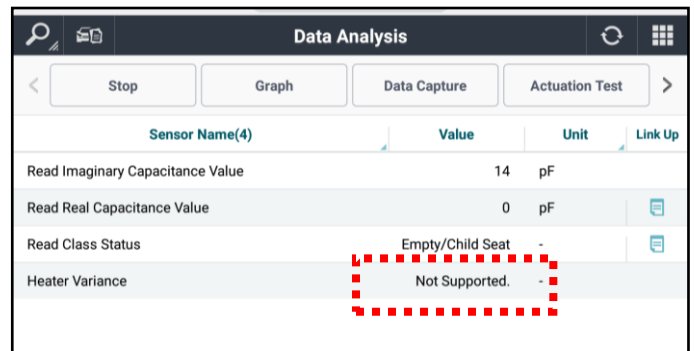
11. Confirm the Heater Variance under Value column is displayed as “**Not Supported**”.

If it is displayed as “Heater” or “Non-Heater” then perform the calibration procedure again by repeating steps 2-7.

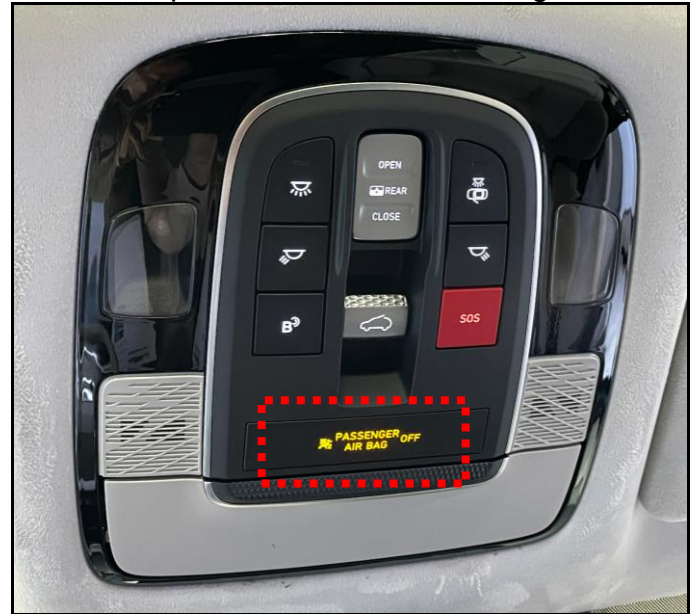
No Occupant In The Front Passenger Seat

Turn the ignition to ON position. The “Passenger Air Bag” light should be lit.

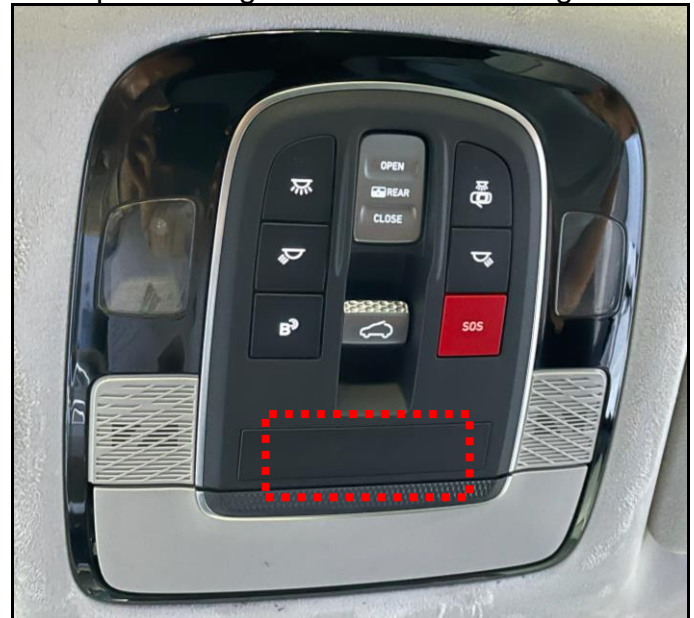
Occupant Sitting In The Front Passenger Seat

- 14. Sit in the passenger front seat and confirm the “Passenger Air Bag” light turns OFF after a few seconds.
