PRODUCT CAMPAIGN BULLETIN

APPLICABILITY: 2022MY BRZ

NUMBER: WRM-23

SUBJECT: Safety Recall – BRZ Rear turn signal illumination failure

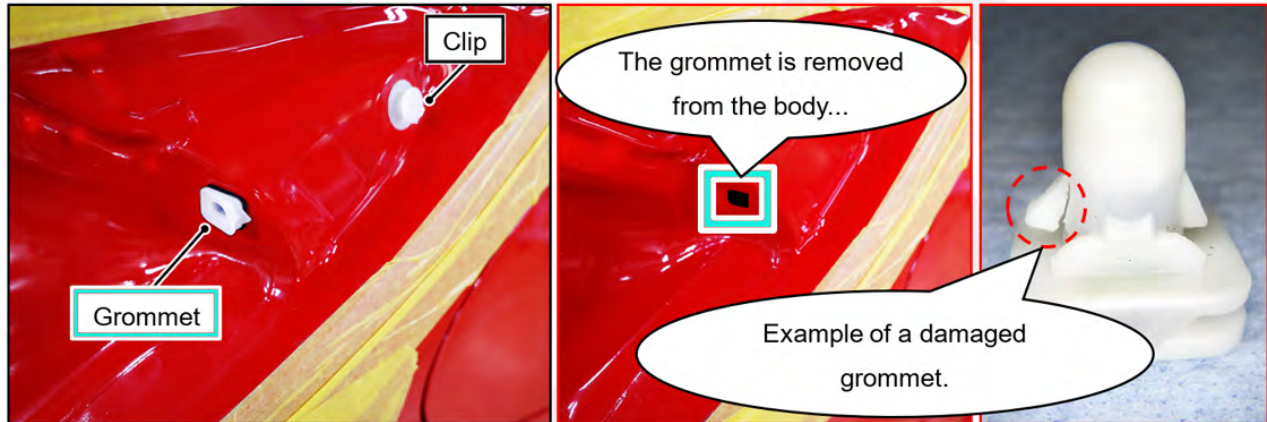
CAUTION: When removing the combination lamp, it is possible for the grommet to be removed along with the lamp. If this occurs, replacement will be required.

STEP 10: Inspect the clip and grommet attached to the body of the vehicle. Confirm there is no loose fitment or physical damage of any kind. If damage is found to the clip or grommet, replacement will be required.
