PRODUCT CAMPAIGN BULLETIN

APPLICABILITY: 2022MY BRZ

NUMBER: WRM-23

SUBJECT: Safety Recall – BRZ Rear turn signal illumination failure

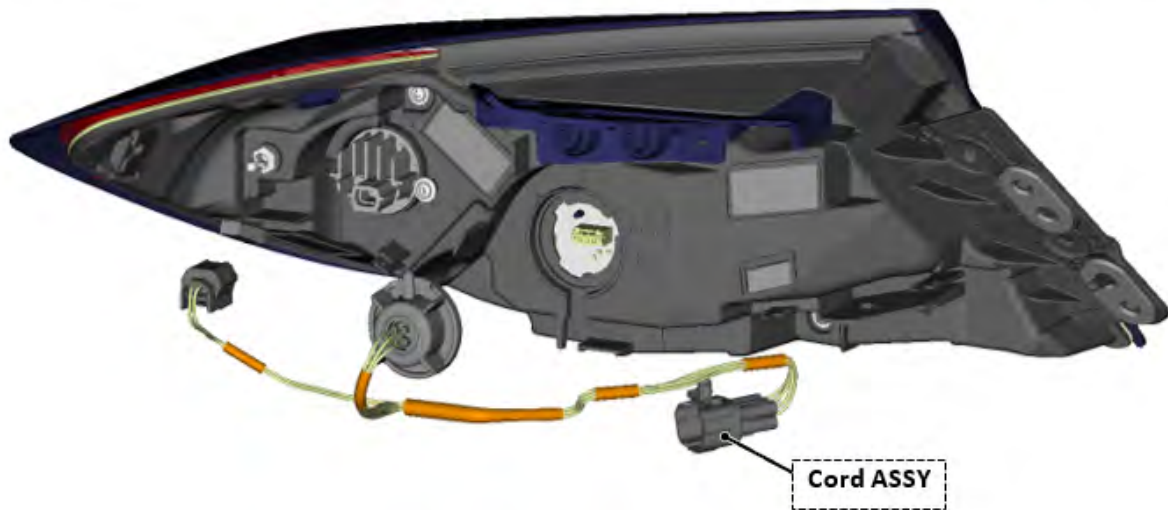
COMPONENT DESCRIPTION:

Defective Part

Part Susceptible to Damage

Tightening Torque

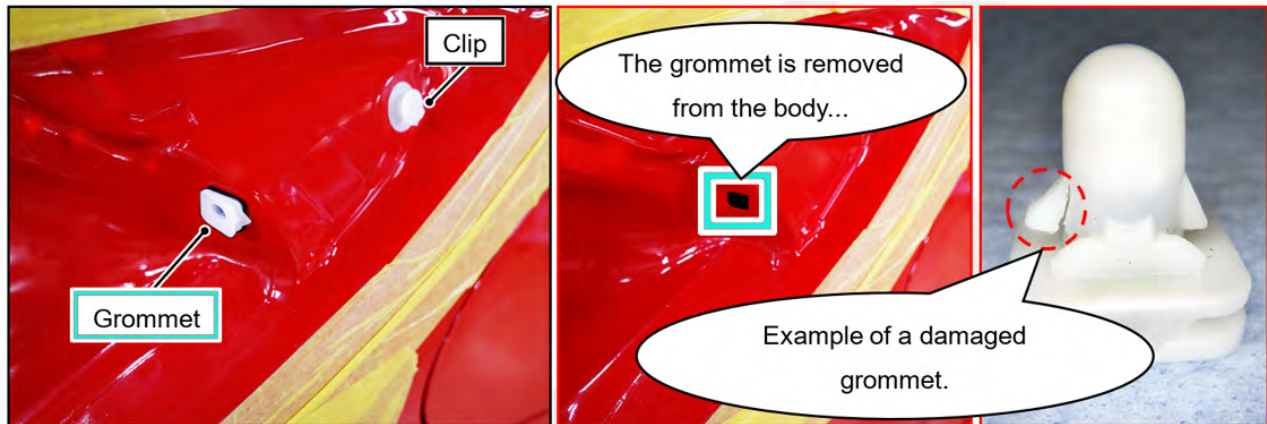
CAUTION: When removing the combination lamp, it is possible for the grommet to be removed along with the lamp. If this occurs, replacement will be required.

STEP 10: Inspect the clip and grommet attached to the body of the vehicle. Confirm there is no loose fitment or physical damage of any kind. If damage is found to the clip or grommet, replacement will be required.
