CR255 – Replacement of Side Stand Bracket and Spring Plate

XDiavel Model Year 2018-2021 (all versions)

Safety Recall Campaign SRV-RCL-23-004

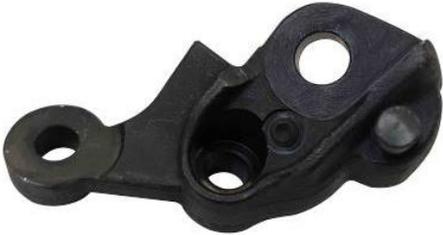
Side Stand Bracket Part Number 55621052AA	Spring Hooking Plate Part Number 82718981AA

As a result of the continuous quality checks on the product, we have decided to extend the fleet subject from the previous CR206 recall campaign, as we have found a potential concern with the Side Stand Mounting Bracket. In some rare cases the Spring Hooking Pin may break and cause the undesired extension of the Side Stand, even when riding. Unlike the previous CR206, this campaign does not require replacement of the side stand as it will need to be reused.

- The **Side Stand Mounting Bracket** with a new version, **Part no. 55621052AA** which has been redesigned to avoid the above-described issue.
- The **Spring Hooking Plate** with a new replacement, **Part no. 82718981AA**.
