Pending TBB SAF-T-LINER C2 Recall Campaign FL981

FL981: TBB SAF-T-LINER C2 AC Electrical Wiring
NHTSA #: TBD

Inspection and Work Instructions

Subject: TBB SAF-T-LINER C2 A/C Electrical Wiring

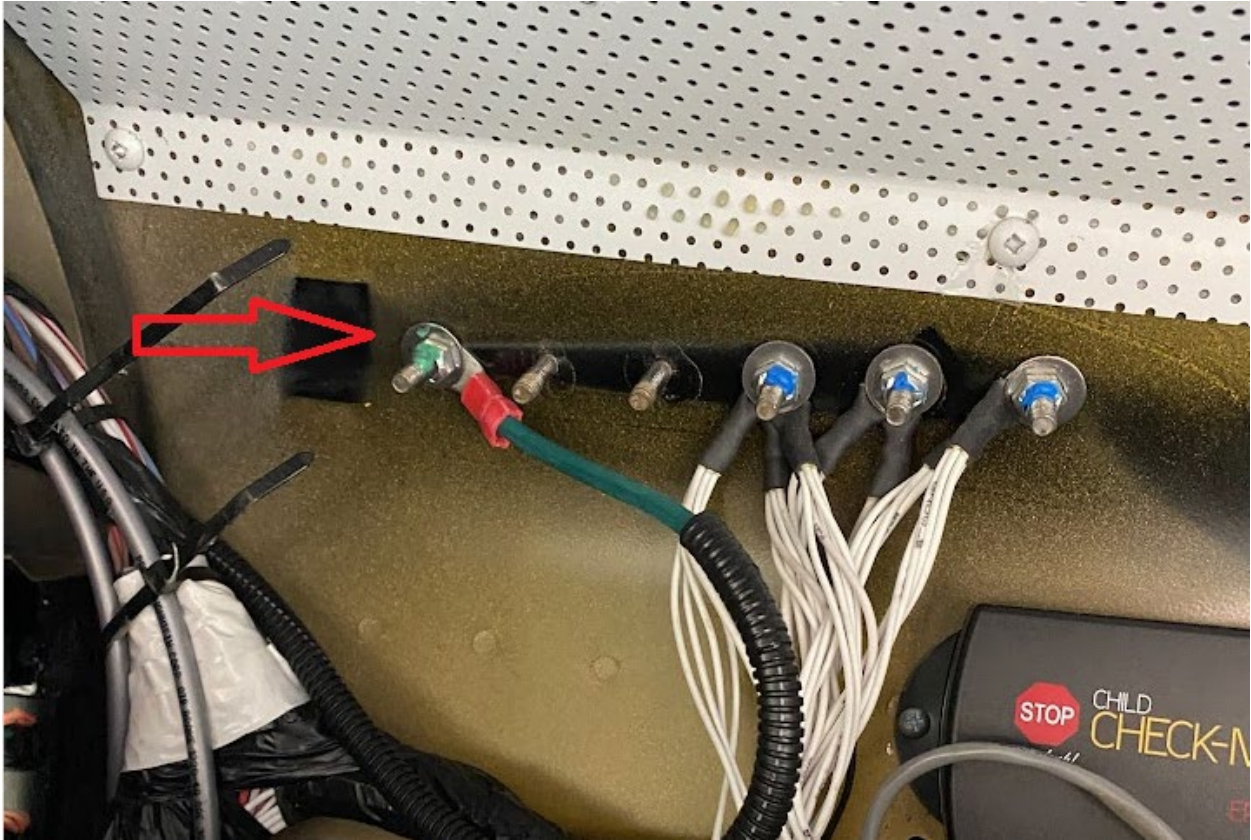
Ground studs – front side evaporator: Remove 2 square head screws that hold in place the glove box inner liner located left of driver side overhead compartment. Check nut on the grounding stud for tightness. If loose, tighten (recommended torque 95 in-lbs). If the ground stud happens to break, move the ground to a separate stud. If the nut was not tight, inspect the wiring for any damage – if there is damage to the ground wire, contact TBB for further guidance.

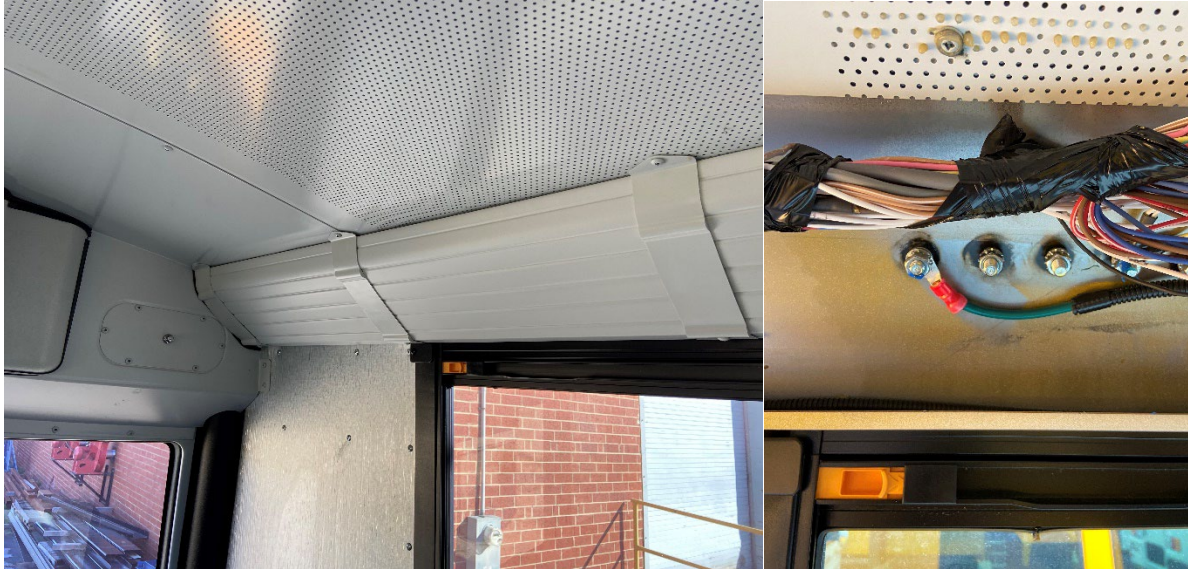
Ground stud – rear evaporator: Remove 2-3 phillips style screws from brackets holding plastic curtain molding to be able to pull the curtain molding away enough to expose the metal header with the ground studs. Check nut on the grounding stud for tightness. If loose, tighten (recommended torque 95 in-lbs). If the ground stud happens to break, move the ground to a separate stud. If the nut was not tight, inspect the wiring for any damage – if there is damage to the ground wire, contact TBB for further guidance.

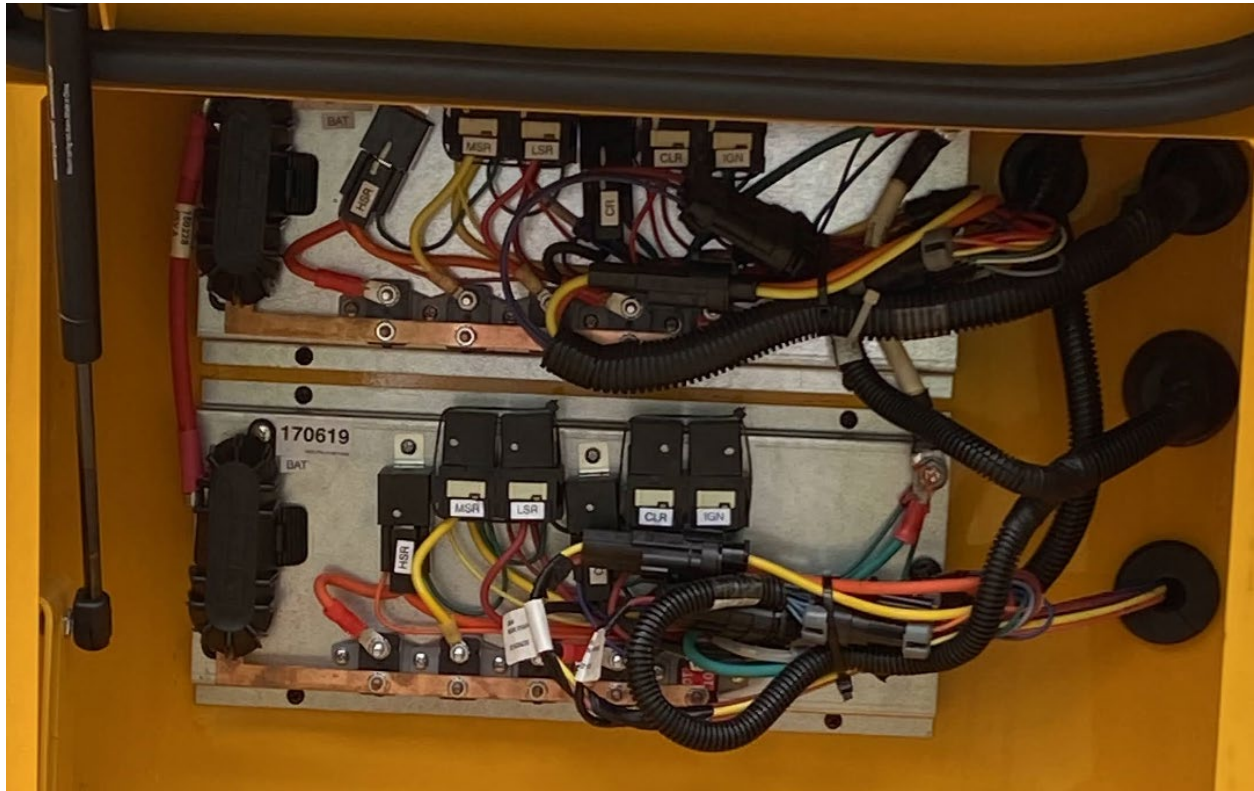
Connections inside A/C box: Open the cover of the first door behind the battery compartment. Check for tightness of nuts attaching cables to the BCC control modules. Recommended torque is 95 in-lbs on the B (+) connectors between the cables and the megafuses. Check all connections to the bus bar on the control modules – joints should not be loose – torque nuts connecting wires to bus bar to 24-32 in-lbs if loose. Check all crimped connection joints – wires should be firmly connected.
