Recall Campaign Bulletin

Campaign No. 2023090010, October 2023

SUBJECT: **Model GLC (254 platform)**
Model Year 2023

Inspect Front Tow Eye Receiver

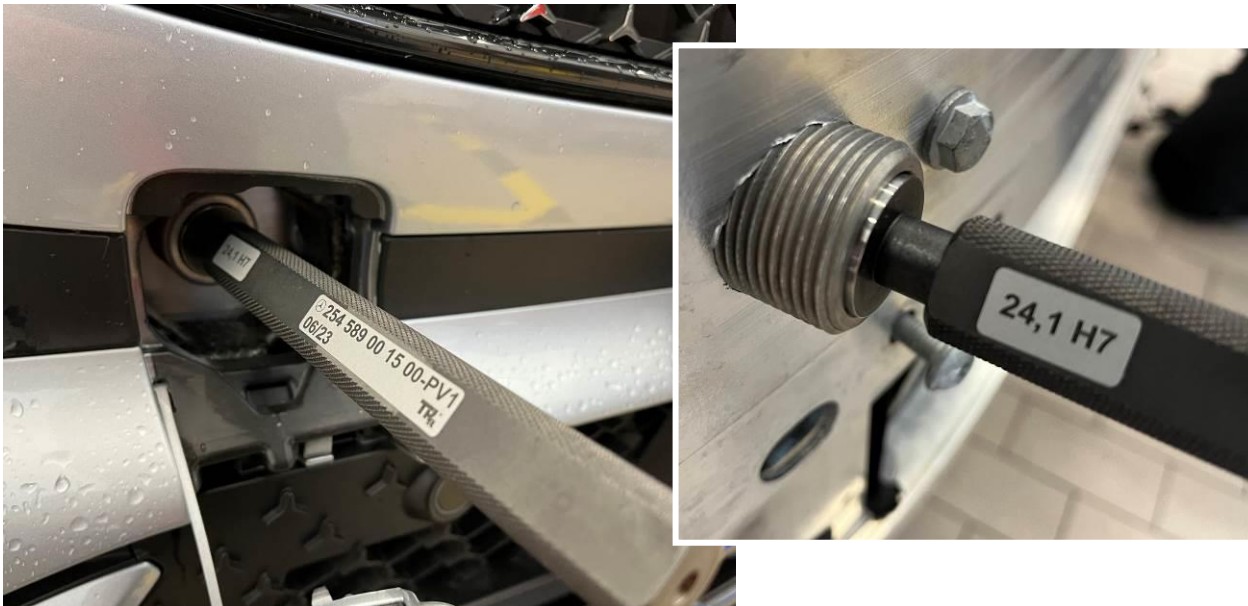
Figure 1, with and without bumper for a clearer illustration

i If the Limit check mandrel can be inserted almost completely with a slight protrusion, this is an “OK” result.

i If the Limit check mandrel tool cannot be threaded into the towing eye receiver on the crossmember, the towing eye receiver may be too narrow. This is a “Not OK” result.

- a. Limit check mandrel **can be** inserted into towing eye receiver on the front crossmember: **End measure and invoice operation item 12-1881** (check towing eye receiver on front crossmember, findings: OK).
- b. Limit check mandrel **cannot** be inserted into towing eye receiver on the front crossmember: **End measure and invoice operation item 12-1882** (check towing eye receiver on front crossmember, findings: **NOT OK**).
