SIB 61 22 23

RECALL 23V-644: WIPER LINKAGE

E-Series	Model Description	Production Date
G70	7 Series Sedan	October 13, 2022 – January 26, 2023

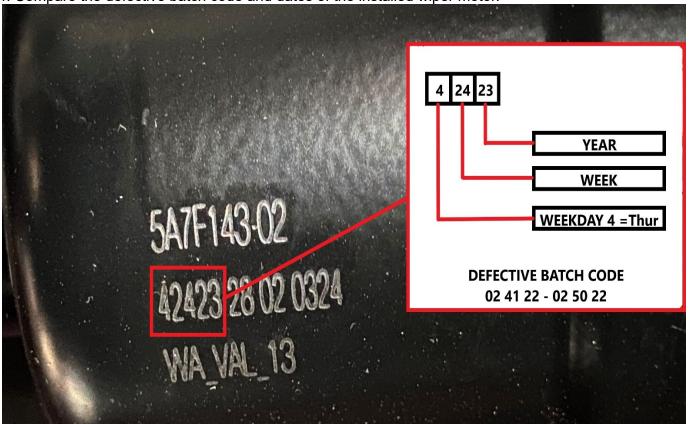
3. Raise the windshield panel cover on the driver's side and record the wiper motor code.

4. Compare the defective batch code and dates of the installed wiper motor.

- 5. If the batch code falls under the affected dates (from **02 41 22** to **02 50 22**), the wiper linkage must be replaced.
 - Refer to AIR repair instructions 61 61 271 "Replace the console for the windshield wiper system"
- 6. If the windshield wiper console does not match the defective batch code dates, the wiper console is OK. Reinstall the removed parts in the reverse order of their removal.
