GROUP	MODEL
Safety Recall Campaign	2023MY Forte (BDm)
NUMBER	DATE
SC283	September 2023

FRONT RIGHT LOWER CONTROL ARM REPLACEMENT (SC283)

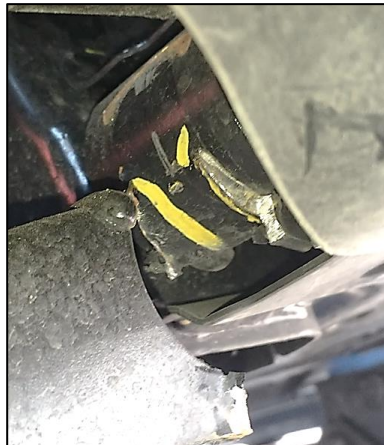
This bulletin provides information to replace the right front lower control arm (LCA) on certain 2023MY Forte (BDm) vehicles produced from April 12, 2023 through June 7, 2023. One of the joint connection points of the right (passenger side) front LCA to the vehicle's crossmember in the subject vehicles may have been improperly welded. Over time, an improperly welded joint can fatigue and break causing partial separation of the LCA from the vehicle's crossmember. If partial separation occurs, the vehicle's front toe angle may change impacting the vehicle's steering, thereby increasing the risk of a crash. Follow the procedure outlined in this publication to replace the right front LCA with a new part on the applicable vehicle. Before conducting the procedure, verify that the vehicle is included in the list of affected VINs.

1. Replace the right lower control arm with the new part by referring to "Suspension System → Front Suspension System → Front Lower Arm → Repair procedures" in the applicable Shop Manual on KGIS.

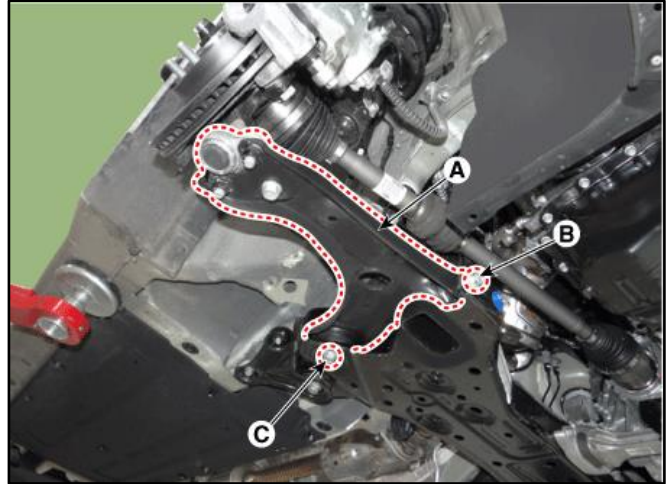
Note: Required SST 09568 1S100 listed on KGIS was '**Superseded**' by **09568 34000**

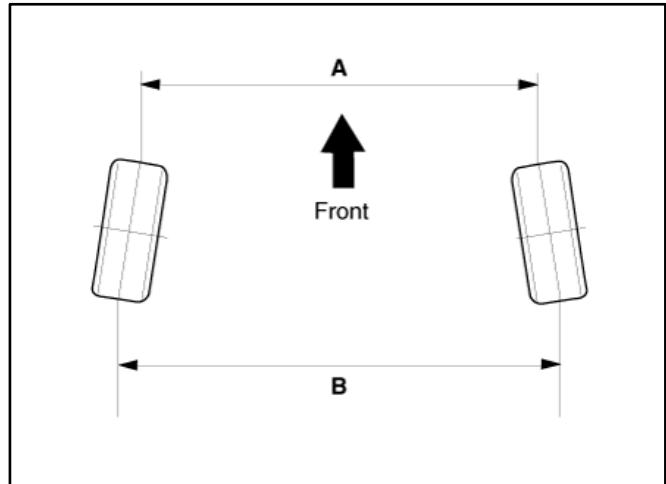
Keep SST tied to the car because there is a risk of injury by dropping the SST during removal of the front lower control arm.

Be careful not to damage the hub bolts when removing the front wheel and tire.

When using SST, be sure not to damage the dust cover of lower arm ball joint.

The peripheral parts may be damaged when removing the lower arm ball joint with a general tool such as lever, so be sure to use SST.

2. After replacement is completed, refer to "Suspension System → Front Suspension System → Front Alignment → Repair procedures" in the applicable Shop Manual on KGIS to adjust the toe angle.
