Recall Number:	Brinkley RV ID: PCI-2023-01; NHTSA Recall No. 23V-664		
Product:	Power Control System		
Date:	September 28,2023 Labor Rate: 1.0 hours

This document refers to Brinkley Model G Series 5<sup>th</sup> Wheels and the requirement to replace the 10-gauge white wire with a larger 6-gauge white wire in the energy management Power Control System. This will be done by replacing the complete box assembly that houses the wiring.

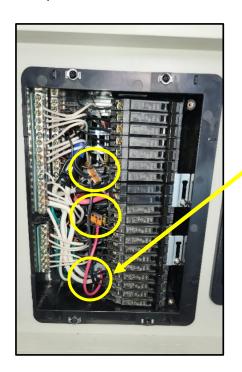
This is where the Power Contol System wires enter into the panel from back of the power distribution center.

3. Remove the 12-gauge black wire and red wire from Wago Connectors for wires connecting to the Power Control System.
