SERVICE BULLETIN

M1610 2023-10-16

M1610: RECALL 0184 - 2023 CVO STREET GLIDE (FLHXSE) AND ROAD GLIDE (FLTRXSE) BRAKE LINE CLAMP

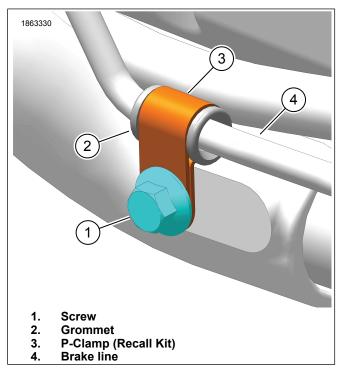
Figure 2. P-Clamp Orientation

This bulletin informs dealers that Harley-Davidson has learned that certain 2023 CVO Street Glide (FLHXSE) or Road Glide (FLTRXSE) model motorcycles may not have the rear brake line properly retained in a lower frame rail clamp, which may allow the brake line to contact the exhaust. Contact between the brake line and the exhaust could, over time, lead to a hole in the brake line and a loss of rear brake fluid. If brake loss remains undetected, rear braking may be compromised, increasing the risk of a crash.

- 1. See Figure 1. Remove and retain screw (1).
- Remove and discard Original Equipment (OE) brake line clamp (2).
- See Figure 2. Install **new** P-Clamp (3) from recall kit (Part No. 91500116).
 - Make sure P-Clamp (3) is properly orientated.
- Install screw (1). Tighten.

Torque: 80-97 in-lbs (9-11 N·m)
