Safety Recall

N232422960 Pedestrian Friendly Alert May Not Sound During Deceleration

Release Date: October 2023

Condition	General Motors has decided that a defect which relates to motor vehicle safety exists in certain 2023 model year Cadillac LYRIQ vehicles. The Body Control Module (BCM) in these vehicles may have been updated with incorrectly calibrated software. This software may cause the vehicles to fail to emit the pedestrian-warning sounds required by F/CMVSS 141 while decelerating from 30 to 25 kph. A pedestrian may not hear an approaching vehicle equipped with this software, increasing risk of a crash with a pedestrian.
Correction	Dealers will reprogram the BCM.

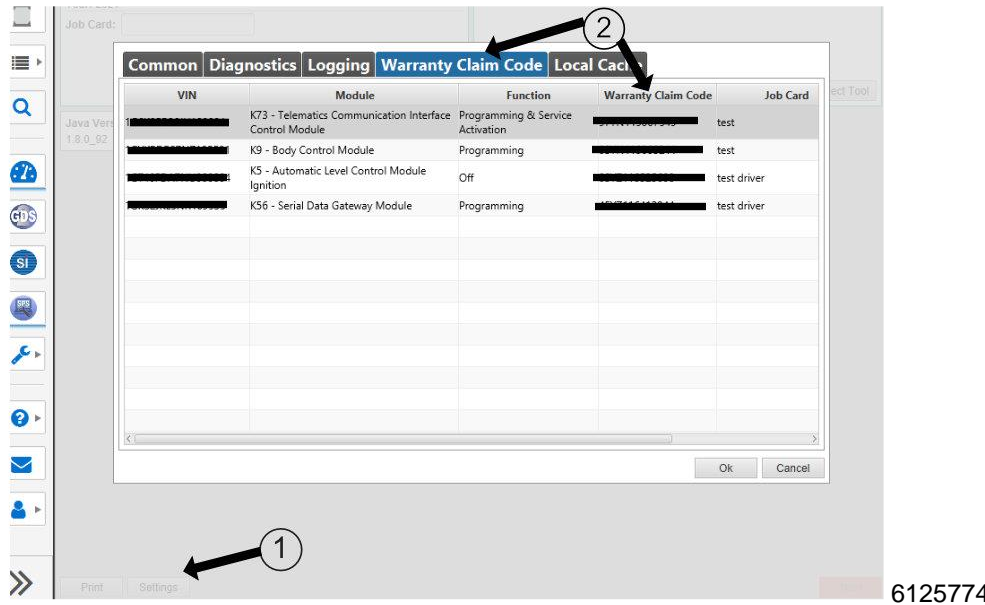
Warranty Claim Code Information Retrieval

If the Warranty Claim Code was not recorded on the Job Card, the code can be retrieved in the SPS2 system as follows:

1. Open TLC on the computer used to program the vehicle.
2. Select and start SPS2.
3. Select Settings (1).
4. Select the Warranty Claim Code tab (2).

The VIN, Warranty Claim Code and Date/Time will be listed on a roster of recent programming events. If the code is retrievable, dealers should resubmit the transaction making sure to include the code in the SPS Warranty Claim Code field.

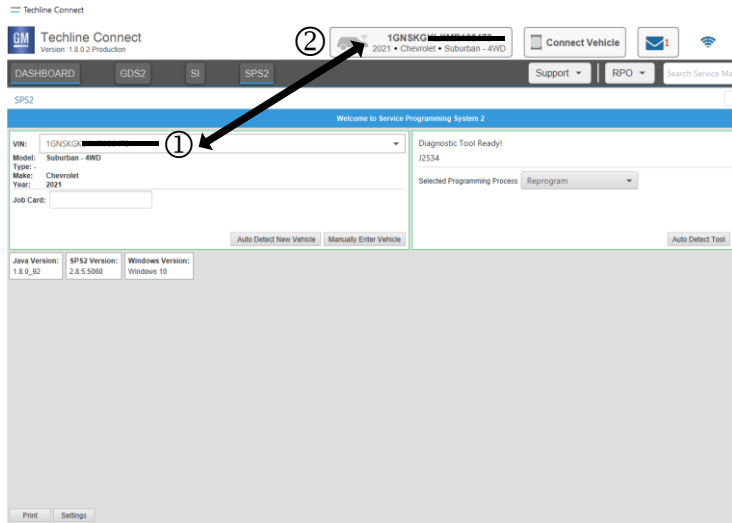
5743643

Caution: Be sure the VIN selected in the drop down menu (1) is the same as the vehicle connected (2) before beginning programming.

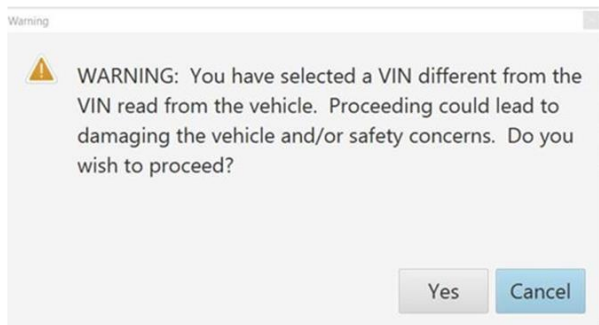
5877000

Important: If the vehicle VIN DOES NOT match, the message below will be shown.

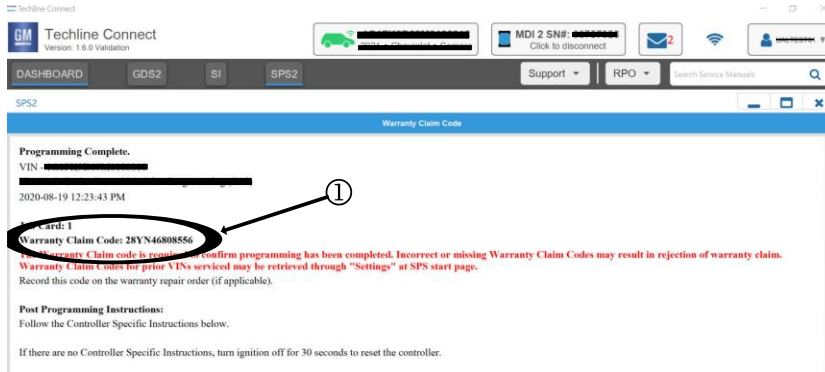
5644478

Note: The screenshot above is an example of module programming and may not be indicative of the specific module that is being programmed. Module selection and VIN information have been blacked out.

1. Reprogram the Body Control Module. Refer to *K9 Body Control Module: Programming and Setup* in SI.

Important: To avoid warranty transaction rejections, you **MUST** record the warranty claim code provided on the Warranty Claim Code (WCC) screen shown above on the job card. Refer to callout 1 above for the location of the WCC on the screen.

2. Record SPS Warranty Claim Code on job card for warranty transaction submission.
