Service Bulletin

Front Corner Weld Reinforcement on Fiberlite POD and POD XL Replaceable Tongue Frame

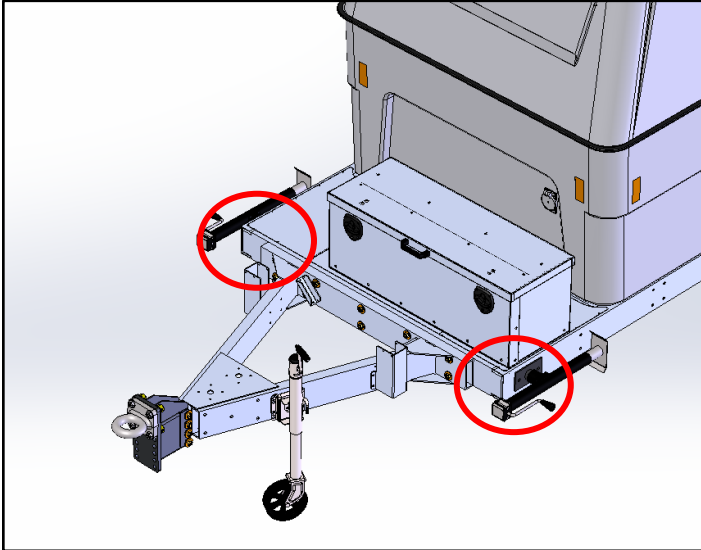
Inspection location – Top View

Inspect the welds between the frame rails and front cross-member. Picture below shows a representative trailer with the impacted areas circled in red.

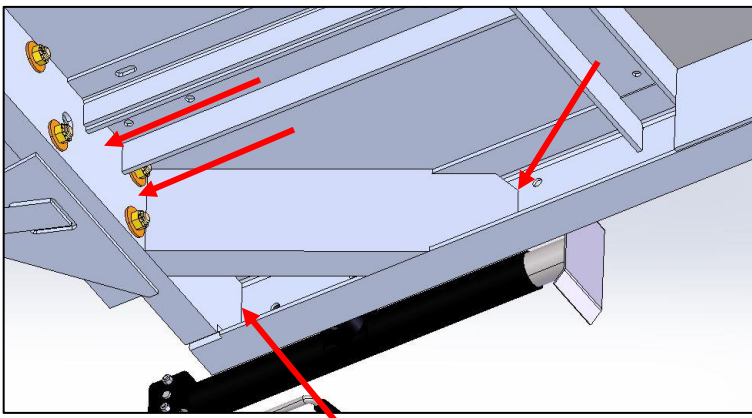
Inspection Location – Bottom View

In order to fully inspect the affected areas, the inspector must view the frame from underneath. The representative image below is a view of the front curbside corner of the frame weldment from underneath the trailer. The red arrows point to the specific weld joints to closely inspect for any cracks in or around the welds. Be sure to check the weld joints on both the street side and curbside of the trailer.

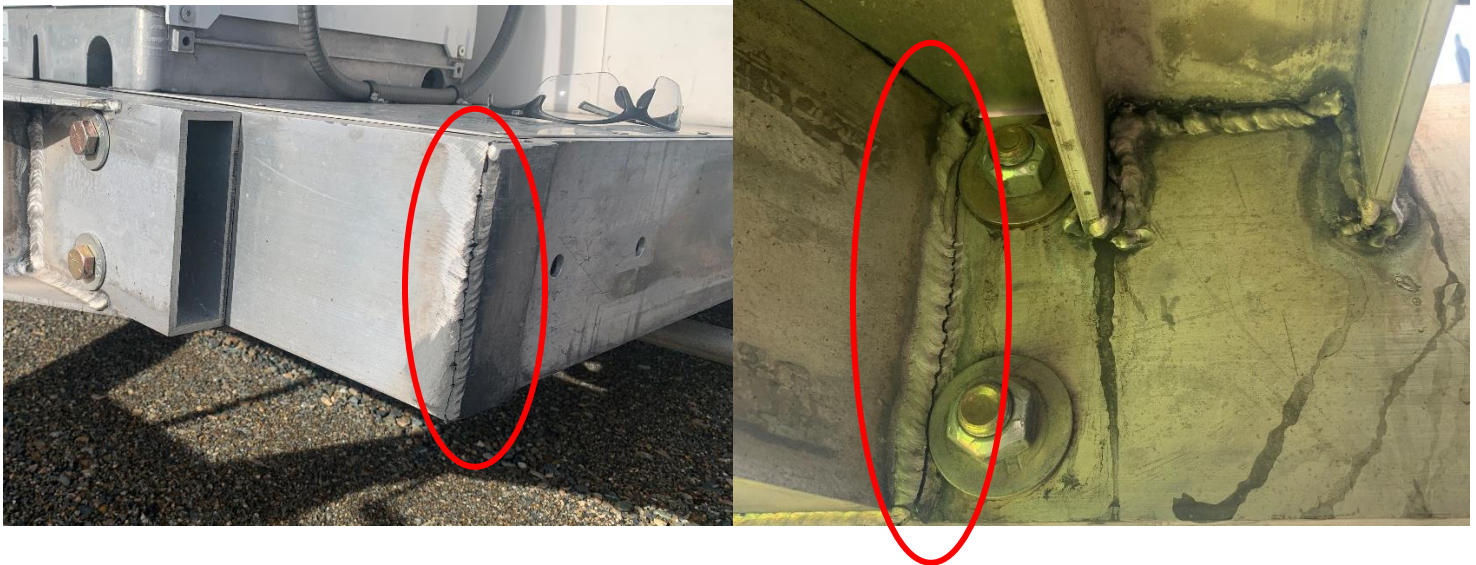
Representative pictures of cracked welds for a trailer that should be immediately removed from service are below:

In the event that a crack is discovered during the inspection in these areas, do not attempt to use the trailer for routine use.

With the trailer jacks deployed and the trailer fully secured, remove any heavy equipment (within reason) and contact Pelsue immediately to report the case. Pictures of the trailer and any cracks or failures can be sent to service@pelsue.com along with identifying information on the customer and trailer model.
