INSTRUCTION TO SERVICE

ITS: 60843		October 18, 2023
SECTION:	304- Paint & Decals	
WRITTEN BY:	Troy Stutsky	
SUBJECT:	Incorrect GVWR on Vin decal. Replace affected portion of VIN decal.	
ISSUE:	Incorrect data was provided to the production clerk responsible for VIN decal creation. The GVWR is incorrect.	
SUMMARY:	A new portion of the VIN decal will be created with the correct GVWR on it. This will be affixed on top of the incorrect information on the existing decal.

ITS60843

Ref. NHTSA Recall No.	Ref. Transport Canada Recall No.
23V711	Not Applicable

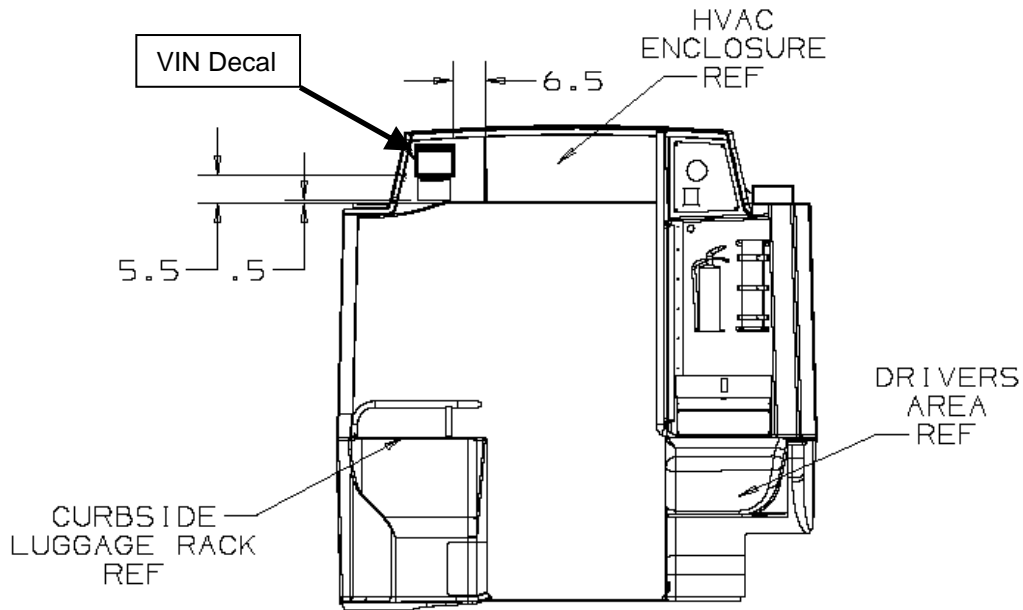
Figure 1: Existing VIN Decal Location

1. Set park brake and chock wheels.
2. Turn the main battery disconnect switch to the "OFF" position.
3. Locate the existing VIN decal on the HVAC enclosure. See Figure 1.

4. Carefully center and affix the new decal portion (NF PN 055088) with the correct GVWR information on it directly over the existing decal with the incorrect GVWR information or it. See Figure 2.
