# VOLUNTARY RECALL CAMPAIGN

Classification: DA23-009	Reference: NTB23-082	Date: October 26, 2023
-----------------------------	-------------------------	---------------------------

## VOLUNTARY SAFETY RECALL CAMPAIGN 2023-2024 Z; LEFT FRONT BUMPER CLIP

**CAMPAIGN ID #:** R23C8  
**APPLIED VEHICLES:** 2023-2024 Z (Z34)

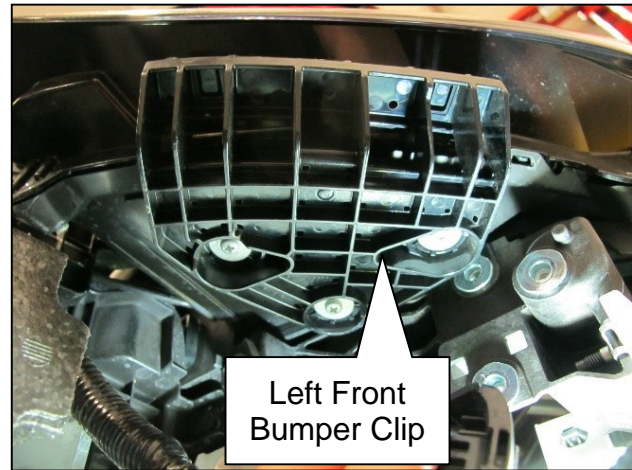
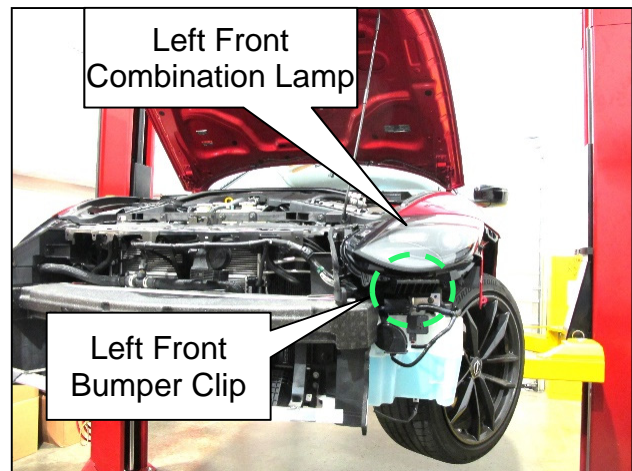
- The Left Front Bumper Clip is attached to the bottom of the Left Front Combination Lamp.

7. Locate the Left Front Bumper Clip.
