SAFETY RECALL

12V Isolator Post

Reference: B0A / NHTSA 23V-753

Remedy available for
2023 (RU) Chrysler Pacifica

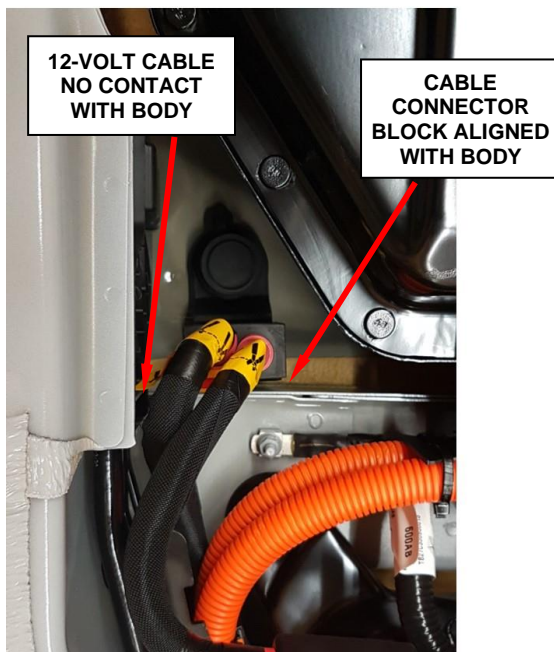
Acceptable

- 12-volt cable is NOT contacting the body
- Cable connector block is aligned with body NOT rotated or contacting the body

NOTE: The 12-volt cable terminal connector block may rotate during tightening. Ensure the connector block stays stationary during tightening and is properly aligned when fully tightened. Connector block should not be visibly rotated and cables should not be touching any metal surfaces after the terminal nut has been tightened to the proper torque specification (Figure 29).

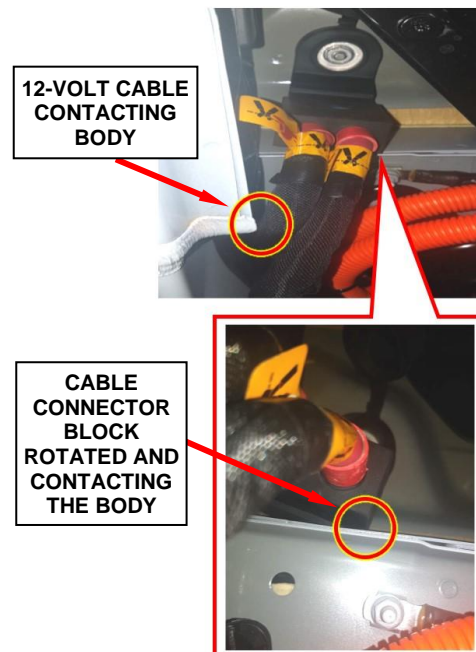
Not Acceptable

- 12-volt cable is contacting the body
- Cable connector block is rotated and contacting the body
