Subarunet Announcement

From: Subaru of America, Inc.

Date: December 14, 2023

UPDATE Safety Recall/STOP SALE: WRP-23 Driveshaft Failure

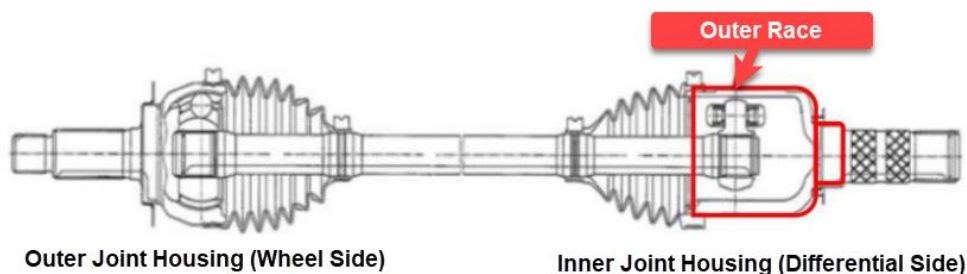
The vehicles included in this recall may be equipped with a front drive shaft assembly with an outer race (shown below) that could crack, due to improper cooling during the manufacturing process.

Over time, a cracked outer race could break, potentially resulting in loss of motive power. Additionally, if the outer race breaks, the vehicle may roll when parked if the parking brake is not applied. Both conditions increase the risk of a crash.

For stop sale and SSLP vehicles only, Subaru retailers should inspect the front drive shaft lot numbers. If the affected lot number is found, the vehicle is to remain on HOLD under this stop sale until recall remedy parts are available. A future announcement will be made when parts are available.

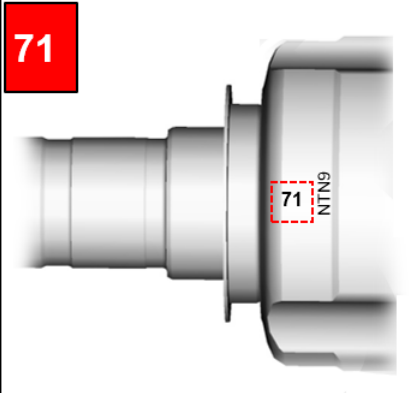
71

Results					
71, 73 or 75		The drive shaft is a defective part. The vehicle is to be placed on HOLD under Stop Sale until further notice.			
Other 2-digit numbers		The drive shaft is a good part. Record and attach the lot number to the repair order.

YES: The vehicle should remain on HOLD under Stop Sale until remedy parts are available. No claim should be submitted until the affected driveshaft(s) are replaced.
