PRODUCT CAMPAIGN BULLETIN

APPLICABILITY: 2021MY Crosstrek
 2022MY Forester
 2021-23MY Legacy
 2021-23MY Outback

NUMBER: WRQ-23R

SUBJECT: Safety Recall – Transmission Inhibitor Switch Replacement

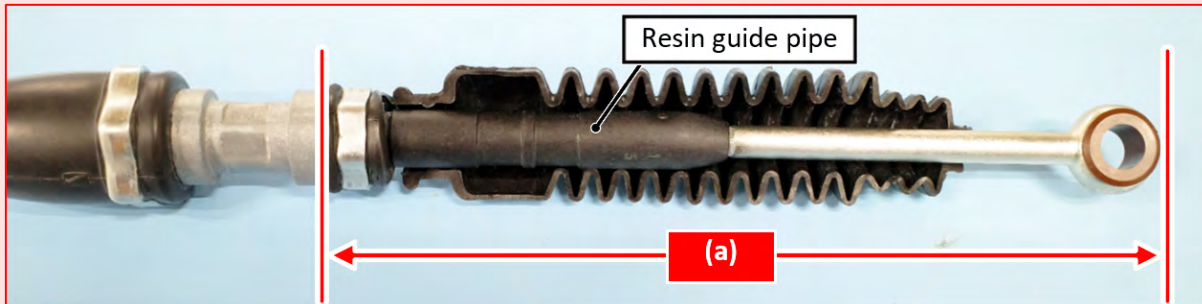
DO NOT apply an impact or a load to part (a) of the gear selector cable shown in the picture below. Doing so may damage the resin guide pipe inside the boot.

If the resin guide pipe is damaged, the inner cable can become slackened when operating the gear selector lever and the shifter arm become inoperative. As a result, the shift positions of the gear selector lever and the inhibitor switch do not match, causing malfunctions such as an engine no crank/no start condition.

Due to the resin guide pipe and the inner cable being unable to be seen, **CAREFULLY** remove and install the gear selector cable.
