SAFETY RELATED RECALL

Global Recall Action
Number: N845

Subject: Oil Cooler Pipe Joint Integrity Concern	Publication No.: N845
	Model: Range Rover (LK)
	Model Year: 2024
	Date of Issue: 06 December 2023

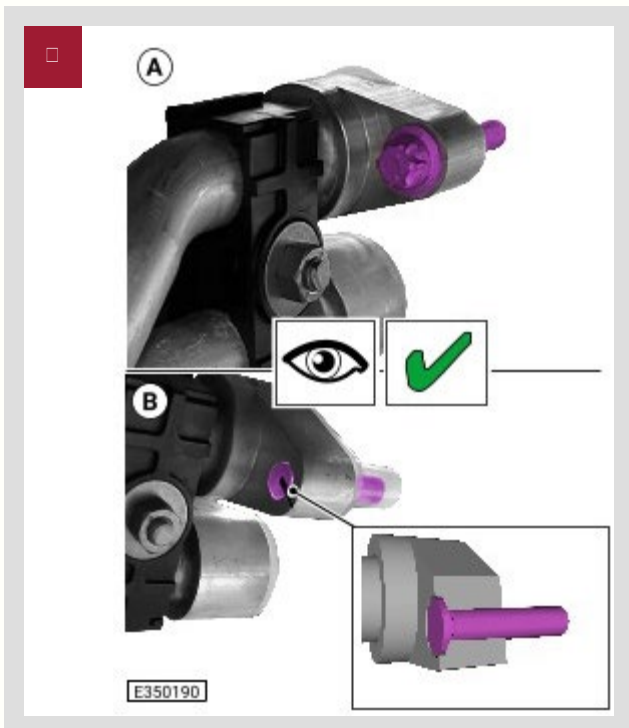
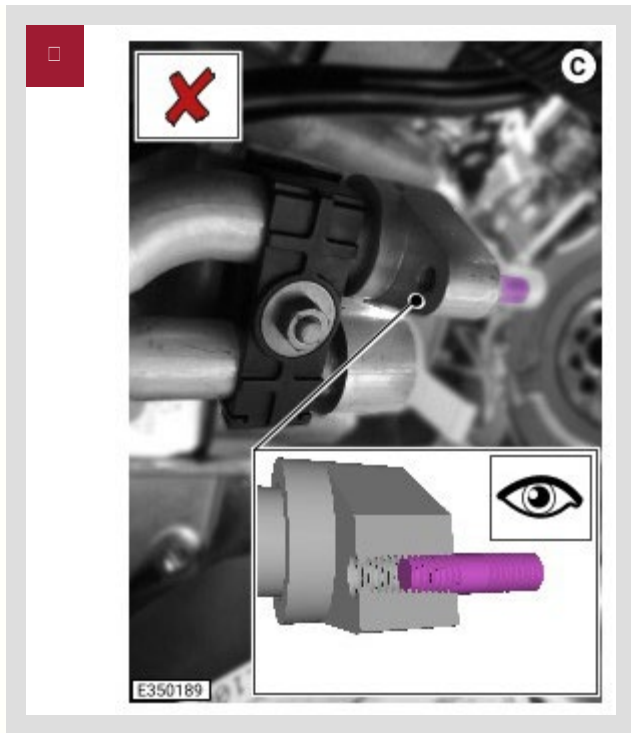
- The image labeled 'A' shows a reworked engine oil cooler pipe with a suitable bolt installed through the joint from the rear of the vehicle.
- The image labeled 'B' shows a new level engine oil cooler pipe with a suitable stud installed through the joint from the rear of the vehicle. The stud can be seen from the rear of the joint.
- The image labeled 'C' shows an previous level engine oil cooler pipe with a stud installed into the joint from the front of the vehicle. The stud cannot be seen from the rear of the joint.
- Use a suitable mirror to inspect the rear of both engine oil cooler pipe joints.

Inspect the fixings/studs on both engine oil cooler pipes.

- If **BOTH** engine oil cooler pipes **ARE** installed with **EITHER** the reworked fixing or the new level stud shown in the image 'A' and 'B' with a **GREEN '✓'**, the vehicle has **PASSED** the inspection. Reverse steps 1 to 3 and release the vehicle.
- If **1 or BOTH** engine oil cooler pipes **ARE** installed with a previous level stud as shown in the image 'C' with a **RED 'X'**, the vehicle has **FAILED** the inspection. Continue to the **SERVICE INSTRUCTION A**. To renew the previous level studs that have failed the inspection.

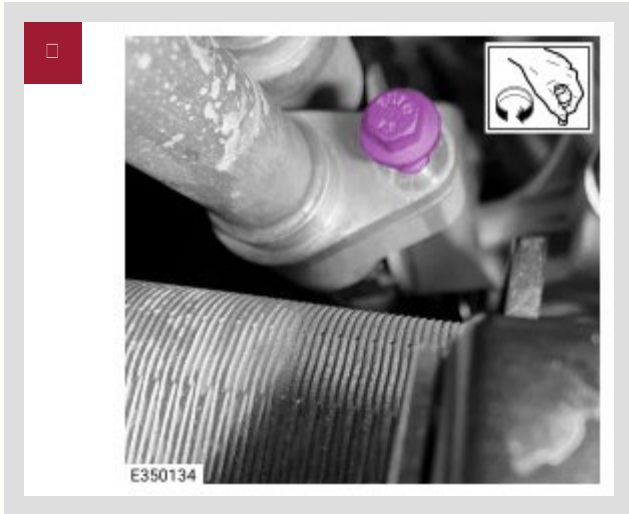
The stud should release from the engine oil cooler pipe during the removal of the nut.

Remove the nut/stud assembly.

- If a stud cannot be removed from an engine oil cooler pipe when removing the nut, additional attempts must be made using different techniques. For example, the double nut / jam nut method, using a stud extractor or tightening the nut to 15 Nm and removing the nut again.
 - If a stud still cannot be removed from the engine oil cooler pipe, continue to **SERVICE INSTRUCTION B**
