SIB 65 36 23

## RECALL 23V-797: DRIVER AIR BAG

This Service Information Bulletin (Revision 1) replaces SI B65 36 23 **dated November 2023**.

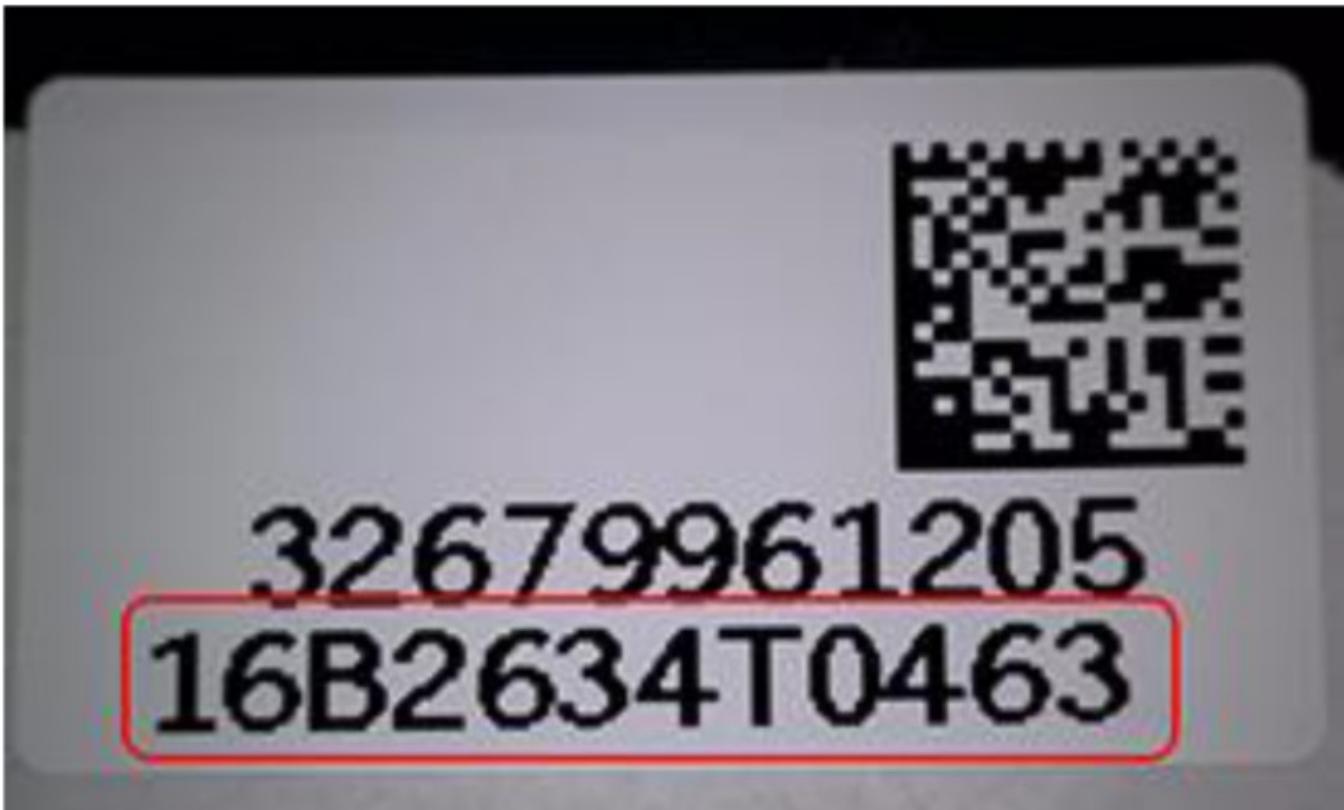
Before installing the replacement part, the new air bag module's serial number (circled above) must be documented by the technician on the repair order so it can also be entered into the warranty claim's comment section.
