SAFETY RECALL

Communication #: I-23-07

Model Year(s): 2023–2024

SUBJECT: HEAVYWEIGHT CRANKSHAFT POSITION SENSOR REASON FOR THIS RECALL

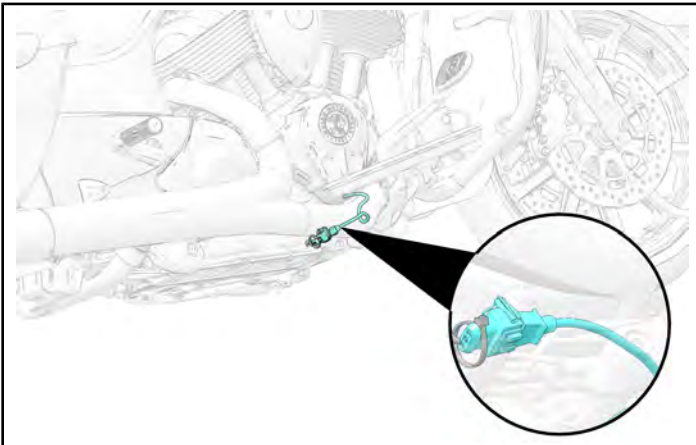
1. Park motorcycle on a flat surface, fully extend side stand, and make sure vehicle is stable.
2. Turn key or ignition switch to OFF position and remove key. If equipped with keyless fob, remove fob from proximity of vehicle.
3. Inspect crankshaft position sensor wiring for damage and routing:

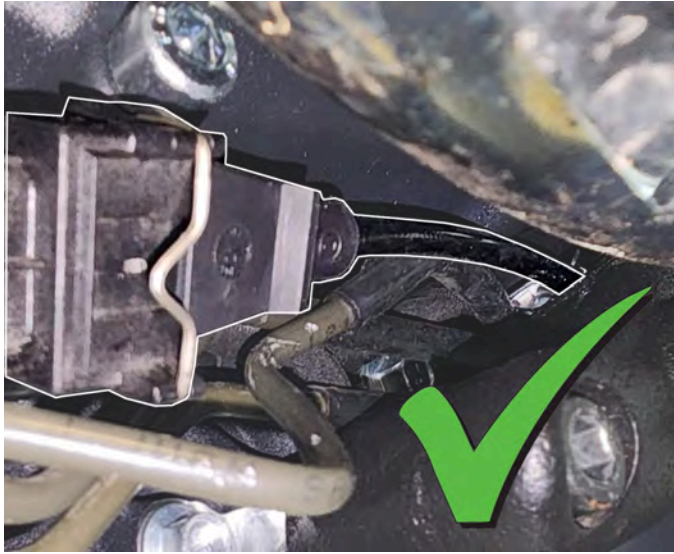
CRANKSHAFT POSITION SENSOR WIRING IS NOT DAMAGED

- Continue to **Step 4**

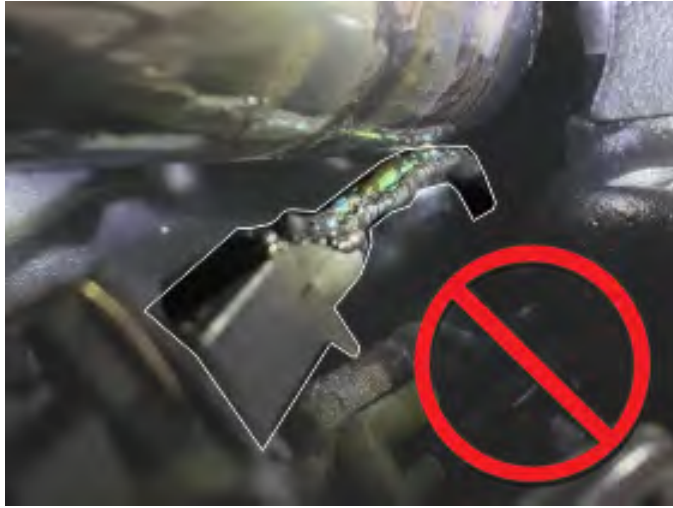
CRANKSHAFT POSITION SENSOR WIRING IS DAMAGED

- Continue to **I-23-07-AB Replace and Retain**

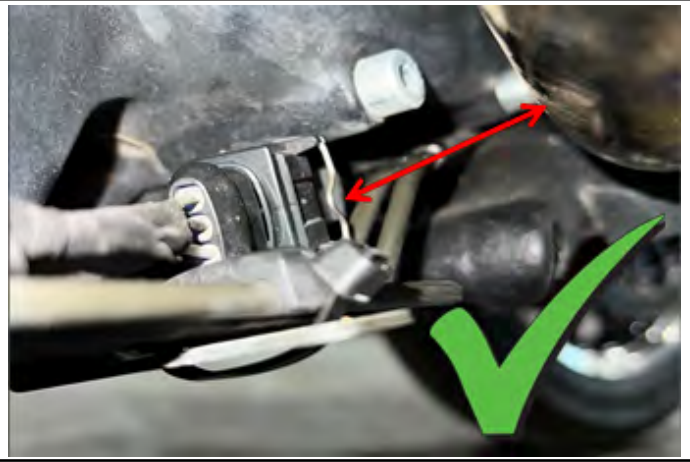
IMPORTANT
Ensure there is proper distance between the crank positions sensor and headpipe.

4. Adjust crankshaft position sensor connector position as needed.
